Comparative scanning electron microscope study of the degradation of a plasticized polyvinyl chloride waterproofing membrane in different conditions

A. Pedrosa✉, M. Del Río

Escuela Técnica Superior de Edificación de Madrid, Universidad Politécnica de Madrid (Madrid, Spain)
✉a.pedrosa@alumnos.upm.es

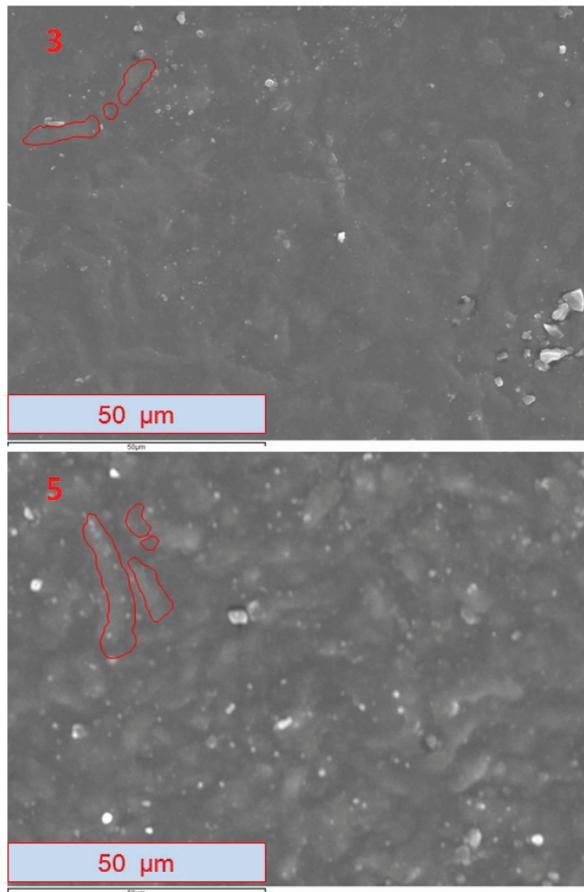
The color of the surface of sample 3cXPSshaded (Figure 3 - image 3) has become darker in comparison with the original sample (5Original in Figure 3 - image 5), making it difficult to distinguish the rounded and elongated shapes, which are much

FIGURE 3. The image presents a comparison between micrographs at 1000 magnification. Micrographs were taken in (SE) mode with a resolution of 1024 x 786 pixels. Image 3 shows 3cXPSshaded; image 5 shows 5Original.

clearer in the original sample. The 3cXPSshaded sample had remained under the extruded polystyrene (XPS) board, in a shaded area of the roof.

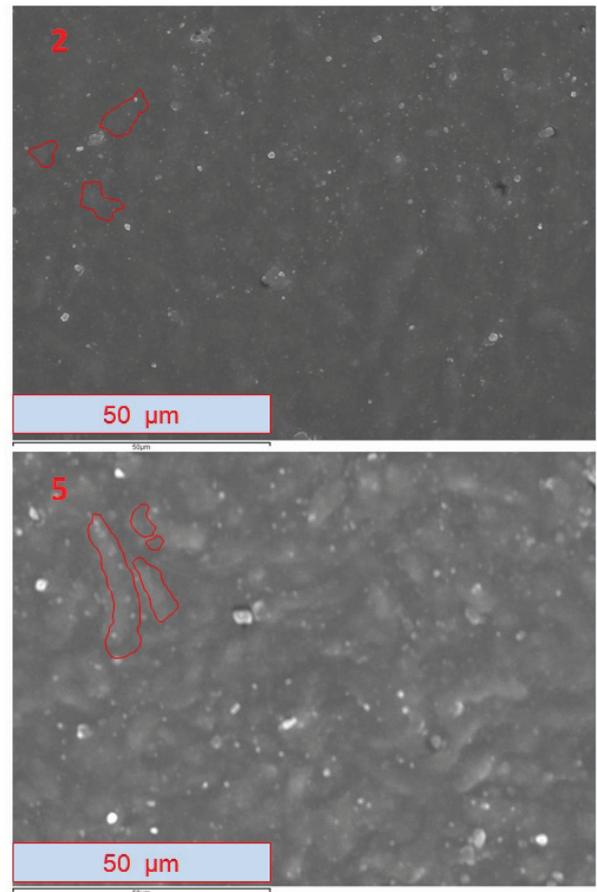
FIGURE 4. The image shows a comparison between micrographs at 1000 magnification: in image 2, 2cXPSsunnyNOInter; in image 5, 5Original. Micrographs were taken in (SE) mode with a resolution of 1024 x 786 pixels.

The color of the surface of sample 2cXPSsunnyNOInter (Figure 4 - image 2) has become uniform and is much darker than it is in the original sample (5Original in Figure 4 - image 5). In certain areas of the 2cXPSsunnyNOInter micrograph, the characteristic rounded and elongated shapes of the polymer's surface are not visible. This sample remained under the XPS in a sunny area of the roof. The darker color of the sample in comparison with the one obtained in 3cXPSshaded (Figure 3 - image 3) is probably caused by higher temperatures in that part of the roof.

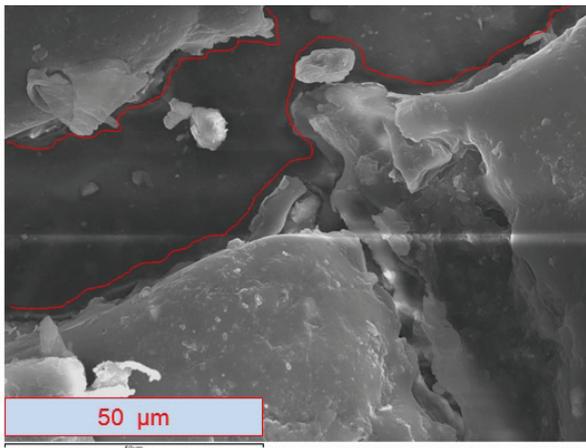
Interaction between PVC-P and XPS implies a chemical reaction that transforms XPS (a plastic foam with low density) into a new material with greater density. This phenomenon involves a substantial volume variation in the XPS. The characteristics of the resulting material make its distribution irregular. Thus, on the surface of the PVC-P sample shown in Figure 5 there is no irregular interaction or lack thereof, but a consequence of interaction.

FIGURE 5. Micrograph of sample 1cXPSsunnyInter at 1000 magnification, with remains of interaction between PVC-P and XPS. The area enclosed by red lines is free of interaction remains. The micrograph was taken in (SE) mode with a resolution of 1024 x 786 pixels.

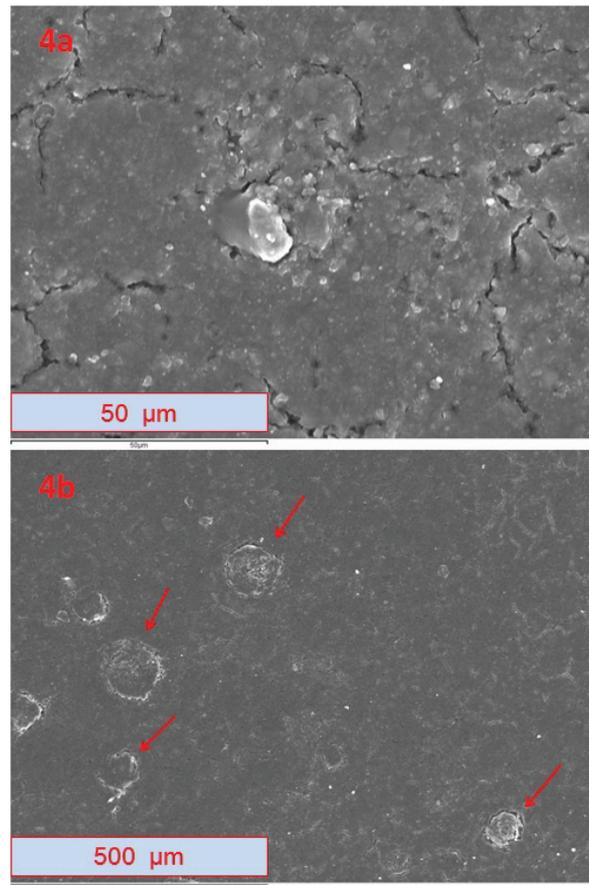
The surface of the polymer is substantially deteriorated and there are numerous cracks and fractures in its surface. Direct exposure to environmental elements caused great degradation in the polymer. The sample underwent a great incidence of direct solar radiation, as well as direct and prolonged exposure to harmful weather conditions such as hail, high temperatures and frost cycles.

In the bottom half of Figure 6 image 4b, many cracks and fractures can again be seen on the surface of the polymer. In addition to this, there are other erosions marked with red arrows. These circular shape erosions look like craters in the surface of the polymer and were probably produced by hail. Both micrographs were taken in SE mode.

Another important factor must be taken into account in considering hail damage: the waterproofing membrane's age. This is the case of sample 4H-exposed: the aged waterproofing membrane has lost a great deal of its initial characteristics, meaning the material has lower resistance to deformation, has

FIGURE 6. Micrographs of sample 4H-exposed, which were taken in (SE) mode with a resolution of 1024 x 786 pixels. Image (4a) shows the sample at 1000 magnification; image (4b), shows the sample at 100 magnification. There are numerous cracks and fractures; micrograph (4b) additionally shows craters, which are marked with red arrows.

become stiffer and may suffer great damage from the impact of hail.

The crater-like erosions were probably caused by relatively recent hail impacts on the surface of the polymer. It is highly unlikely that hail could cause significant damage to a relatively new PVC-P waterproofing membrane. One of the most important pathologies of an aged PVC-P is plasticizer loss (3). An unplasticized PVC-P waterproofing membrane cannot withstand hail impacts without any damage to its surface.

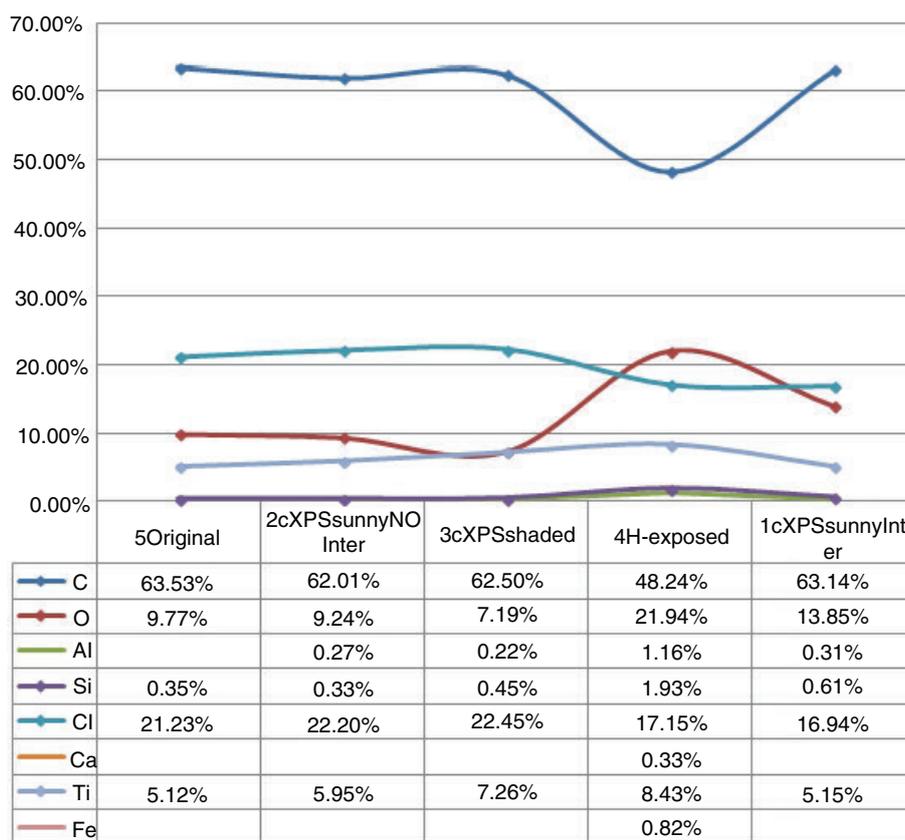
The elemental analysis of sample 4H-exposed shows a highly deteriorated polymer. The carbon content has decreased from 63.53% to 48.24%. The backbone of a polymer is formed by a chain of carbon atoms. The chlorine content has decreased from 21.23% to 17.15%, which clearly indicates a dehydrochlorination process in the polymer.

Sample 1cXPSsunnyInter had been covered with XPS while it was in service. Additionally, however, in this area the XPS interacted with the PVC-P. In view of the results, the interaction between these materials had a significant effect on the chemical composition of the PVC-P. The chlorine content decreased from 21.23% to 16.94%, which means the dehydrochlorination of this sample is slightly greater than that obtained in the analysis of sample 4H-exposed. Dehydrochlorination could be the main mechanism of deterioration, since the percentage of carbon is practically the same.

FIGURE 8. At the top, a graphical representation of the results of the elemental analysis in mass percentage. At the bottom, all of the data obtained in the analysis; the chemical elements shown are carbon, oxygen, aluminum, silicon, chlorine, calcium, titanium and iron.
