Characterisation and diagnosis of heritage concrete: case studies at the Eduardo Torroja Institute, Madrid, Spain

✉ P.M. Carmona-Quiroga^a, A. Pachón-Montaño^a, J. Queipo-de-Llano^a, J.A. Martín-Caro^{b,c},
D. López^b, I. Paniagua^b, I. Martínez^a, F. Rubiano^a, I. García-Lodeiro^a, L. Fernández-Ordóñez^d,
M.T. Blanco-Varela^a, E. Frías-López^a

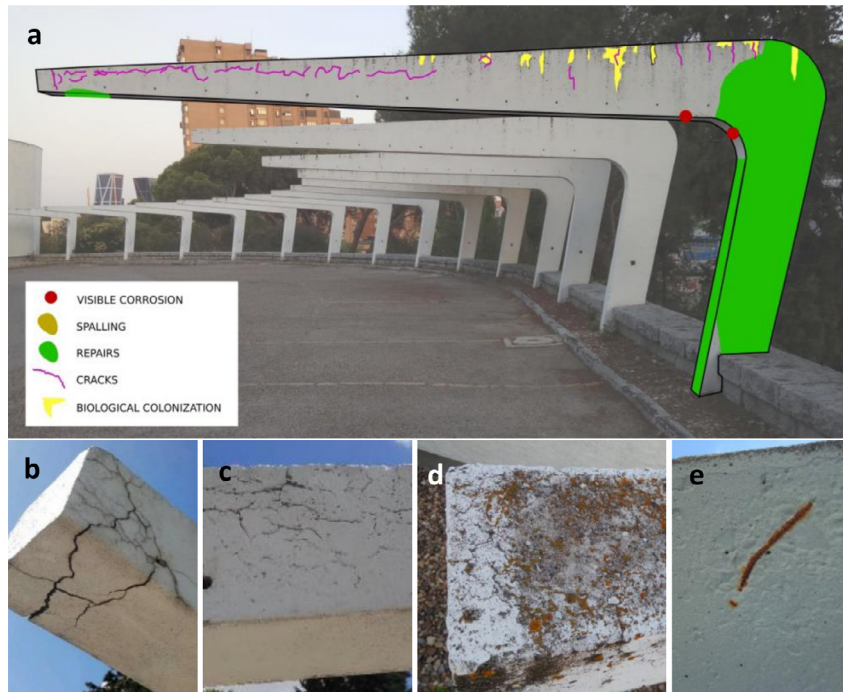
The present visual inspection (Figure 3) revealed concrete cracking at the top and especially at the tip (Figure 3(b)) of the supports, material loss, biological colonisation and corrosion in the exposed rebar.

FIGURE 3. Damage mapping in the car park pergola: (a) Diagnosis. (b) Significant cracking. (c) profuse cracking. (d) Biological colonisation. (e) Steel corrosion.

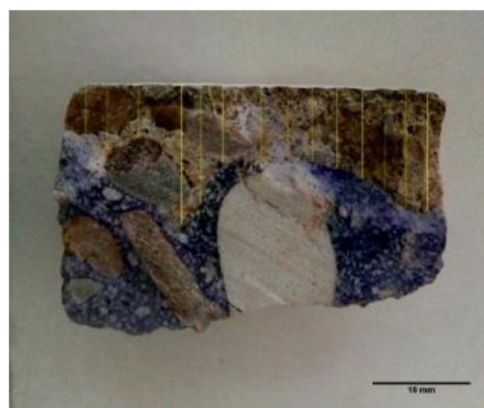
very deep, despite the high levels of air pollution to which the material has been exposed over the years: mean CO₂ penetration was 8.7 mm, with a maximum of 12 mm (Figure 6, Table 2).

FIGURE 6. Surface of freshly broken core sample drawn from the car park pergola after spraying with thymolphthalein (blue dye = non-carbonated material).

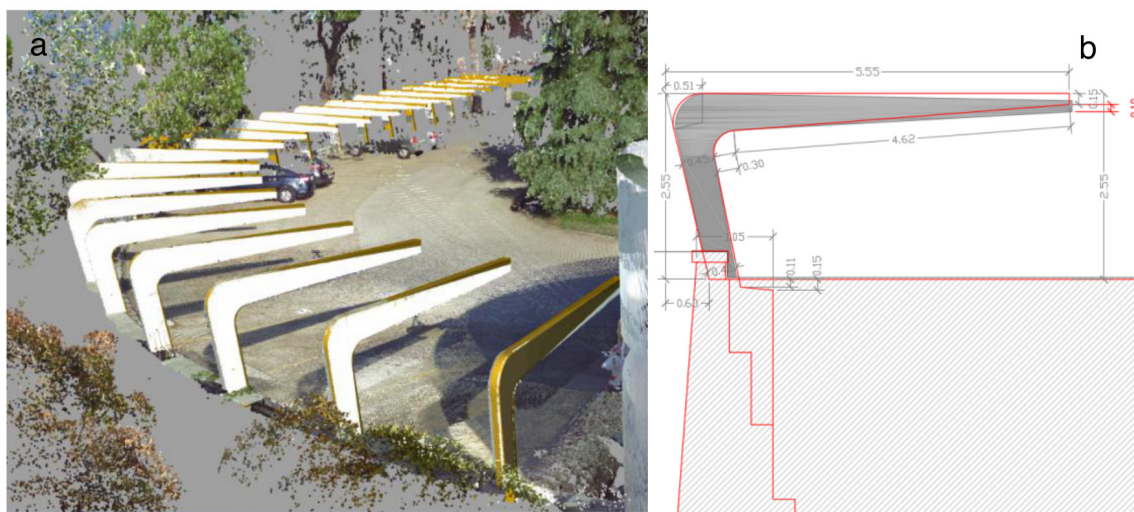
lapsing since construction. The 8 cm to 15 cm slump at the edge of the overhang relative to the design and a curved deformation on its upper side together determined a 0.8 cm to 2 cm difference in mid-span height. Although the value of the slump appearing initially is unknown, the curved deformation along the top of the element might hold a clue to the deflection incurred since it was built (bearing in mind that the formwork used was flat). That relative deformation is in keeping with today's legislative provisions on the construction of cantilevered structural floors in buildings (62). The rest of the slump may be due to rotation in the restrained end, as the overlain geometries (Figure 7(b)) would appear to indicate, and/or related to flawed workmanship or levelling during construction. Moreover, the pergola has to bear only its own weight and no pathologies were observed that would entail structural risk. The deformation nonetheless generates

FIGURE 7. (a) Point cloud (white units) and design geometry (gold unit). (b) Design (red outlining, grey lettering) and built (grey shading) geometries and deformation (red lettering).

tensile stress in the top surface of the overhang that favours the appearance of small or the enlargement of existing cracks on that surface, the one most exposed to rainwater. It should consequently be protected to prevent subsequent pathologies.

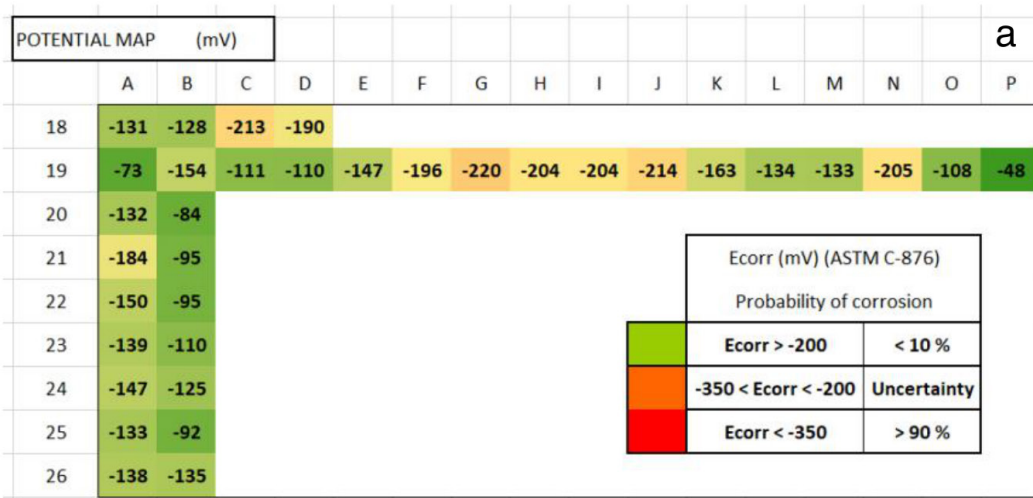
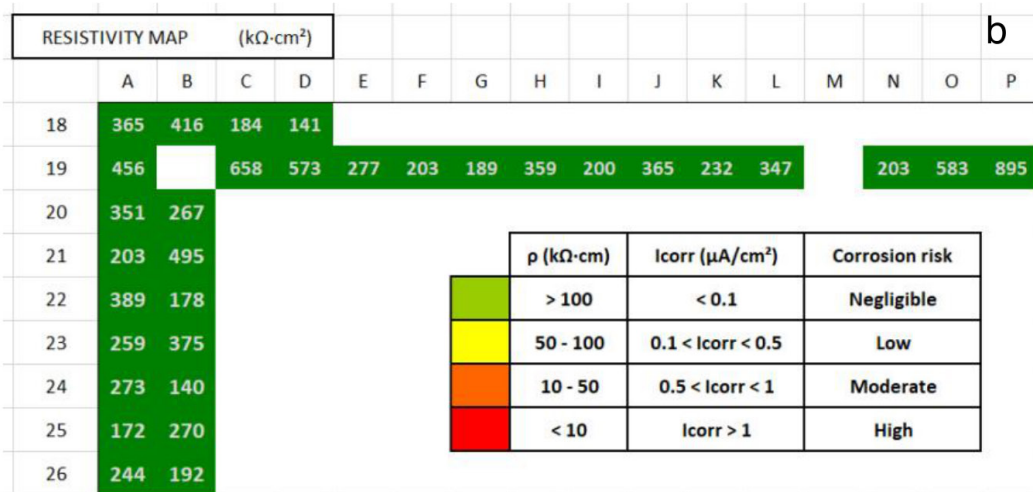
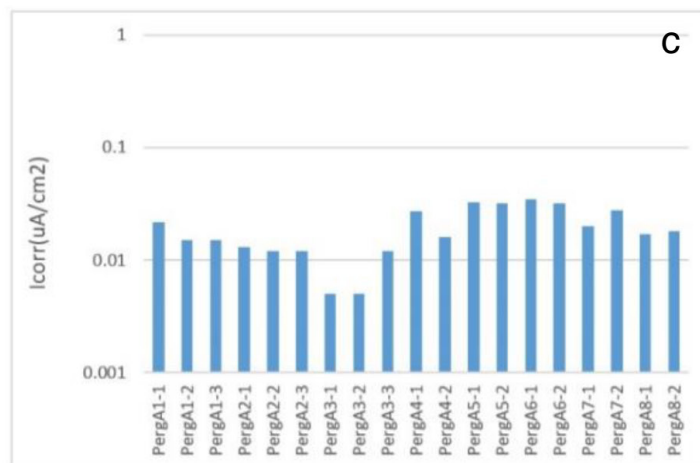
The electrical resistivity and corrosion potential measurements were below the threshold values defined for steel de-passivation, indicating negligible corrosion and high levels of steel corrosion resistance at this time (Figure 8). All the corrosion rate readings taken in the on-site inspection were likewise very low, corroborating the results observed for the other parameters (Figure 8). To determine representative values of corrosion it will be necessary to monitor the structure, determining corrosion parameters variation with environmental parameters and concrete saturation degree. So these measurements are informing us about the actual corrosion progress but we have no information about what happened before.

FIGURE 8. In situ corrosion measurements in pergola unit 1: (a) Corrosion potential. (b) Resistivity. (c) Corrosion rate.

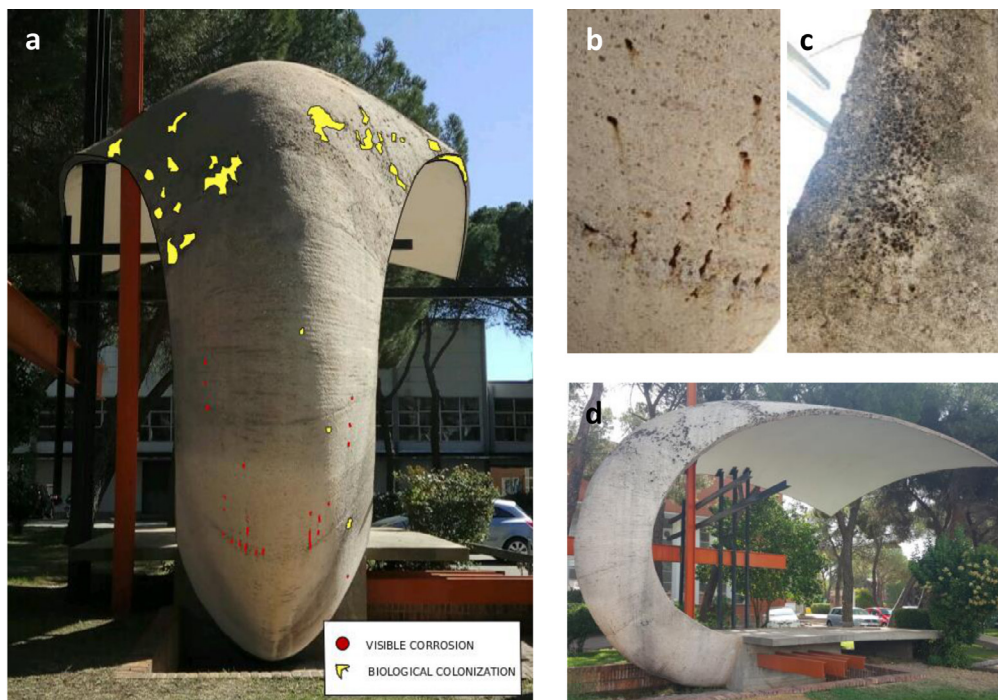
The damage map drawn on the occasion of this analysis shows corrosion in the areas where the reinforcement is exposed, along with biological colonisation, on the top surface of the shell in particular (Figure 10).

FIGURE 10. Damage in rib-like shell: (a) Diagnosis. (b) Steel corrosion. (c) Biological colonisation. (d) Overview.

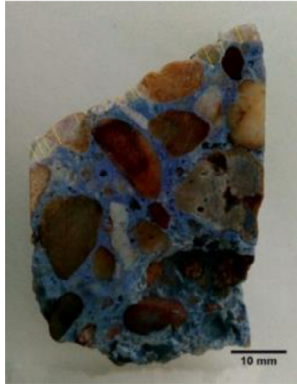
Compressive strength at 33.3 MPa and Young's modulus at 41.1 GPa were similar to the values expected of healthy concrete and similar as well to the findings observed for the pergola. Corrosion resistance, at dry (447.29 kΩ·cm) and saturated (20.07 kΩ·cm) electrical resistivity values, was higher in the shell than in the pergola and the carbonation front shallower (mean 2.6 mm, maximum 4.1 mm; Figure 12), due largely to its lower porosity (6 %).

FIGURE 12. Surface of freshly broken core sample drawn from rib-like shell after spraying with thymolphthalein (blue dye = non-carbonated material)

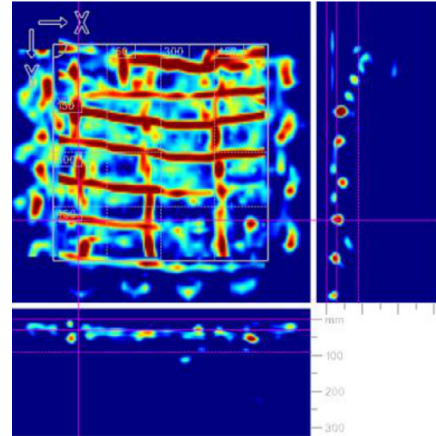
Although a cover of up to 40 mm was specified for the slab (Table 3), according to the GPR findings (Figure 13) the concrete protecting the reinforcement from potential environmentally-induced corrosion is <30 mm. In some sporadic instances there is no cover whatsoever (Figure 10), due to the difficulties involved in laying the forms and positioning the reinforcement described by Cassinello *et al.* (37). Those problems were exacerbated by design specifications calling for a cover of just 10 mm at the unrestrained edge of the structure (Table 3).

FIGURE 13. Shell reinforcement.

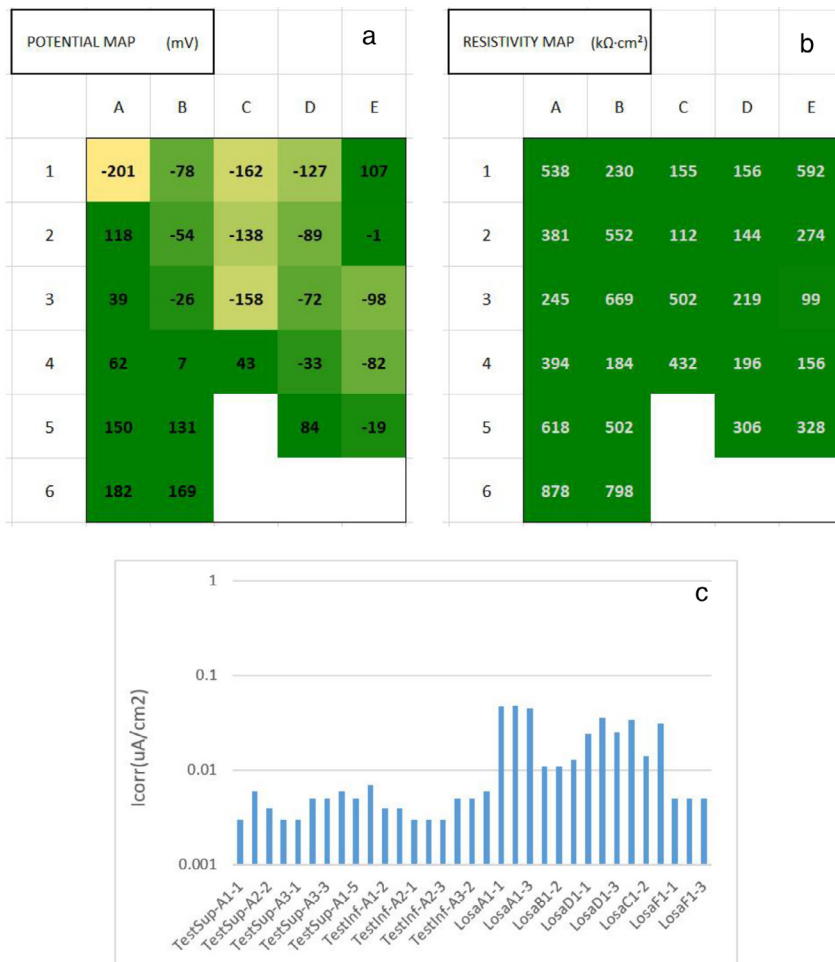
findings revealed that the risk of active corrosion in the slab concrete is low at this time (Figure 14), for like in the pergola, the threshold value indicative of steel de-passivation has not been reached.

FIGURE 14. In situ corrosion measurement in the rib-like shell slab: (a) Corrosion potential. (b) resistivity. (c) corrosion rate.

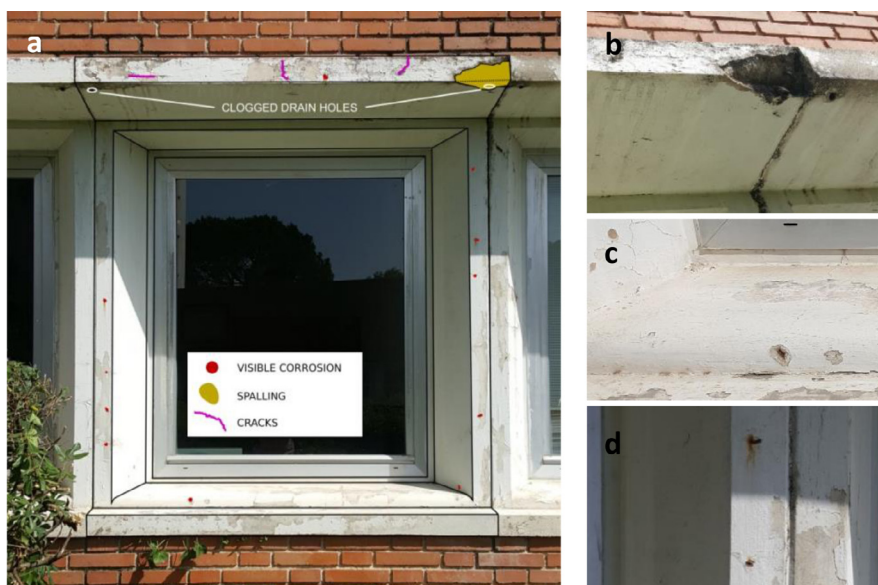
The present damage map shows both corrosion issues and some cracking. The most prominent problem observed was clogged drainage and the resulting ponding of water in the top member. That in turn has often generated further damage in the form of mortar corrosion and crumbling due to cementitious matrix dissolution. Part of one of the corners on the lintel in poorest condition was observed to have detached completely in response to corrosion (Figure 16).

FIGURE 16. Window damage: (a) Diagnosis. (b) Spalling. (c, d) steel corrosion.
