# Electrical resistivity tomography for moisture dynamics analysis in historic adobe structures: practical case of Casa Terán, Aguascalientes, México

**ABSTRACT:** This study employs Electrical Resistivity Tomography (ERT) to analyze moisture dynamics in an adobe wall of Casa Terán, a historic building in Aguascalientes, Mexico. By modifying the ERT technique with medical electrostimulators, the study identifies the causes and propagation patterns of moisture based on material properties. Previous interventions are also reviewed to determine the materials used. By integrating geotechnical and geoelectrical data, the study evaluates subsurface saturation levels, moisture propagation zones, and potentially weak areas in the wall. The correlation of ERT derived models with intervention images helps interpret the influence of construction materials on moisture propagation. This research is crucial for conserving historic structures and mitigating moisture-induced damages.

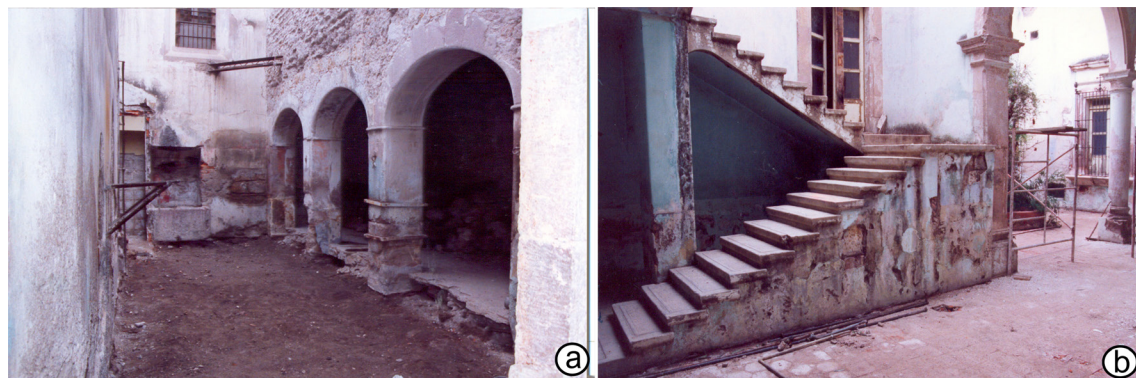
**FIGURE 1.** Images obtained from the interior of the Casa Terán in 1991. Humidity problems are observed in the lower part of the walls, inferior stairs and structural elements. a) Stable area, currently a covered patio with a cinema area. b) Stairs over the corridor on one side of patio 2.

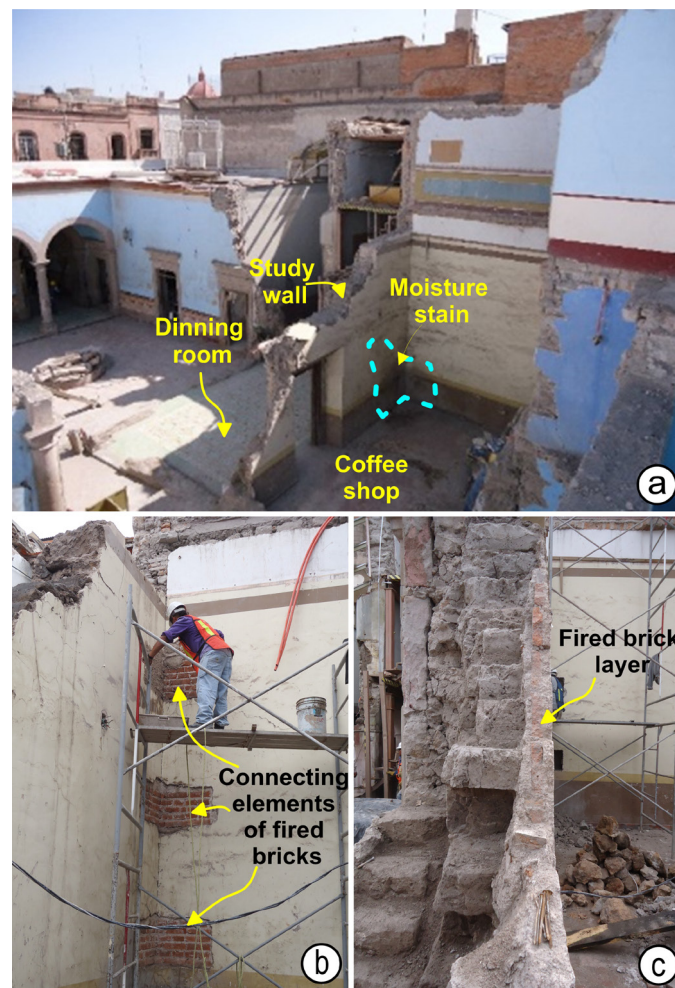
Before the explosion, the wall had moisture ascending from the subsoil (a diagonal stain on the wall is indicated in Figure 3a), thus, in the first intervention of 1991, knapen siphons (systems of tubes introduced to the wall at an angle to reduce humidity) were placed in the wall every 0.80 m and at 0.5 above the finished floor level, staggered pattern on both sides. For this intervention, the wall was completed with adobe blocks similar to the original ones, they were bonded with slaked lime mortar and were placed flattened with slaked lime and sand to create compatibility between the materials and to favor the proper transpiration of the wall.

**FIGURE 3.** Images after the 2012 explosion. a) View of the first patio, dining room, and coffee shop after debris removal. b) Elaboration of connecting elements of fired bricks between walls. c) Section of the partially collapsed wall (32).

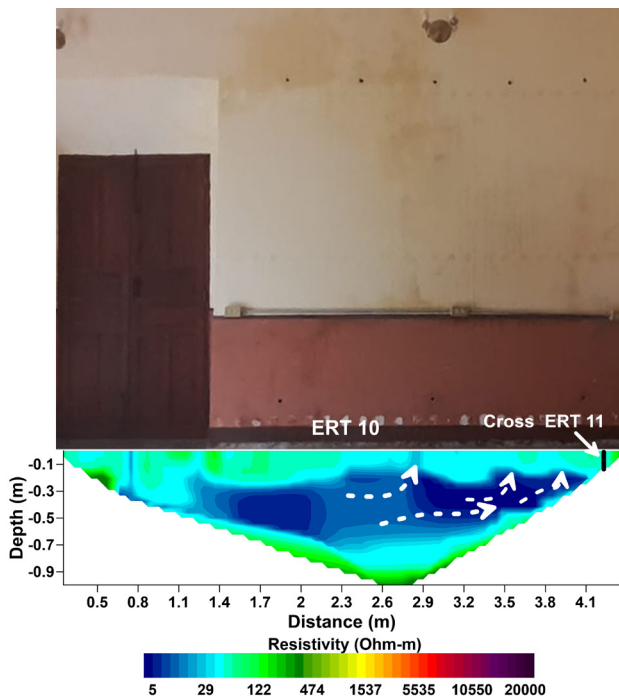
10 and 11 ERT profiles carried out on the floor, both present a similar configuration with values less than 500 Ohm-m. Furthermore, in both profiles, a tendency of water ascending from the subsoil towards the studied wall is observed in the area near the intersection with the D-axis (Figure 7 and 8).

**FIGURE 7.** ERT 10 profile referenced to the wall image and parallel to the wall. This profile is located at 0.3 m from the wall of interest, see Figure 5a. In the profile of resistivity, the white dashed arrows are representing the upward water flow. The RMSE obtained in the inversion process for the profile was 11.5 %.

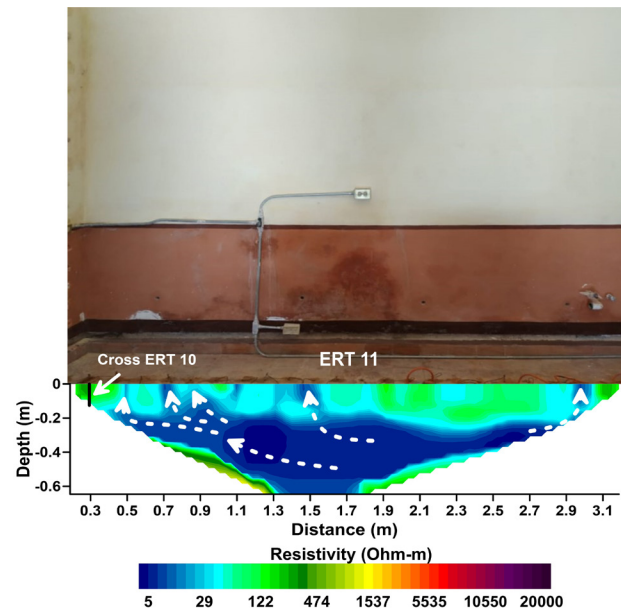
**FIGURE 8.** ERT 11 profile referenced to the wall image and perpendicular to the study wall. This profile is located at 0.42 m from the wall in axis D, see Figure 4a. In the profile of resistivity, the white dashed arrows are representing the upward water flow. The RMSE obtained in the inversion process for the profile was 8.3 %.

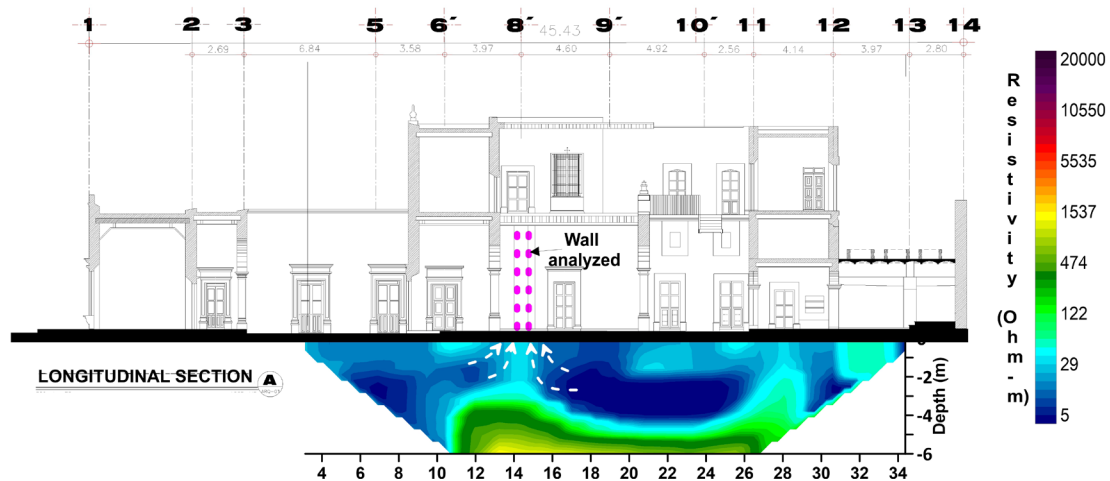
Profile 12 (Figure 9) is located along the corridor in the south-north direction longitudinal to the building (Figure 5a). The profile has a length of 36.8 m with a separation between electrodes of 1.6 m, limited to the dimensions of the hallway where the measurement was made. The resistivity values are in the range of 1 to 1000 Ohm-m.

**FIGURE 9.** ERT 12 profile located along the corridor, superimposed on a longitudinal plane section of the building. The location of the study wall is indicated with a pink dashed line, while white dashed arrows in the ERT model represent the upward flow of moisture in the subsoil below the wall.

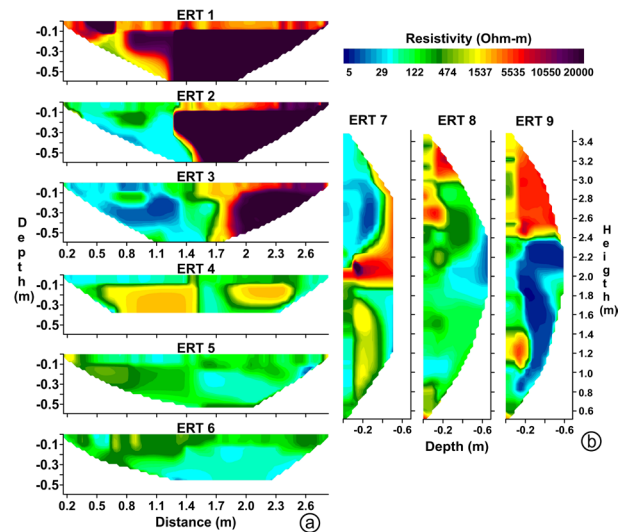
**FIGURE 11.** ERT models of horizontal and vertical measurements. a) ERT profiles 1 through 6 at 3.8, 3.5, 2.7, 1.6, 1.2, and 0.325 m high respectively. a) Image of the dividing wall with horizontal and vertical ERT lines. b) ERT profiles 7, 8 and 9. For these profiles, electrode 1 was located in the lower part, close to the floor and electrode 24, in the upper part, close to the ceiling. The RMSE obtained in the nine profiles in the investment process was in the range of 10.9 to 8.2%.

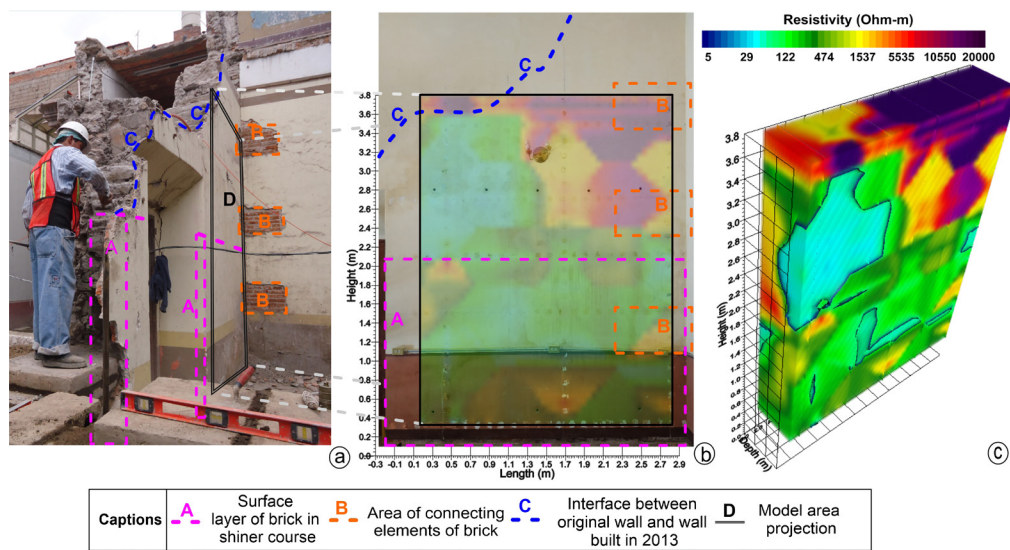
Figure 12 presents a photograph of the damaged wall before its repair in 2013, along with the results of the ERT measurements for interpretation. The original materials of the wall and the locations of the consolidation elements indicated as areas B in the photograph, are shown in Figure 12a. Figure 12b shows a map of the shallower electrical resistivity distribution on the wall face, produced through interpolation of the ERT profiles results, the bounds of the materials identified in the photograph of Figure 12a are pointed with dashed lines in this figure. A pseudo-3D model derived from the 2D sections shown in Figure 11 is presented in Figure 12c, which allowed identify the propagation of the moisture inside the wall.

**FIGURE 12.** Integration of the information for its interpretation. a) Photograph taken during the intervention works in 2013 showing both the original wall material and the added materials. b) Studied area of the wall (rectangle D in Figure 12a) with an overlapped image of the shallower electrical resistivity produced from ERT measurements. d) Pseudo-3D electrical resistivity model of the wall elaborated from 2D ERT profiles.

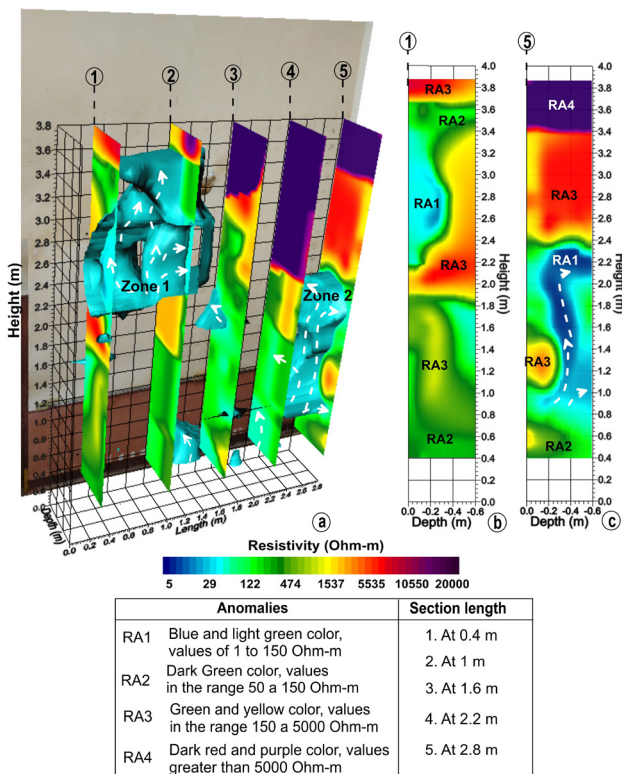
In the 3D model of Figure 13, several resistive anomalies were identified, the first of them (RA1) presented resistivity values between 1 to 150 Ohm-m and identified in blue and light green colors, corresponding to the adobe of the original construction. The blue zones (1 to 20 Ohm-m) are located in the central part of the section (Figure 13 b and c) and are related to a medium with high moisture content, the cyan zones (medium moisture) surround the zones of higher moisture concentration and are located in superficial areas of the wall, highlighting zones 1 and 2 in Figure 13a. From the center of the wall toward the surface, a gradual increase in resistivity is observed, starting in the central zone of the wall with blue color and values from 1 to 20 Ohm-m and continuing in the surface with green color and values of 21 to 150 Ohm-m. A plausible explanation for this change is that the evaporation of moisture from the surface areas of the wall is causing this increase in resistivity (19, 25, 26) (Figure 13).

The second anomaly (RA2) is shown in green color with values from 100 to 500 Ohm-m. This anomaly can be associated with the thin layer of bricks (shiner course) with dimensions of 0.4x0.13x0.26 m and located between the adobe and the plaster from 0 to 2 m in height (Figure 13). According to previous investigations, the resistivity of bricks saturated with salty water approaches to 20 Ohm-m, but for dry bricks the value increases up to 1,080 KOhm-m (41, 42). Therefore, the brick layer located at the bottom of the wall could present a medium of high moisture content.

**FIGURE 13.** Vertical sections located at different distances in the 3D model with the image of the wall as a reference. An envelope volume of resistivity values less than 50 Ohm-m is generated. a) Isometric 3D model with vertical sections 1-5 along the wall b) and c) Sections of greater interest. In these sections, areas with higher moisture concentration are defined. Section 1 displays the maximum height of the wet front, and Section 5 displays the initial rise of moisture in the wall. Four identified resistive anomalies (RA1-RA4) are indicated in the figure.

The resistive anomaly 3 (RA3) is shown in green and yellow colors with values from 150 to 5000 Ohm-m (Figure 13). This anomaly coincides with the area of the wall-to-wall connection shown in Figure 12a. Therefore, this anomaly can be related to brick volumes with medium-to-high moisture content in the periphery of volume and its core with low moisture content located in the lower part of the wall (between 0 and 2.4 m height). Therefore, the consolidation elements located in different sections of the wall below 2.4 m are included in this anomaly (RA3). Likewise, at the height of the area reconstructed in 2013, resistivity values in the RA3 range are shown in yellow and red colors (Figure 12).

Finally, resistive anomaly 4 (RA4) is shown in purple color and located at zones higher than 2.4 m. This anomaly is associated with brick volumes with low moisture content with values larger than 5000 Ohm-m (Figure 13).

Concerning the Knapen siphons placed at 0.42 m and 1.7 m height, when reviewing the 3D model (Figure 12 and 13) there is no variation in the resistivity values in the area of the tubes that indicate a change in humidity, therefore, it can be deduced that the effectiveness of these knapen siphons is low since no zones of influence (zones with humidity reduction) are defined.

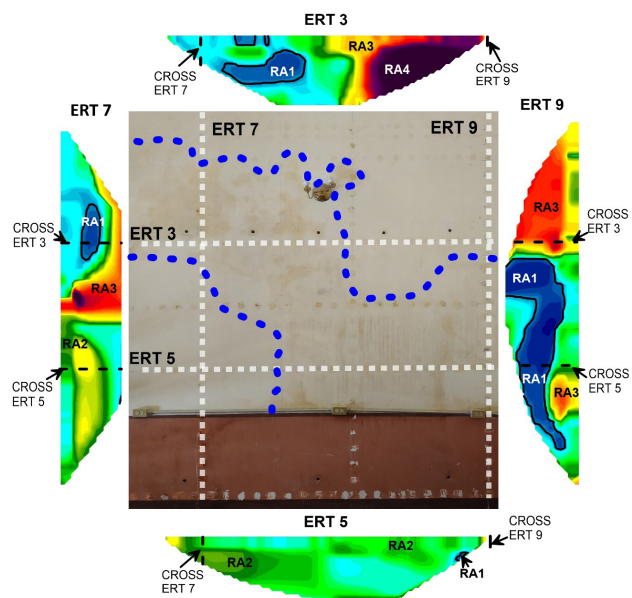
In Figure 14 the blue tones of the RA1 anomaly 3D models (Figure 12c and 13a) coincide with the superficial moisture stains in the ERT profiles. The 3D model shows the presence of moisture in a zone at a height near to the 3.6 m (zone 1 Figure 13a), corroborated by the stain of moisture observed in the surface of the wall moisture stain over the same zone in the image of the wall (Figure 14). Above zone 1 (Figure 13a), a drastic vertical change is observed from a low resistivity value identified in blue color (1 to 150 Ohm-m) to a high one in yellow and red colors (values above 2000 Ohm-m). This zone of change coincides with the initial level of the 2013 reconstruction (Figure 12b). Under the reconstructed area located above 3.6 m height, a small area of low resistivity is observed (Figure 12c), indicating that moisture continues ascending through the central part of the wall. The above explanation suggests that from the initial level of the reconstructed area the material has zero or low moisture content, which generates a drastic change in resistivity values. Therefore, it is inferred that before the explosion, the upper level of the moisture front in the wall was located above the 3.6 m height. The cappuccino wall layer is probably causing a reduction in the evaporation rate in the first 2 m of height, which instead is causing the moisture front to reach higher inside the wall. According to several authors (19, 29, 40) one of the factors that affect the maximum height reached by the moisture front is evaporation, in addition to the abundant flow and the relatively high permeability of the construction materials.

**FIGURE 14.** Image of the wall with moisture stain delimited with the two dashed blue lines as well as the horizontal and vertical ERT profiles marked with the white dashed lines. The predominant resistive anomalies (RA1 through RA4) are indicated in the ERT models.

The moisture problem in the wall is due to rising dampness by capillarity. As stated in the introduction, the building was constructed without foundation in the walls, thus there is no barrier to interrupt the flow of moisture into the wall. Furthermore, based on the photographic records of the interventions conducted on the wall and resistivity data, it can be deduced that the newly integrated materials in the wall exhibit low or no moisture content. This suggests that moisture gradually penetrates the inserted material over time.
