Nota Técnica:  
Tabiques de yeso laminado: inspección, caracterización patológica  
y estudio estadístico mediante un sistema experto

*Technical Note:*  
*Gypsum plasterboard walls: inspection, pathological characterization  
and statistical survey using an expert system*

C. Gaião<sup>(\*)</sup>, J. de Brito<sup>(\*)</sup>, J. D. Silvestre<sup>(\*)</sup>

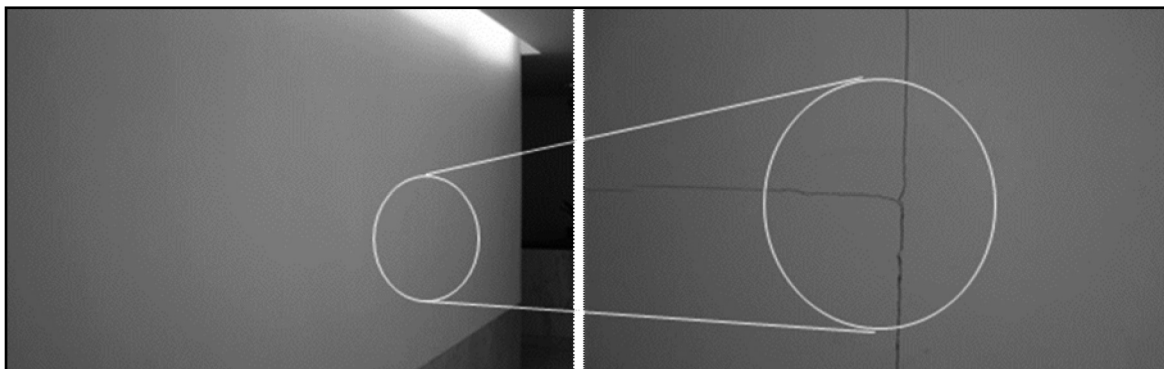
occurs due to lack of joint tape (Figure 1). The joint material does not have enough elasticity to support structural movements without cracking. Convex joints are affected by exterior mechanical actions which can cause their slow or quick deterioration depending on the frequency and intensity of the actions (Figure 2).

Figure 1. Lack of joint tape between boards (20).

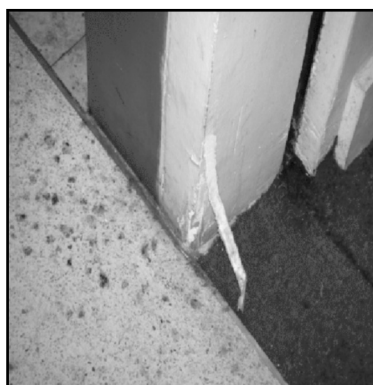
Figure 2. Degradation of tape in a convex corner (20).

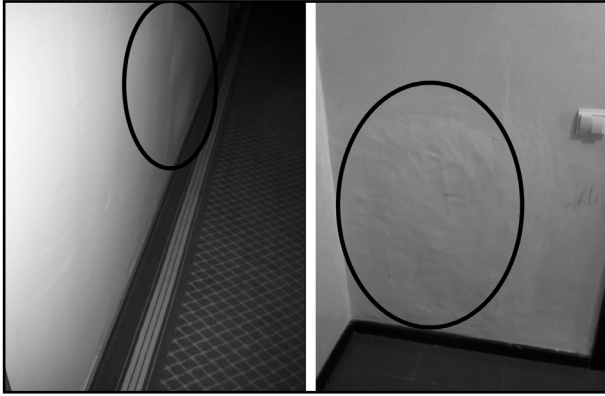
wall support structure or irregular positioning of metal-metal drywall screws near the baseboard can also cause this anomaly. Inadequate gypsum board finish can be noticed at the joints between boards or in the plaster over the screws at the centre of the boards (Figure 3).

Figure 3. Walls with irregularities due to inadequate gypsum board finish (20).

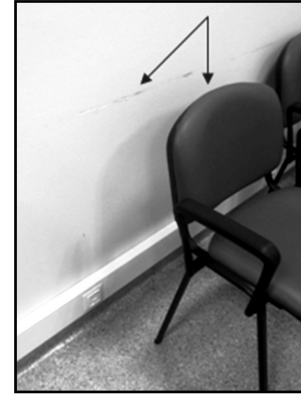
Anomaly A-A7 – boards broken or damaged – is normally observed in places with high-traffic of furniture on-wheels, namely hospitals (Figure 4), due to the frequent impact and slip of these equipments.

Figure 4. Damaged wall due to the frequent impact of chairs (20).

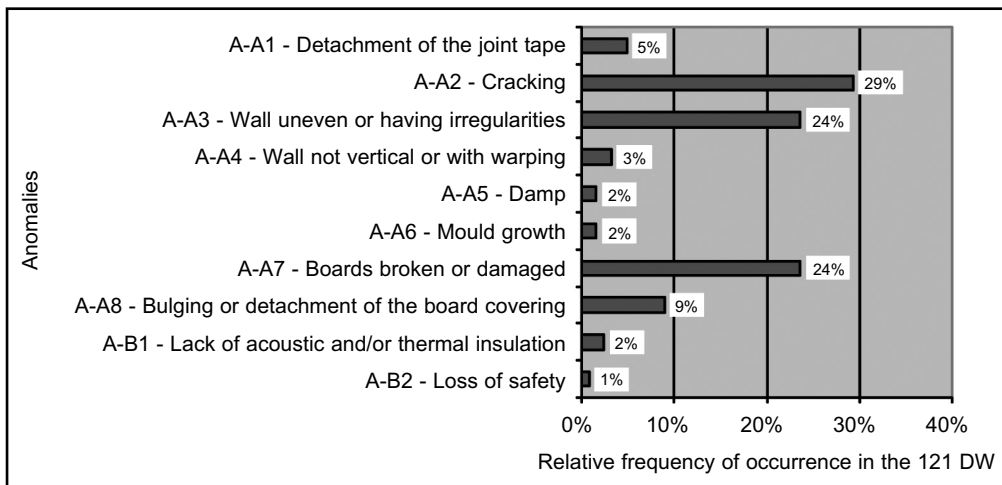
The statistical analysis of the data collected from the inspection of the DWs begins with the relative frequency of occurrence of anomalies (Figure 5). The chart in Figure 5 shows that the commonest anomaly is A-A2 – cracking at concave or convex joints, between boards or at the wall/ceiling interface. Since this anomaly is not easy to identify even for daily users, especially if it occurs

Figure 5. Relative frequency of occurrence of anomalies in the 121 DWs inspected.

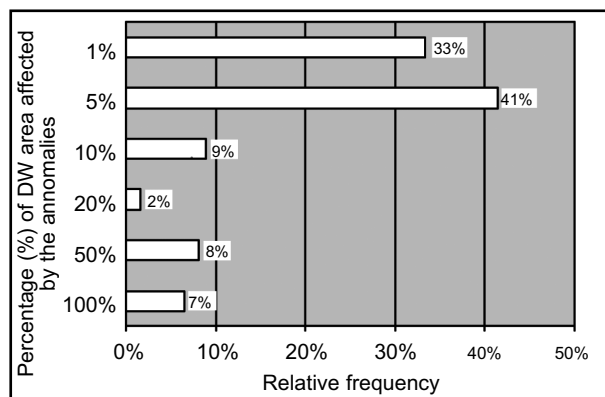
(Figure 6) gives the percentage of DW area affected by the anomalies. The values were divided into six groups: 1%, 5%, 10%, 20%, 50% or 100% of the wall area affected. Most anomalies (74%) affect only up to 5% of the wall area. Figures 7 and 8 present the percentage of DW area affected, for each anomaly. It becomes obvious that anomalies from the A-B group (functional) affect larger wall areas, despite occurring less often. Anomaly A-B2 – loss of safety affected the whole wall area the only time it occurred. Anomalies A-A1 – detachment of the joint tape, A-A2 – cracking at concave or convex joints, between boards or at the wall/ceiling interface, and A-A8 – bulging or detachment of the board covering always affected small areas (up to 10%) of the DW.

Figure 6. Relative frequency of percentage of DW area affected by the anomalies.

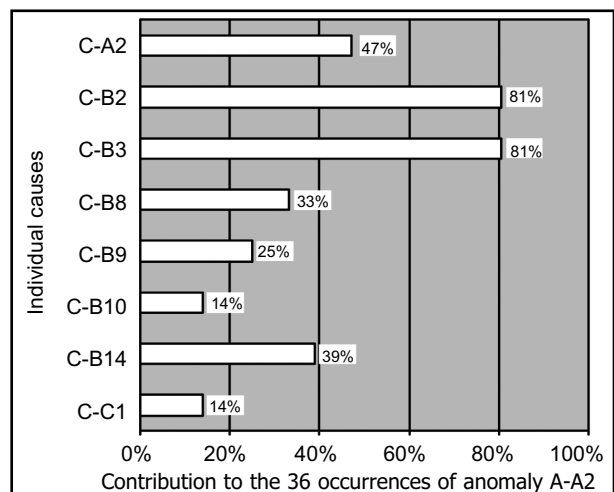
The individual contribution of each cause to the anomalies can be established from the relative frequency of the causes with an occurrence frequency of more than 10% and which were associated with the most frequent anomalies (A-A2, A-A3, A-A7 and A-A8 as shown in Figure 5). Anomaly A-A2 – cracking at concave or convex joints, between boards or at the wall/ceiling interface could have various causes, but it is mostly (81%) due to causes C-B2 – inexperienced or unskilled drywall workers, and C-B3 – lack of supervision, quality control and/or correct procedures (Figure 16). In third place there is a cause (C-A2 – incomplete system detailing) also related to lack of professional training, in this case of the designer, that leads to the occurrence of anomalies. The remaining causes (in order of decreasing significance) are C-B14, C-B8, C-B9 and C-B10, all from the C-B – execution errors group, demonstrating the high contribution of execution errors to the occurrence of this anomaly.

Figure 16. Contribution of the causes to the 36 occurrences of anomaly A-A2 – cracking at concave or convex joints, between boards or at the wall/ceiling interface.

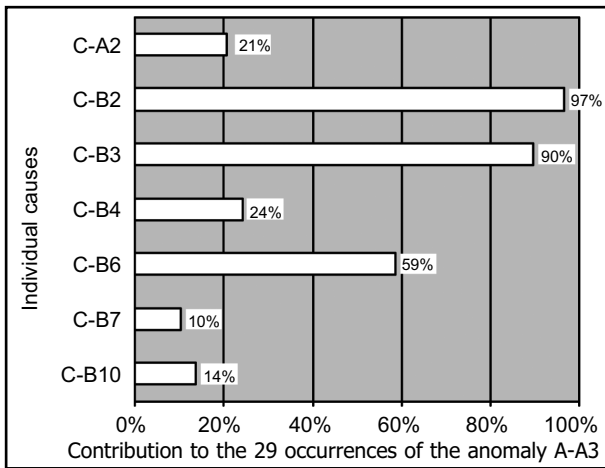
The chart in Figure 17 shows the relative frequency of causes related to the 29 instances of anomaly A-A3 – wall uneven or having irregularities. The cause correlated with almost all (97%) these occurrences is C-B2 – inexperienced or unskilled drywall workers, followed by C-B3 – lack of supervision, quality control and/or correct procedures. Once again workers and work supervisors are responsible for the occurrence of anomalies and most of the remaining causes belong to the group C-B – execution errors.

Figure 17. Contribution of the causes to the 29 occurrences of anomaly A-A3 – wall uneven or having irregularities.

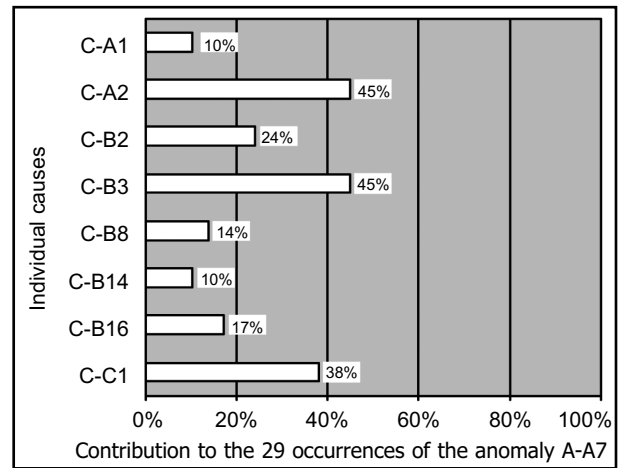
Figure 18 presents the relative frequency of the causes related to the 29 instances of anomaly A-A7 – boards broken or damaged. Both C-A2 – incomplete system detailing – and C-B3 – lack of supervision, quality control and/or correct procedures are strongly related to the

Figure 18. Contribution of the causes to the 29 occurrences of anomaly A-A7 – boards broken or damaged.

occurrence of this anomaly (45%). The other causes are from different groups, but cause C-C1 – impacts on DW – is also important (38%).

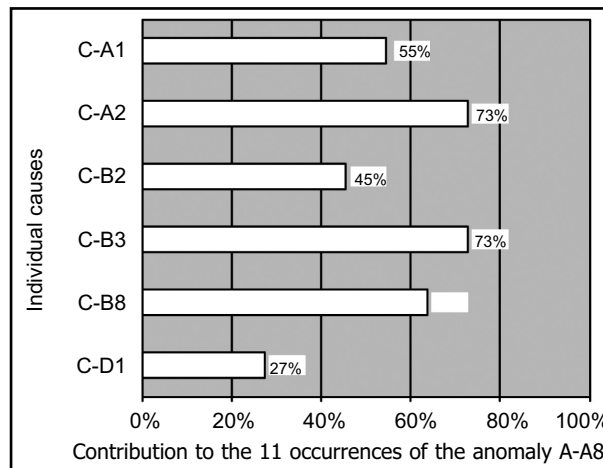
Figure 19. Contribution of the causes to the 11 occurrences of anomaly A-A8 – bulging or detachment of the board covering.

Figure 19 proves that both C-A2 – incomplete system detailing— and C-B3 – lack of supervision, quality control and/or correct procedures make an important contribution to the 11 cases where anomaly A-A8 – bulging or detachment of the board covering was identified (73%). The other causes belong to these two groups and to C-D – environmental actions. This means that this anomaly can stem from the action of a single cause or from several causes in different groups.
