## Seismic retrofitting of timber framed walls

A.M. Gonçalves ✉, J. Gomes-Ferreira, L. Guerreiro, F. Branco

University of Lisbon, Instituto Superior Técnico, DECivil, ICIST  
✉goncalves.amn@gmail.com

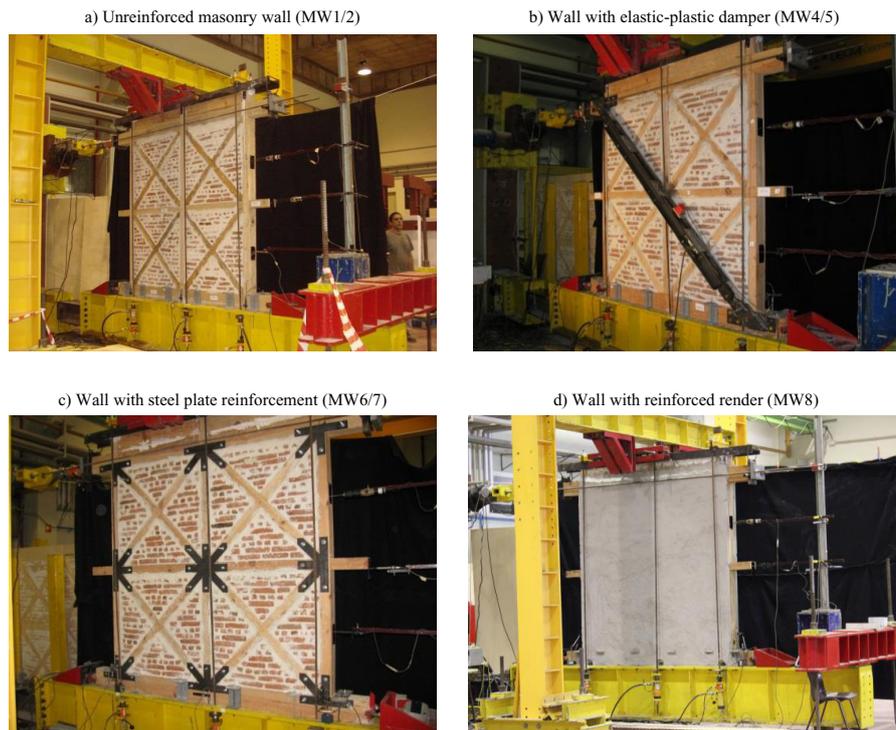
FIGURE 1. Timber framed masonry models with and without reinforcement.

The tested walls are constituted by four Saint Andrew's crosses. A total of seven walls were constructed and tested in the laboratory. Two specimens consist of non-reinforced timber framed wall modules, while the remaining walls were strengthened with the referred seismic rehabilitation methods based on elastic-plastic dampers, steel plate reinforcement and reinforced rendering (Figure 1). Table 1 summarizes the performed tests.

their end nodes were obtained by simply sawing at 45°. All connections were reinforced with iron nails. The timber used was stone pine (*pinus pinea*), the timber frames presented a thickness of 12 cm and wood sections were: 16 × 12 cm<sup>2</sup> (base and top beam) and 8 × 12 cm<sup>2</sup> (all other elements) (Figure 1).

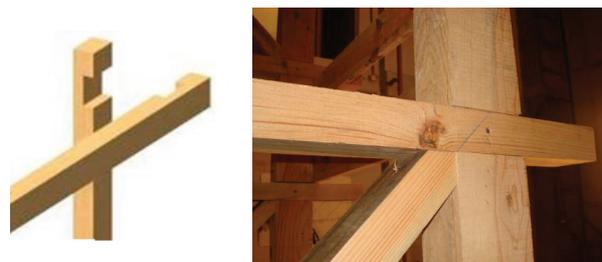
FIGURE 2. Cross-halving joints.

In the execution of models, assured by the construction and rehabilitation contractor "HCI Construções" the construction techniques used for the rehabilitation of such structures were reproduced. Cross-halving joints (Figure 2) were used in the connections between vertical and horizontal timber elements and between the crossing diagonals. The connections between the diagonals and

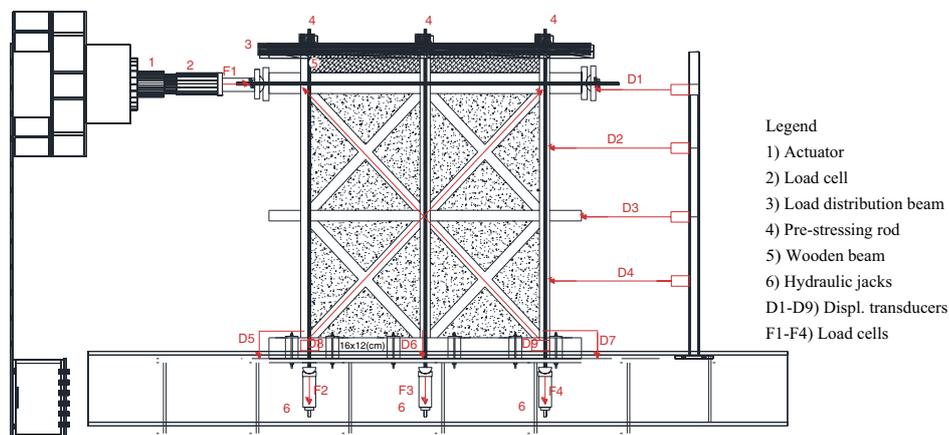
FIGURE 3. Test set-up.

The walls were fully instrumented to measure the displacement at different points. The general layout of the equipment is shown in Figure 3. The displacement transducers D1 to D4 measured the horizontal displacement on the wall at different heights, D5 to D7 measured the vertical lift of the vertical timber element in regard to the bottom

wood beam, D8 and D9 measured the displacement in the diagonals. The load imposed by the actuator was also measured with a load cell, as well as the tension load in the vertical cables used to impose the vertical load.

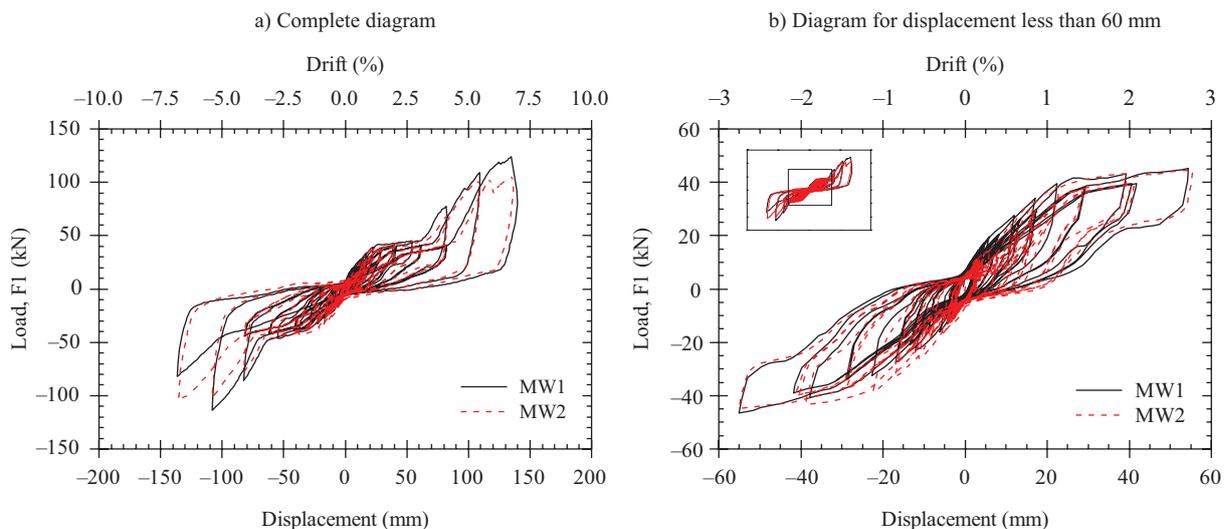
FIGURE 4. Load-displacement curves of MW1 and MW2 walls.

The load-displacement diagrams obtained for the unreinforced masonry walls (MW1 and MW2) are shown in Figure 4. Figure 4a) shows the complete

diagrams, while the Figure 4b) shows the diagrams corresponding only to displacement up to 60 mm. An increase in the wall stiffness for

displacements higher than 60 mm was observed. However, this boost in the stiffness is due to the increase of load in the tensioned cables when the attached jacks reach their limit course and these values cannot be taken into account for characterization of the walls. Then, the analysis is limited to a range of ± 55 mm displacements, which nevertheless results in a significant value of 2.6% drift.

The hysteretic behaviour of these walls subjected to cyclic loading is characterized by nonlinear behaviour with a high ductility response. The maximum strength within this cycles amplitude is about 50 kN measured at the displacement of 55 mm.

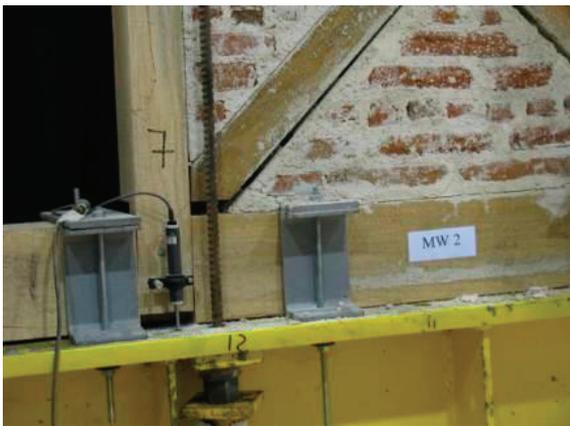
FIGURE 5. Vertical lift of bottom beam and vertical member.

A certain vertical lift of the bottom beam together with a separation of the vertical timber element from the bottom beam occurred during the wall test as an effect of a rocking motion that was

not completely eliminated, becoming more significant with the increase of the overall deformation (Figure 5).

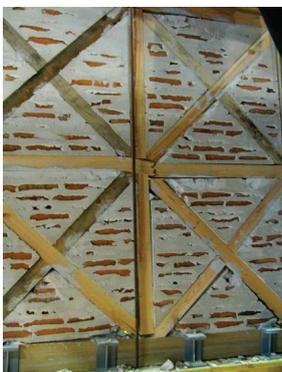
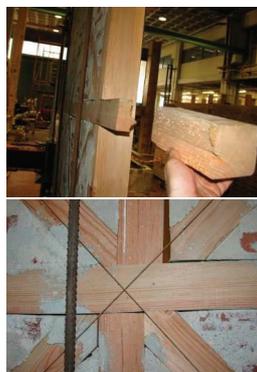
a) Shear failure of intermediate timber beam in MW1

b) Failure by longitudinal shear of intermediate timber beam in MW2

FIGURE 6. Failure mode of masonry walls MW1 and MW2.

Figure 6 shows the failure modes of these models. Rupture in MW1 is associated with compression of the diagonals that caused the shear failure at the intermediate beam. In the case of the model MW2 the wall had an early rupture by longitudinal shear of the timber fibres at one end of the intermediate beam, adjacent to the cross-halving joint.

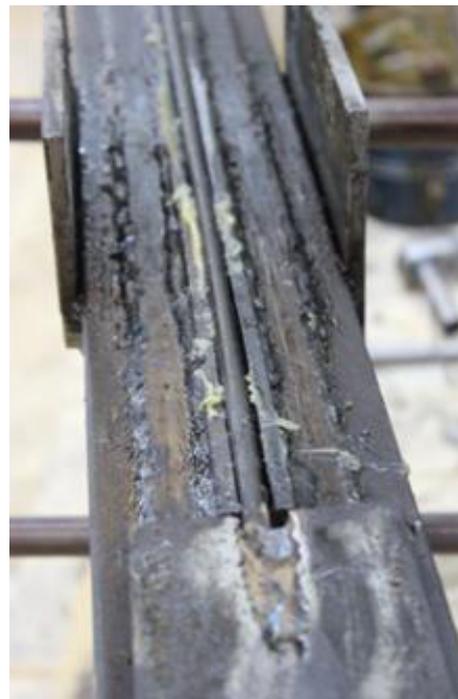
FIGURE 7. Guides, rod and plate.

The damper itself was composed by a steel rod (8 mm diameter, 55.5 cm length), laterally restrained by steel plates and profiles according to the scheme presented in Figure 8. The rod was placed within a runway in which it can move freely in the axial direction, preventing the occurrence of bending. The runway is constituted by the two UNP100 profiles and the steel plates welded to them (Figures 1b, 7 and 8). The relative displacement between the device ends are fully transmitted to the  $\phi 8$  mm steel rod.

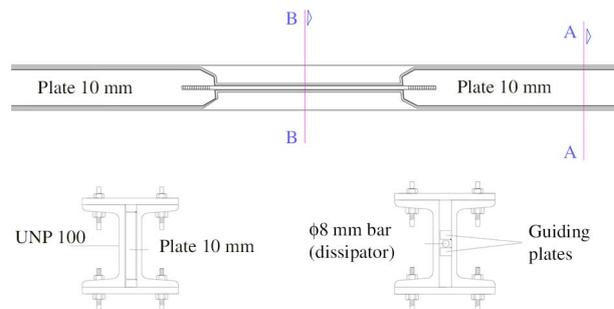
FIGURE 8. Scheme of damper.

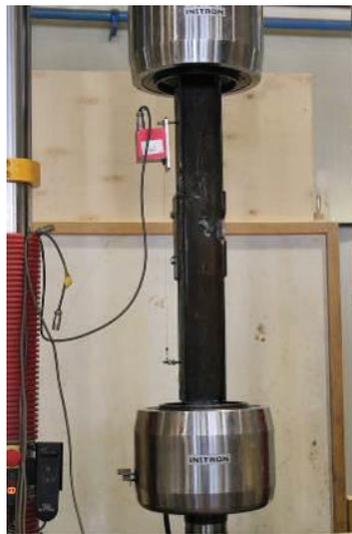
FIGURE 9. Damper test.

universal Instron testing machine, at a load speed of 0.05 mm/s (Figure 9). The results of the cyclic tests are presented in Figure 10 showing a good energy dissipation capacity.

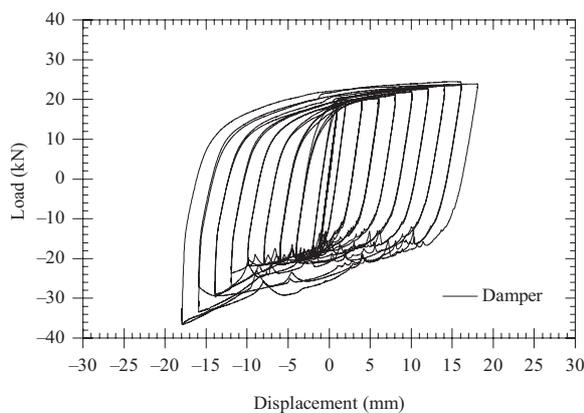
FIGURE 10. Cyclic response of the damper (compression is positive).

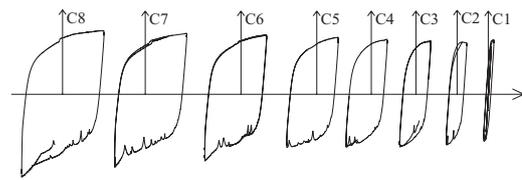
FIGURE 11. Groups of load cycles in the damper.

Figure 11 (individual damper cycles) and Table 3 (calculation of damping coefficient) show that the damper has a significant energy dissipation capacity, typical of mild steel. In table 3,  $d_{max}$  is the maximum displacement in the cycle,  $F_{tension}$ ,  $F_{compr}$  and  $F_{max,average}$  are the maximum load in tension and in compression and the respective average,  $E_d$  is the dissipated energy and  $\zeta$  is the damping coefficient.

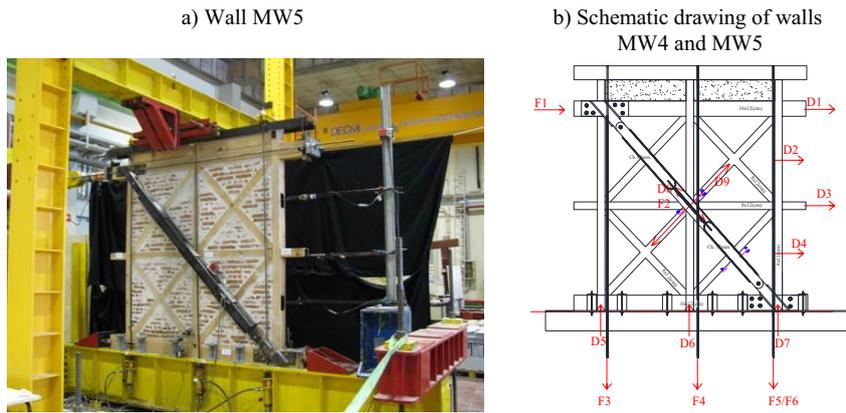
FIGURE 12. Walls MW4 and MW5.

The timber framed walls reinforced with elastic-plastic steel dampers placed diagonally in the structure, MW 4 and MW5, were analysed. Figure 12 shows the location and orientation of the loading and displacements measured by instrumentation of these walls.

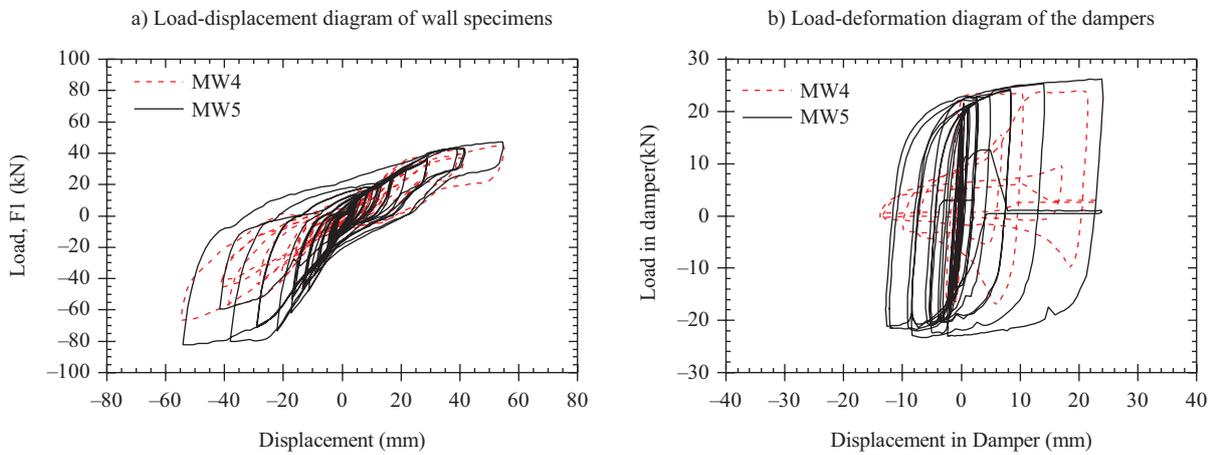
FIGURE 13. Comparison of specimens with dampers MW4 and MW5.

The experimental testing consisted of submitting the walls to the cyclic displacements history formerly (Table 2) described until rupture occurs. The load-displacement diagrams regarding the tested walls and the dampers themselves presented in Figure 13 show that the damper installed on wall MW5 showed a better performance than that installed on MW4.

Figure 13a shows that some energy dissipation occurred in the first cycles of MW4 damper. However, the rod runway system welding collapsed during the test and, as a consequence, the rod buckled and no more energy dissipation occurred (Figure 14a). Because of this occurrence, the test results of MW4 were disregarded. This shows the importance

The energy dissipation in the MW5 wall occurred both in tension and compression, as observed in Figure 13a) although a significant asymmetry is noticeable, due to the localized buckling which the rod undergoes in compression (Figure 14b). This results in better energy dissipation during the tension phase than in compression (Figure 13a). Note that the damper undergoes compressive (negative) deformation when the wall undergoes positive displacements.

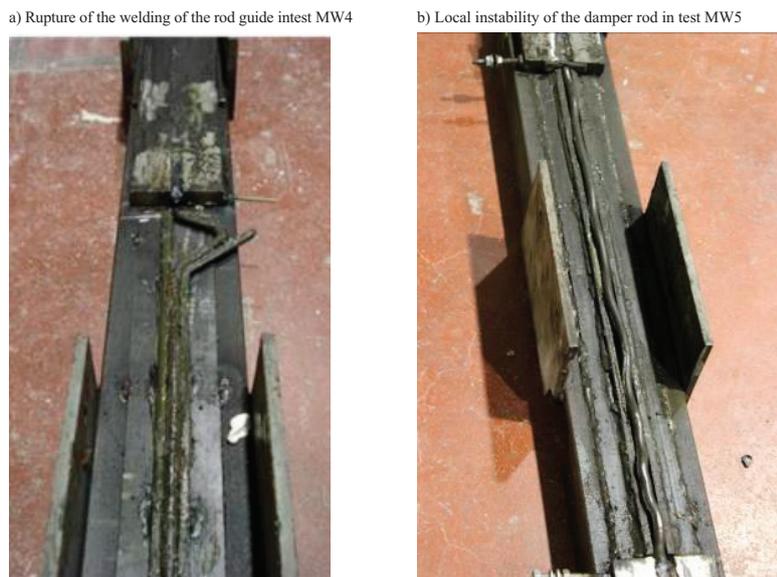
FIGURE 14. Rupture of the welding and instability of the damper rod.

Figure 14 shows the welding failure in the test element MW4 (Figure 14a) and the (controlled) localized buckling of the damper rod in the element MW5 (Figure 14b).

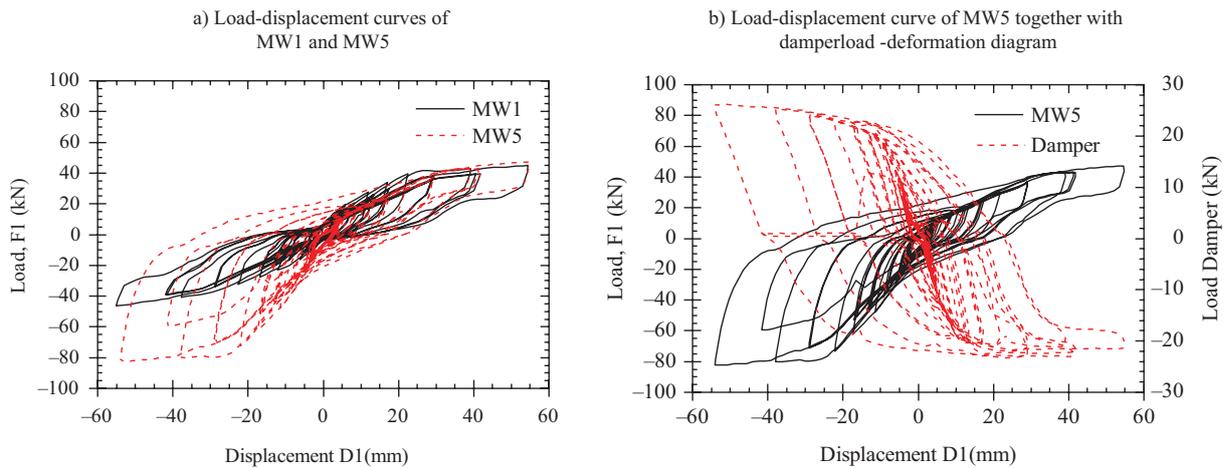
FIGURE 15. load -displacement curves of MW5 and MW1 walls.

The load-displacement curves of tests MW1 and MW5, respectively unreinforced wall and

wall reinforced with the functioning damper, are shown in Figure 15. The maximum strength values are 82.3 kN for the reinforced wall and 46.4 kN for the unreinforced masonry wall, measured at the displacement of 55 mm, corresponding to a 2.6% drift.

The diagrams presented in Figures 15 and 16 show that the damper has a good capacity to dissipate energy, although under compression the hysteresis is quite smaller than in tension due to the localized buckling that the rod undergoes. This phenomenon leads to increased difficulty in obtaining a symmetrical behaviour, which can be solved by placing one damper in each wall face, in opposed diagonals. This implies, however, an increase in wall thickness, which would be a disadvantage of the strengthening solution.

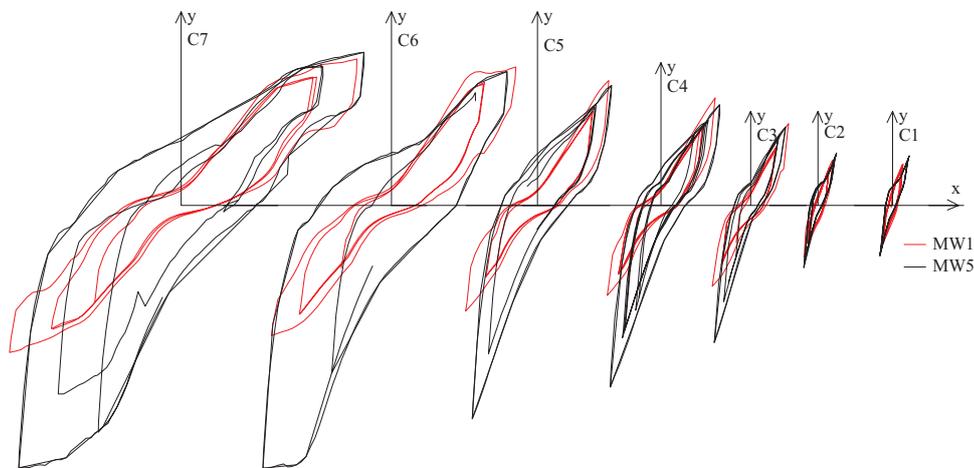
FIGURE 16. Groups of load cycles in the walls MW1 and MW5.

Figure 16 shows the hysteresis cycles along the tests of MW1 and MW5 and Table 4 presents the respective damping coefficients and the data needed to obtain them. In table 4,  $d_{max}$  is the maximum displacement in the cycle,  $F_{max}$ ,  $F_{min}$  and  $F_{max,average}$  are the maximum positive and negative load and the respective average,  $E_d$  is the dissipated energy and  $\zeta$  is the damping coefficient. A general increase in the damping coefficient with the growing cycles' amplitude is observed in MW5 (Table 4 and Figure 17), associated to the reinforcement wall (the contrary occurs in the unreinforced wall MW1).

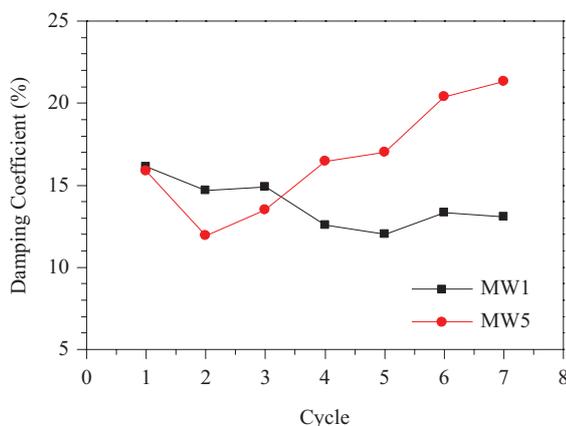
FIGURE 17. Damping coefficient in the walls MW1 and MW5 in each load cycle.

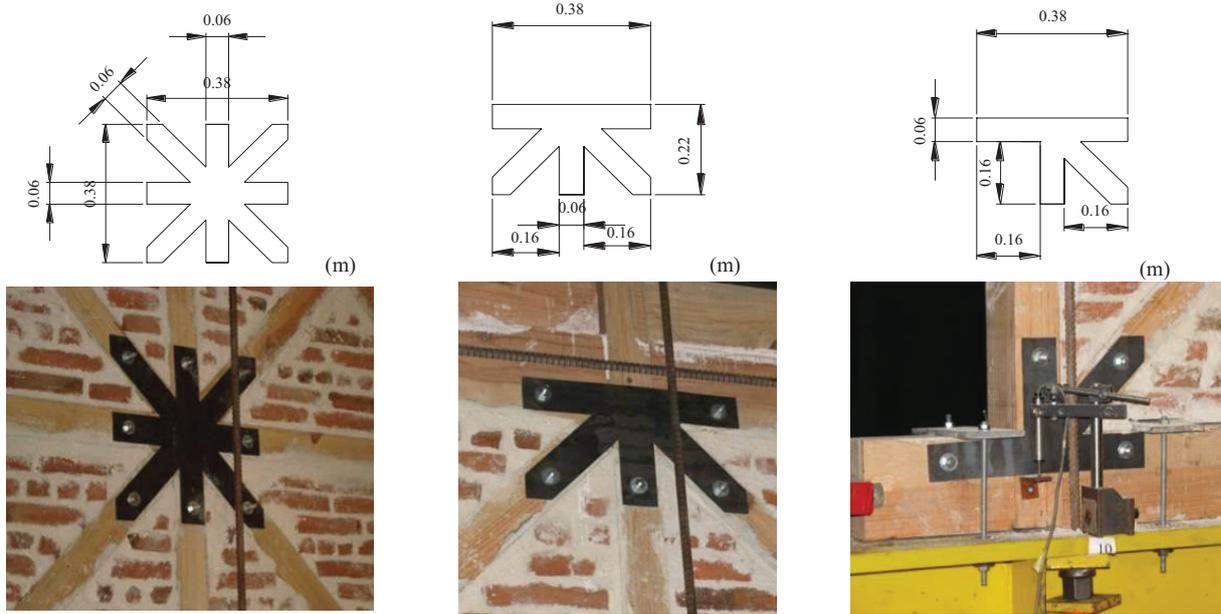
FIGURE 18. Reinforcing steel plates.

Two walls with reinforcing steel plates were tested (MW6 and MW7). The plates were placed in all cross-halving connections between vertical and horizontal timber elements (Figure 21a). The plates were designed to reinforce the connections providing more strength and stiffness but still ensuring deformation and energy dissipation capacity. All plates are 3 mm thick and have legs connected to each timber element crossing the joint with one M8

class 8.8 steel bolt. Figure 18 shows the dimensions of the different plates.

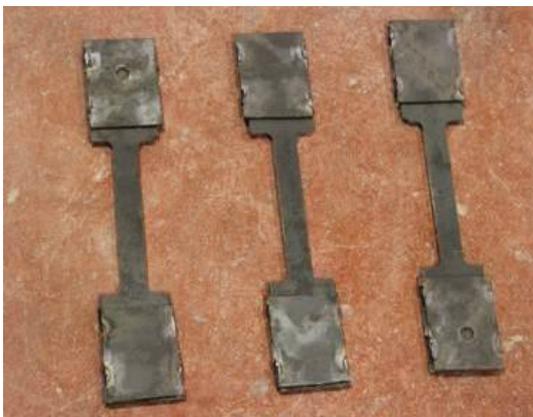
FIGURE 19. Steel specimens.

In order to obtain the mechanical properties of steel, namely tension strength and elastic modulus, tests were performed on specimens according to the EN 10002-1:2001 (7) (Figure 19). The tests were carried out in a universal Instron testing machine, at a load speed of 0.05 mm/s (displacement between grips). The stress-strain diagrams of the plates are presented in Figure 20.

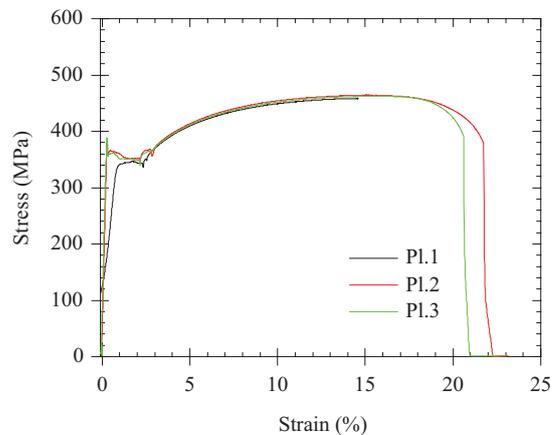
FIGURE 20. Stress-strain response of 3 mm steel plates.

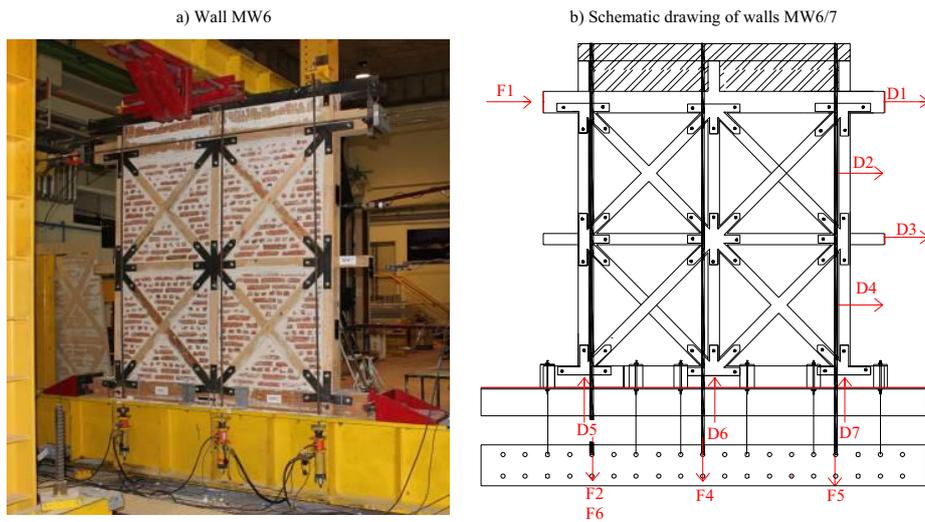
FIGURE 21. Walls MW6 and MW7.

The experimental testing consisted of submitting the walls to the same cyclic displacements history formerly (Table 2) described until rupture occurs. Figure 21b) shows the location and orientation of the loading and displacement measured by instrumentation of the walls MW6 and MW7.

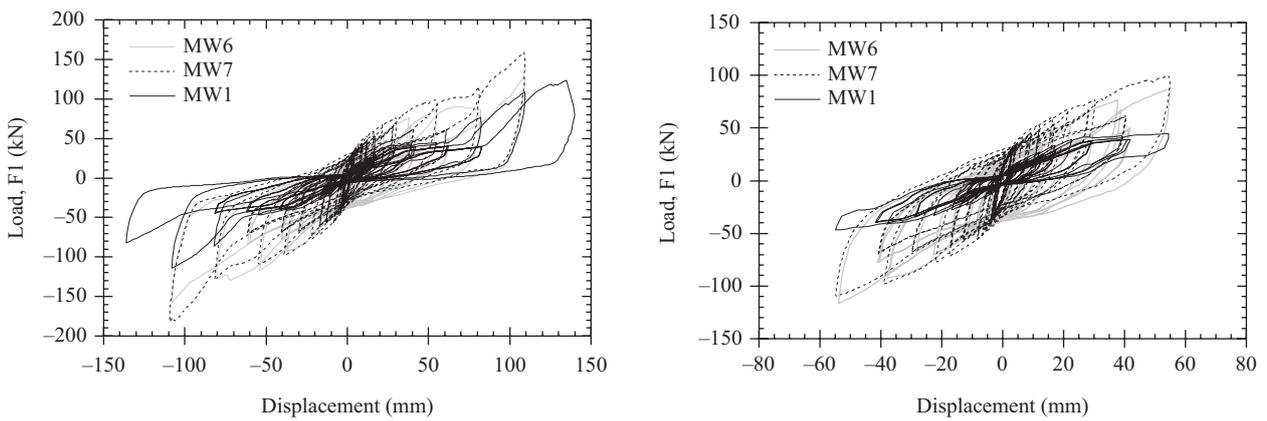
FIGURE 22. Load-displacement curves of MW6, MW7 and MW1 walls.

As expected, the behaviour of the walls with reinforcing steel plates resulted in an increased stiffness and energy dissipation (Figure 22). The connection of the timber elements with steel plates promotes an increase in the energy dissipation from the beginning of the test, taking advantage of the geometry of the wall for this purpose. A sudden increase in the wall stiffness occurred for displacements higher than about 60 mm due to the reasons formerly pointed out and, because of that, those results were discarded. Nevertheless, the 55 mm displacement corresponds to a 2.6% drift, which is already quite significant for practical purposes.

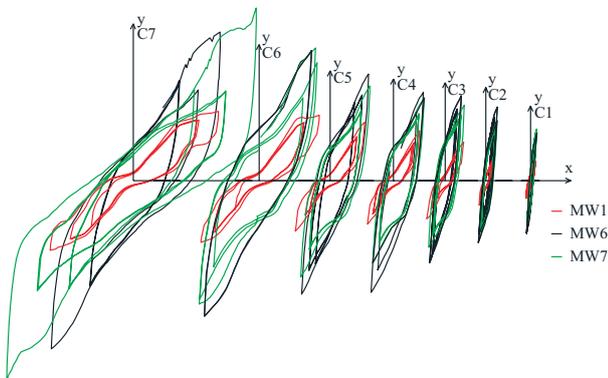
FIGURE 23. Groups of load cycles in the walls MW1, MW6 and MW7.

Figures 23 and 24 and Table 5 show the energy dissipated in each cycle for specimens MW6 and MW7, together with the results of the MW1 unreinforced wall.

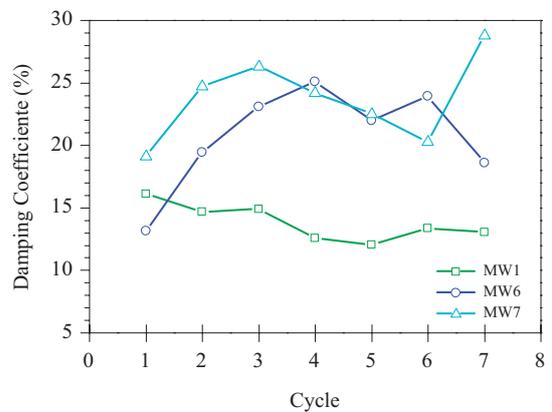
FIGURE 24. Damping coefficient in the walls MW1, MW6 and MW7 in each load cycle.

energy dissipation: MW6/7 average value of 17346 J instead of 4899 J in MW1); iii) the damping coefficient in each cycle increased, as showed in Figure 24 (increase of 61%: MW6/7 average value of 22.2% instead of 13.8% in MW1). All these differences show a better behaviour of the reinforced walls when subjected to an earthquake load.

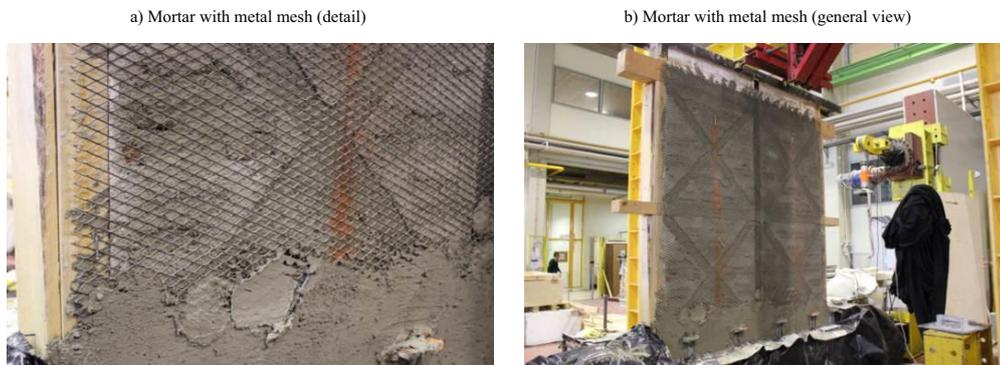
FIGURE 25. Reinforced rendering.

sides of the wall MW8 (Figure 25), comprised the following stages:

- i. Application of mortar, approximately 2 cm thick;
- ii. Placement of galvanized metal mesh stretched ridge;
- iii. Fixation of the metal mesh with nailing through-holes in staggered rows, one per meter, with threaded rods  $\varnothing 8$  mm/1m;
- iv. Finally, the application of mortar, with 3 cm thickness.

The galvanized metal mesh stretched ridge is type L62T20/25, with a 25 mm  $\times$  62 mm diamond grid and 2 mm thickness. The mortar used is based on a Secil commercial dry roughcast product composed by hydraulic binders with lime and siliceous fine aggregates.

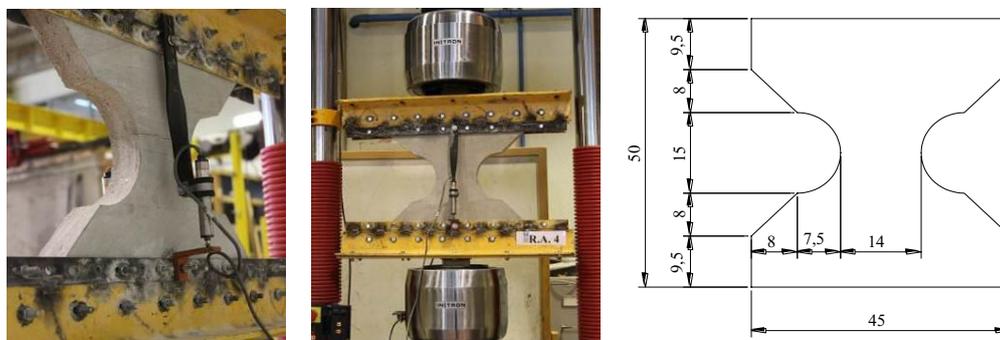
FIGURE 26. Test on the reinforced render specimen (dimensions in cm).

In order to obtain the mechanical properties of the studied material, such as strength and elastic modulus, tensile tests were carried out on two specimens of reinforced render (Ra1 and Ra2) with envelope dimensions of 50  $\times$  45  $\times$  5 cm

(Figure 26). The specimens present a circular notch to ensure that the rupture occurs in its smaller section ( $14 \times 5 \text{ cm}^2$ ) and does not occur in the grips. The tests were carried out in a universal Instron testing machine, at a load speed of 0.05 mm/s (displacement between grips). The load was obtained from the press load cell while the element elongation to compute the strain was measured with displacement transducers attached to the specimens' ends. The stress-strain diagrams (Figure 27) show maximum stresses of 2.4 MPa (Ra1) and 1.8 MPa (Ra2).

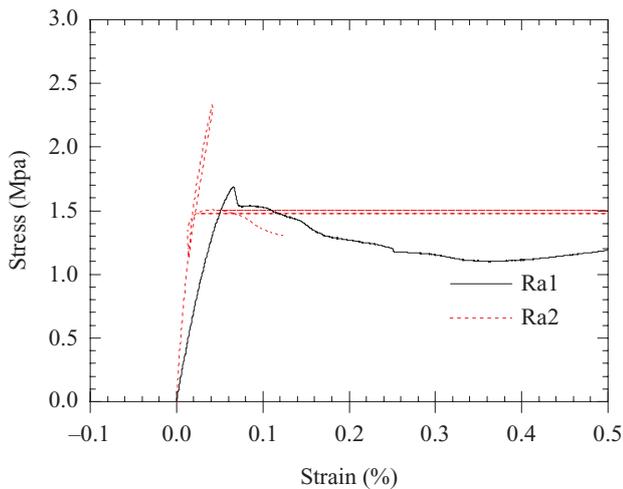
FIGURE 27. Stress-strain response for reinforced render specimens.

Although the tension strength is not particularly high, the reinforcing steel mesh ensures that its value does not present a sudden decay even if there are any cracks in the mortar due to shrinkage or other phenomenon. Based on these results (tension strength of about 2 MPa), the overall resistance of the 5 cm thick reinforced render is estimated as

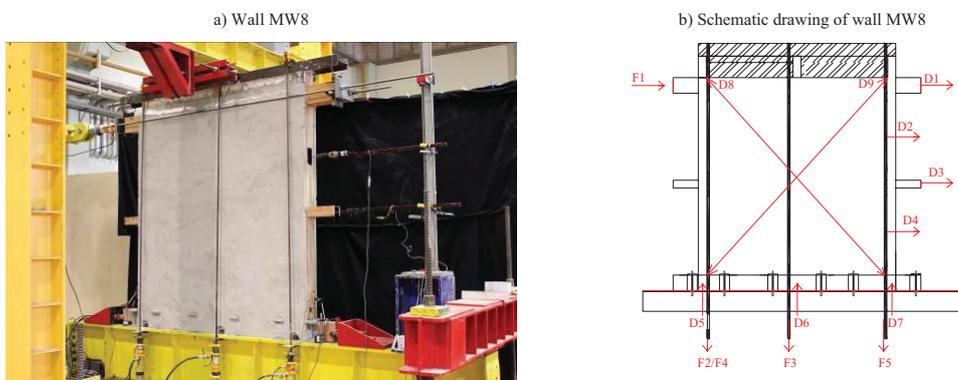
FIGURE 28. Wall MW8.

Figure 28 shows the location and orientation of the loading and displacements measured by instrumentation of wall MW8.

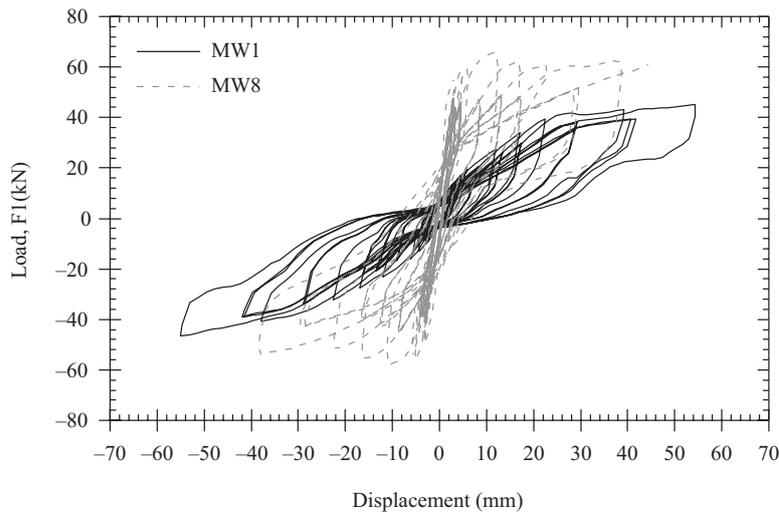
FIGURE 29. Load-displacement curves of MW8 and MW1 walls.

The hysteresis' curves of tests MW1 and MW8 (Figure 29) show that the reinforced wall has an increased stiffness in the first cycles, until 10 mm displacement. After that, some cracking in the reinforced rendering starts to occur and the load remains constant leading to the loss of stiffness. For a displacement of 40 mm, the corresponding average load is 58.3 kN and 41.9 kN at the reinforced wall and at the simple wall, respectively (Figure 29, Table 6).

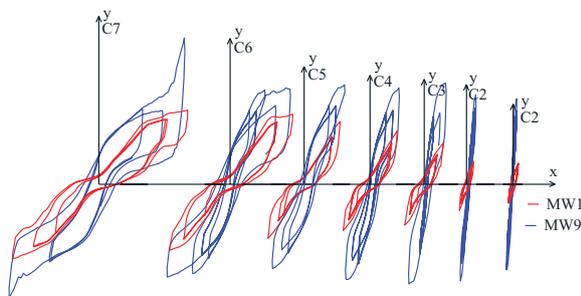
FIGURE 30. Groups of load cycles in the walls MW1 and MW8.

Although the reinforced wall presents a higher energy dissipation capacity when compared to the unreinforced wall MW1 (Figure 30 and Table 6), it shows a lower deformation capacity and a similar damping coefficient at the final cycles (Figure 31).

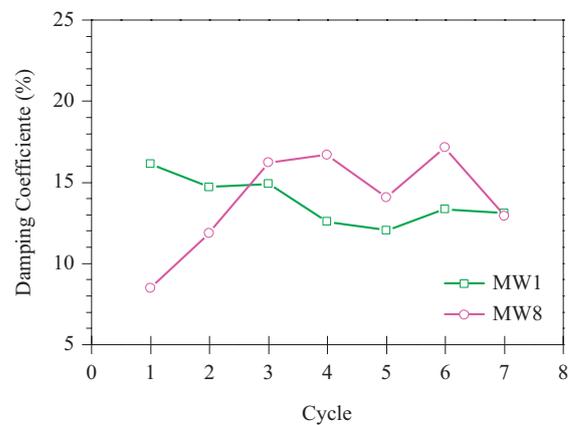
FIGURE 31. Damping coefficient in the walls MW1 and MW8 in each load cycle.

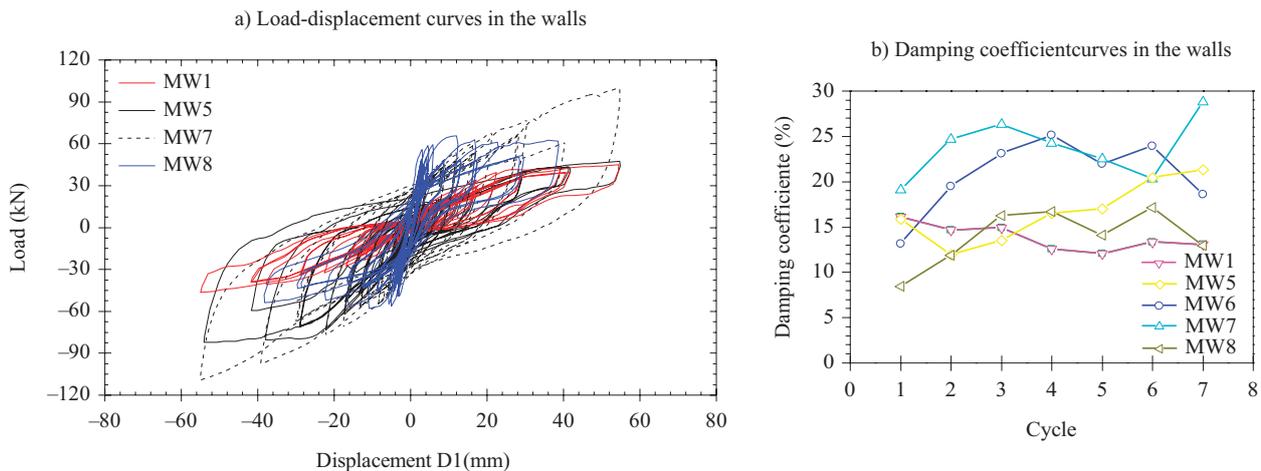
FIGURE 32. Load-displacement curves of walls MW1 (unreinforced wall), MW5 (wall with damper), MW6 and MW7 (wall with steel plates), MW8 (wall with reinforced render).

- According to the load-displacement curves, all reinforcement provided a higher ability to dissipate energy and a stiffness increase (Figure 32);
- The elastic-plastic damper (MW5) showed a good behaviour in tension but in the compression cycles some local instability was observed, making this system difficult to implement when performing the rehabilitation;
