Comparison of PZT and FBG sensing technologies for debonding detection on reinforced concrete beams strengthened with external CFRP strips subjected to bending loads

E. Sevillano^a, R. Sun^a, R. Perera^a✉, A. Arteaga^b, A. de Diego^b, D. Cisneros^b

a. Department of Structural Mechanics, Technical University of Madrid (Madrid, Spain)

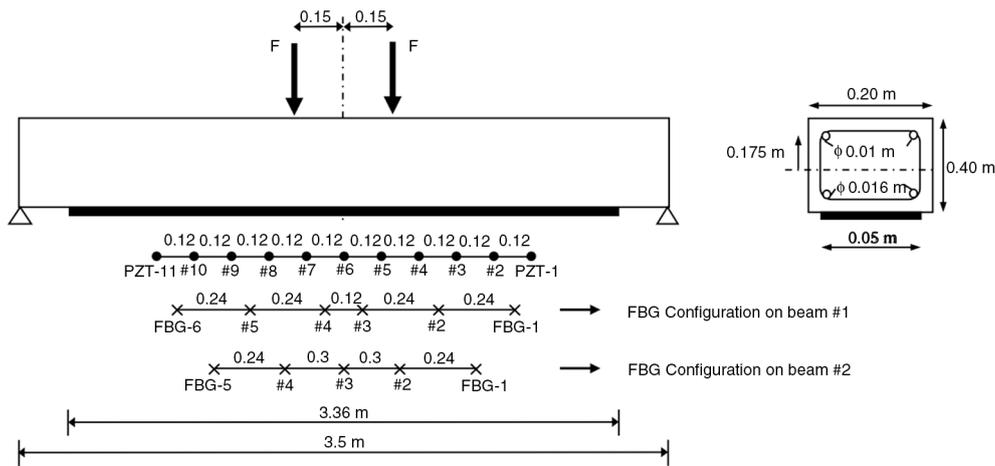
FIGURE 1. Geometry, loading scheme and sensor location map for the RC beams.

Two RC beams with the same steel reinforcement and also the same external CFRP strengthening were used during the experimental campaign carried out in this work at the Eduardo Torroja Institute (Madrid-Spain), in order not only to study the behavior of these reinforced concrete beams, but also to test the performance and adequacy of the selected smart sensors for the particular monitoring application evaluated in this paper. The mechanical properties of the tested specimens are presented in Table 1. The geometric dimensions and the reinforcement layout in the transversal sections, which were common for both beams, are illustrated in Figure 1, and details about the sensors used are given in Figure 2. For a better understanding, Figure 3 shows the basic FBG strain sensing principles. The procedure for the specimens preparation is properly illustrated in Figure 4, while the overall experimental set-up is shown in Figure 5.

During the application of each loading step, the microstrains were constantly measured by using identical os3200 Non-metallic Optical Strain Gages supplied by Micron Optics, as indicated in Figure 1. In order to measure the microstrains

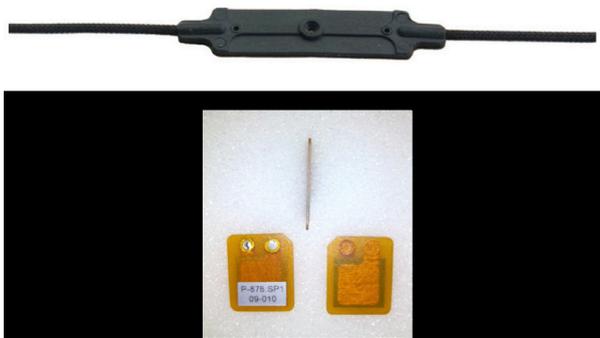
FIGURE 2. FBG sensors (top) and PZT sensors (bottom).

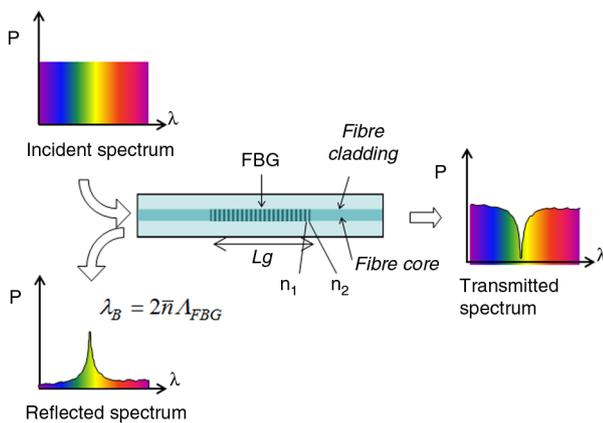
FIGURE 3. Basic FBG strain sensing principle.

These fibers consist of a very small inner core that has a periodic variation of its diffraction index with a periodic λ , which is generally achieved by exposing the core of photosensitive optical fibers to light from an ultraviolet laser (23). The sensor reflects a portion of the incoming light with a particular wavelength known as Bragg wavelength, while the rest of the light keeps traveling with its properties unaltered through the optic fiber. Thanks to the modulation of its core, Bragg wavelength can be affected by external environment changes, such as temperature, vibration or strains, thus generating a shift of the reflected Bragg wavelength. As the gratings can be written at different initial wavelengths, they can be identified by their spectral location, and correlated to physical locations along the fiber. This gives the sensor system the capability to ‘map’ the strain along the fiber, and offers a new and very powerful sensing capability for structural analysis (28). For example, when adhered to the surface of the host structure (or embedded in the structure) it is possible to obtain the record of strains of the structure subjected to any external load, which is highly useful in order to develop an SHM system in real time. Furthermore, the wavelength-encoded nature of the output also provides the basis for the multiplexing of several gratings along a single optical fiber.

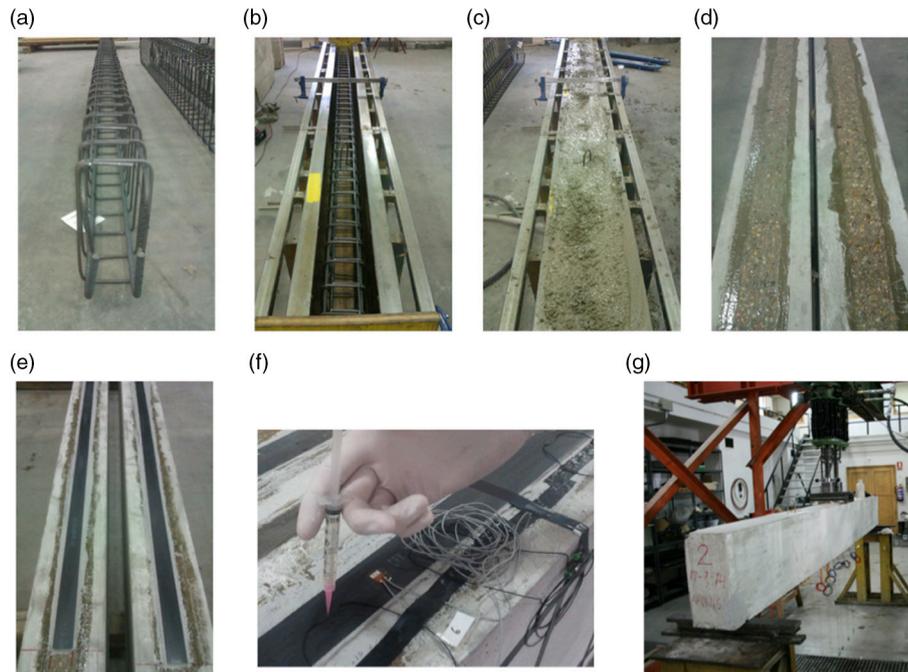
FIGURE 4. Specimen preparation's procedure: (a) tied stirrups and longitudinal reinforcement; (b) steel reinforcement inside the formwork; (c) concrete casting; (d) beams' bottom surfaces after sand blasting operations; (e) CFRP reinforcement; (f) instrumentation of the beams; (g) simple supports and loads preparation

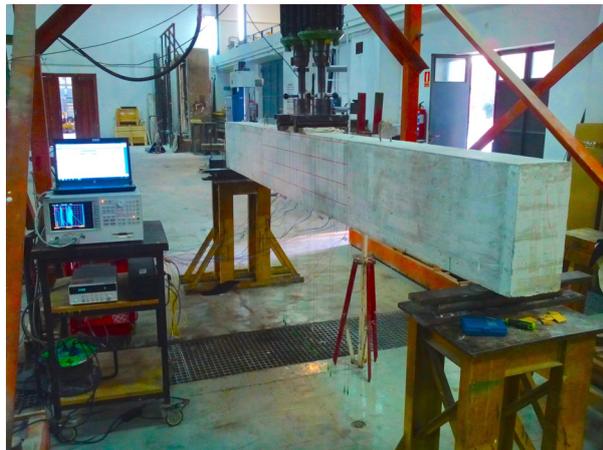
FIGURE 5. Experimental setup for the RC beams externally strengthened with CFRP.

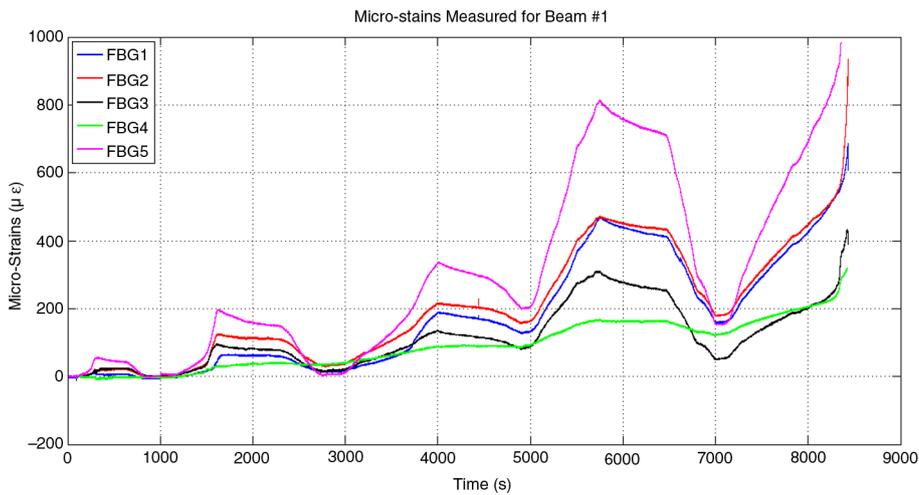
FIGURE 6. Microstrains measured for RC-Beam #1.

different locations along the beam. These results are shown in Figure 6.

In Figure 6, sensor number 5 shows clearly that the strain increments after the fourth loading step are noticeably higher than the rest. However, although this fact might lead one to conclude with certainty that there is incipient debonding in the

vicinity of this sensor (several flexural cracks can be observed in this region - Figure 7), here there is one limitation, which is that there is no way to distinguish between just a simple concentration of flexural cracks and the real origin of debonding damage. Actually, the origin of the debonding could be estimated after the whole test program, to be 18 centimeters away from sensor number 5, which shows the sensitivity of these sensors to the appearance and propagation of cracks. Sensor number 4, whose results clearly differ from the rest (green line in Figure 6), is located closer to the damage, but its strain increments are not significant at all (it is expectable that higher strain values on the strip lead to earlier debonding appearance due to the higher concentration of stresses in the area), which clearly lead to a misleading conclusion about the damage: in comparison to sensor number 5, it seems that the results from sensor number 4 indicate that there is no presence of damage in its vicinity, which is totally false given the damage distribution shown in Figure 7. Nevertheless, given the difference between these results and those from the rest of the sensors, it is reasonable to discard sensor number 4 from this analysis due to a possible anomaly in the measurements. Finally, it is important to remark that sensors numbers 2 and 3 almost obtain the same results, which makes sense since each of them turned out to be located close to a debonding region, according to the observations made after the whole loading test program in Figure 8. However in practice, sensor number 2 was a bit closer to its corresponding disbond, which could explain why, at the end of the strain curve, the strain increment is exponentially higher for sensor 2 than for sensor 3.

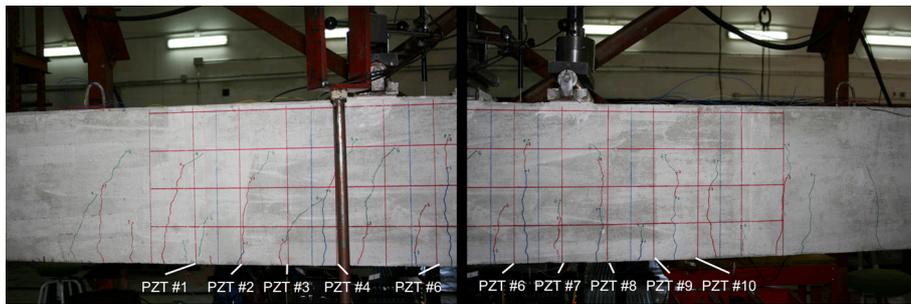
FIGURE 7. Cracking map of the RC-Beam #1 after the last loading stage.

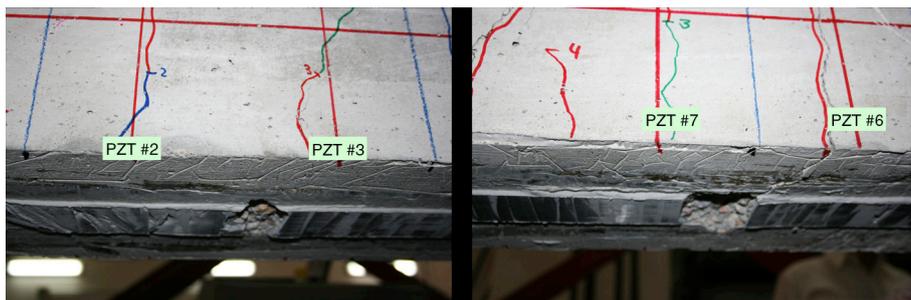
FIGURE 8. Damages with concrete cover separation between sensors 2 and 3 (left) and sensors 6 and 7 (right) for the RC-Beam #1.

end of the test program as shown in Figure 8. On the other hand, in Figure 14 it is also confirmed that, at that point of the test program, no damage seems to have been originated around the position of sensor 1, where no debonding was detected, as advanced in the analysis of Figure 13.

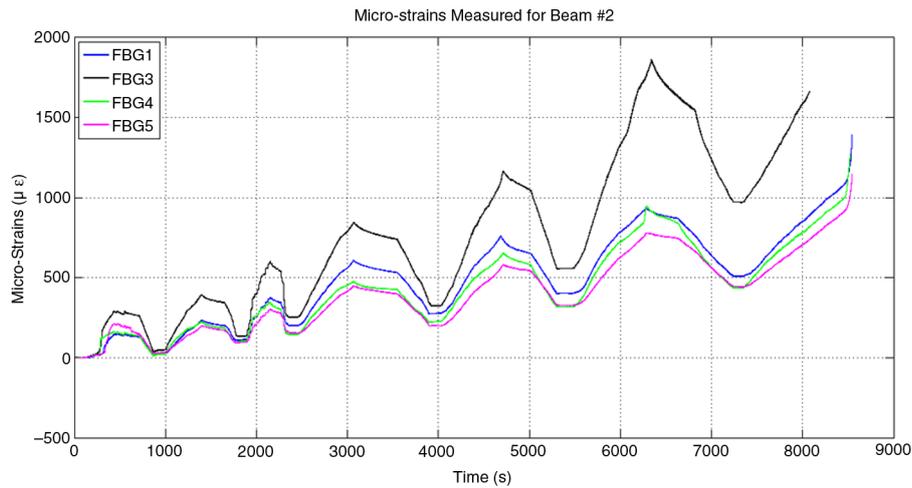
FIGURE 9. Microstrains measured for RC-Beam #2.

Analogue strain measurements were taken for beam #2, whose results are shown in Figure 9, where

all data collected from the FBGs in all loading steps are depicted.

From this Figure it is easy to see how FBG number 3 is the one collecting the highest strain increments among all the sensors deployed along the beam. This induces one to consider that this sensor is in the vicinity of an area with a high concentration of cracks, which may lead to debonding failure, and due to the remarkable difference between the strain increments measured by this sensor and the rest, it actually seems reasonable to conclude that the concentration of flexural cracks in this location incite the debonding appearance (Figures 10 and 11 would support this conclusion). However, according to the observations made with the previous beam, this is just a qualitative assessment and it is not enough for an accurate damage prediction. The rest of the sensors in Figure 9 show almost the same progression through time, clearly lower than that followed by FBG number 3 when increasing the loads, so no further conclusions could be obtained by a direct inspection of the diagram except the fact that in all those positions the damage by debonding is, initially, expected to be lower.

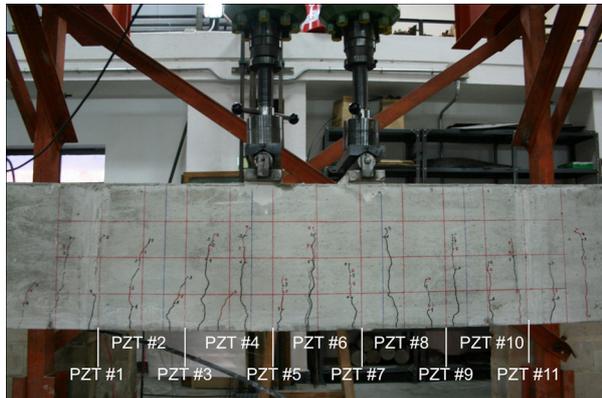
FIGURE 10. Cracking map of the RC-Beam #2 after the last loading stage.

In Figure 10, the cracking map after the whole loading procedure is shown on one of the beam’s sides. As occurred with the previous specimen, the complex damage condition of the specimen suggests that its mechanical properties, as well as the adhesion between concrete and CFRP, have been significantly affected.

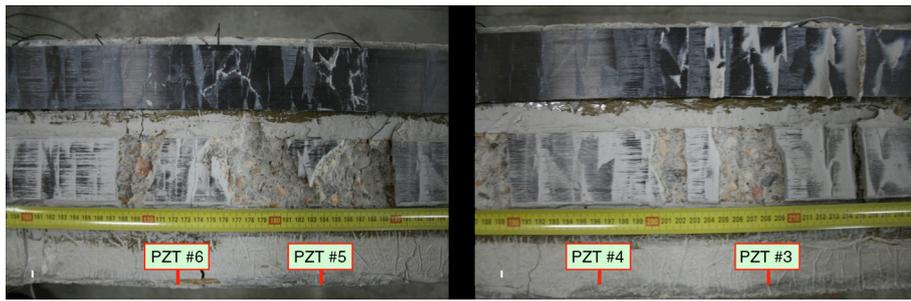
FIGURE 11. Damages with concrete cover separation between sensors 5 and 6 (left) and sensors 3 and 4 (right) for the RC-Beam #2.

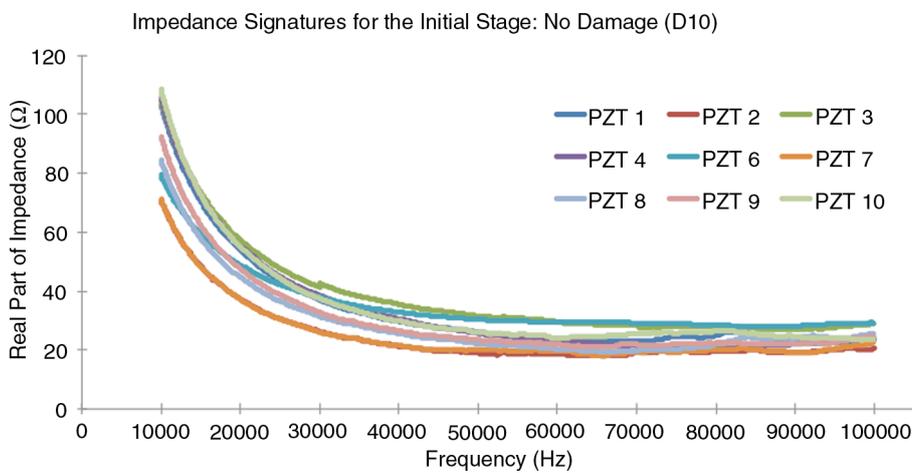
FIGURE 12. Impedance signatures for the initial stage (D10) of RC-Beam #1.

used to capture the electromechanical impedance signatures of the structure, monitoring it from 10 kHz to 100 kHz after each static load test (Table 2). Initially, the impedance curves were obtained for all sensors in order to define, prior to the loading sequence, stage D10, i.e., the baseline of the beam in terms of impedances. These results are shown in Figure 12.

The differences encountered in Figure 12 between all the curves are due to the slightly different amount of adhesive used to bond each sensor to the CFRP surface, as well as their being caused by the soldering process applied to each PZT patch. The cracking map for this specimen once the whole test program had been applied is shown in Figure 7. At a first glance, it is easy to deduce that the mechanical capabilities of

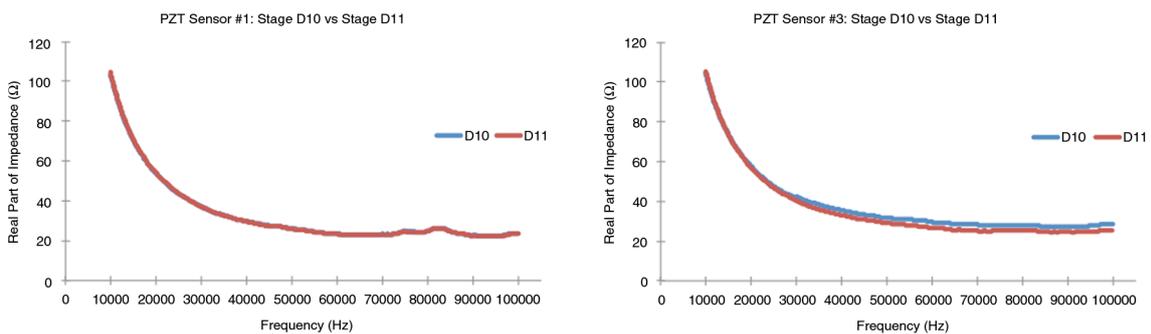
FIGURE 13. Stage D10 vs Stage D11 comparison for sensors #1 and #3.

of the sensors reacted (while others did not) indicating that damage had actually been caused, either in the inner part of the concrete or in the interphase between the concrete and the CFRP. This situation is illustrated in Figure 13, where the impedance signatures for PZT #1 and PZT #3 are compared between Stage D10 and Stage D11. While sensor 1 does not seem to show any reaction to the new health condition, sensor number 3 clearly shows a modification of the impedance curve, specially around the highest frequency ranges, which suggests not only the presence of damage in the beam, but also and more important, that this damage is close to sensor 3 (35).

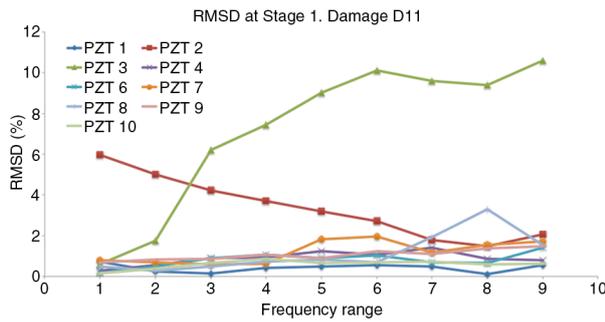
FIGURE 14. RMSD values for the comparison between Stage D10 and Stage D11.

It is clear, from the figure, that sensor 3 is the most affected by the damage, even when no visual cracks were detected during and after the loading process. This indicates that, around the position of sensor 3, there is a potential debonding location. By evaluating the RMSD values for the rest of the sensors, it is easy to see how sensor 2 is the second more affected by the presence of damage, while sensor 4 is practically not affected at all. From this fact, it can be concluded that there is a potential damage by debonding emerging between sensors 2 and 3, which actually came to be confirmed at the

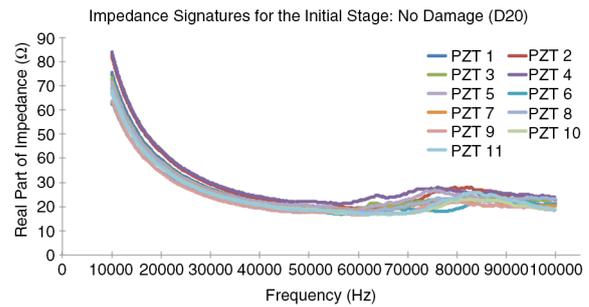
FIGURE 15. Impedance signatures for the initial stage (D20) of RC-Beam #2.

In the same way as was done with the other specimen, this beam was subjected to the corresponding static loads specified in Table 2. Once again, the impedance measurements were captured before loading each beam so that stage D20 (baseline of the beam) could be defined. These results are shown in Figure 15.

Differences encountered in Figure 15 between all the curves are due to the same reasons detailed in the previous example, all of them related to the mechanical set-up of the experiment. Furthermore, the values of the impedances also differ slightly to the previous ones, since the compressive cylinder strength resulted to be lower for this specimen.

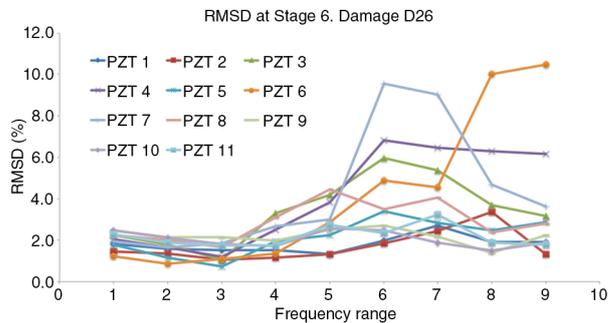
FIGURE 16. RMSD values for the comparison between Stage D25 and Stage D26.

of the structure. Figure 16 shows the RMSD values for each one of the frequency ranges.

Damage stage D26, which is actually very close to the failure condition of the beam, is analyzed this time in Figure 16. As can be appreciated in this figure, the sensors presenting higher RMSD values are sensor 4 (6.28% at 80–90 kHz and 6.1% at 90–100 kHz), sensor 6 (10% at 80–90 kHz and 10.47% at 90–100 kHz), sensor 3 (5.97% at 60–70 kHz and 5.36% at 70–80 kHz), and sensor 7 (9.55% at 60–70 kHz and 9% at 70–80 kHz). Although the indication of sensor #5 is not remarkable at all in this graphic, it collected a number of important RMSD high values in previous stages, a fact that makes that the interface between the FRP and the concrete becomes really weak in the entire region between sensor 4 and sensor 7, being more likely the debonding appearance.

Although sensor number 7 did not show such remarkable RMSD values in previous stages, the ones collected here at lower frequency ranges than the rest of the sensors (sensor 6 in particular), made us think that this sensor also detected the weakness of the interface around sensor 6 as a further damage at this stage. Finally, it is also clear that the region between sensors #3 and #4 is also likely to be debonded during the last loading step, given their high indications.
