Accelerated action of external sulfate and chloride to study corrosion of tensile steel in reinforced concrete

Citation/Citar como: Silva, M.A.G.; Cunha, M.P.; Pinho-Ramos, A.; Sena da Fonseca, B.; Pinho, F.F.S. (2017) Accelerated action of external sulfate and chloride to study corrosion of tensile steel in reinforced concrete. *Mater. Construcc.* 67 [328], e141 <http://dx.doi.org/10.3989/mc.2017.10116>

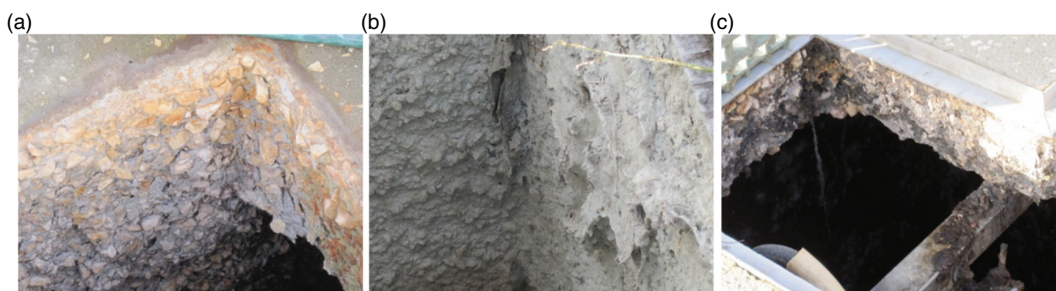
FIGURE 1. Aspects of concrete degradation. Waste treatment unit. Aveiro, Portugal.

Sewage systems often present signs of superficial deterioration of concrete with dissolution of cement paste and the main deterioration located above the water level (5) in a process that involves sulfates. Figure 1 shows evident deterioration of concrete in a waste water treatment plant in Portugal a few years after its opening, a problem equally present in Canada (6) where degradation of the exterior walls was attributed to sulfur-rich water and soils. Another source of aggression by sulfates is the combustion of coals (especially lignites) and heavy fuel-oils that produces flue gases containing large amounts of sulfur dioxide (7, 8) that degrade the power plant stacks.

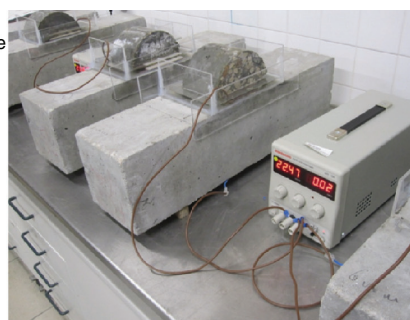
FIGURE 2. View of the external container with stainless grid. A weight is placed over the grid to maintain pressure on sponge.

The contamination by sulfate and chloride ions was started after concrete was cured for 28 days at 20 °C and 90% RH (23). A small acrylic container was installed having the bottom on the tensile side of the beam, as shown in Figure 2. Inside the container a thin sponge was positioned under a stainless steel mesh, and connected to a copper conductor. After assemblage, the container was partially filled with a solution of sodium sulfate and sodium chloride at 5% and 3% by weight, respectively.

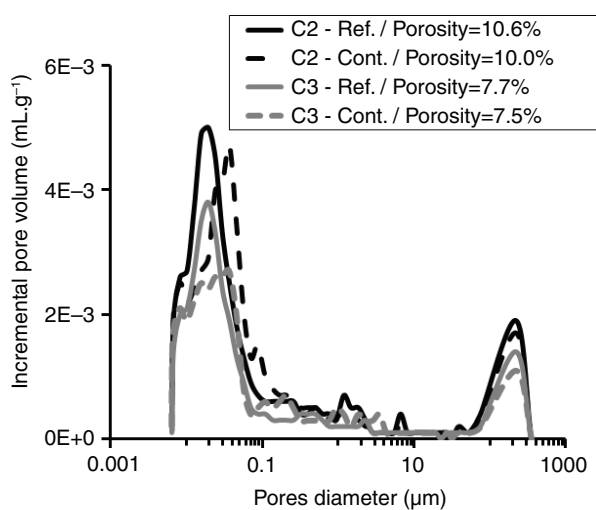
FIGURE 5. Pore size distributions of concrete mortar before (ref.) and after contamination.

The total porosities calculated by Hg intrusion and the corresponding pores size distribution are shown in Figure 5. As expected, concrete C2 is considerably more porous than C3. This difference was reflected in the overall concrete electrical resistance and had implications on the beams contamination through differential ionic current flows. Despite the different porosities, the pore size distribution in each mortar is quite similar.

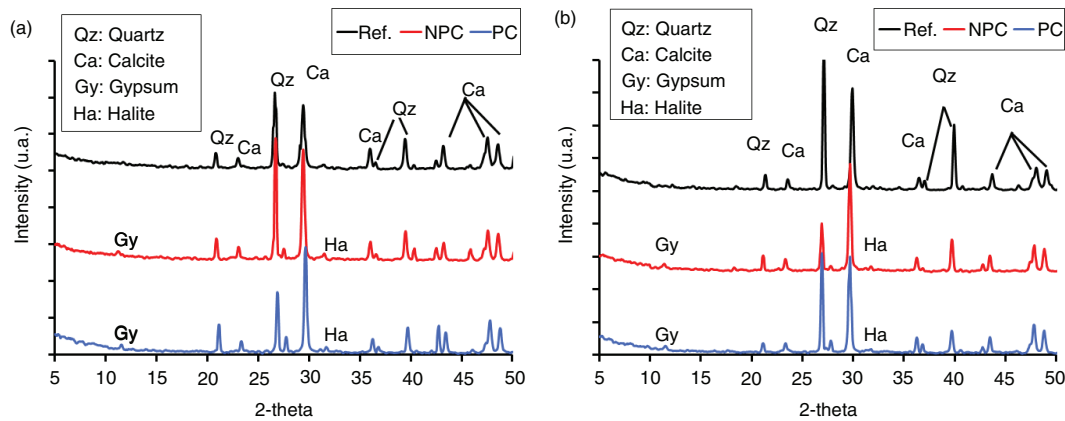
FIGURE 6. X-ray diffraction patterns of concrete mortar C2 (a) and C3 (b), before (ref.) and after contamination.

To investigate the eventual development of new mineral forms during the contamination, the cement paste was also analysed by x-ray diffraction, Figure 6. In all cases, for both concrete types and in pre-cracked and non-cracked beams, gypsum and halite were identified. The major peaks identified in all samples corresponded to quartz and calcite whose presence is attributed to the concrete aggregates (limestone and siliceous sand). In all the contaminated specimens, additional peaks appeared that were attributed to gypsum and halite. These new mineral forms are a consequence of concrete contamination by sulfates and chlorides, respectively. While the occurrence of halite did not indicate any reaction between the cement components, the presence of gypsum confirmed chemical reactions between sulfates and cement alkaline compounds. It was not possible to identify ettringite and thaumasite, probably because the contamination did not last long enough to allow the generation of significant quantities.

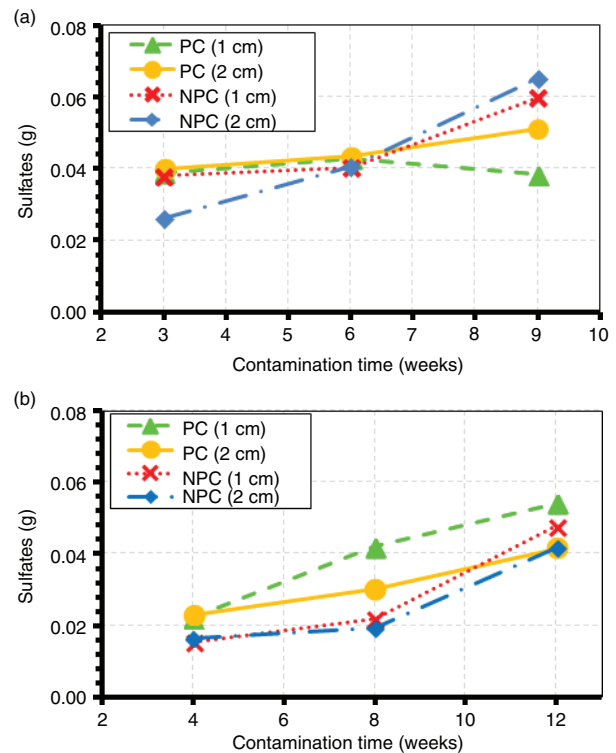
FIGURE 7. Sulfate amount for as-built and pre-cracked concrete beams along contamination, concrete C2 (a) and concrete C3 (b).

Figure 7 displays the evolution in time of the quantity of sulfates in the concrete. The data represent the mean values of the gain of mass of sulfates found for each type of beam.

At the end of the contamination process of the specimens C2 and C3, for 9 and 12 weeks, respectively, the results obtained varied between 0.04g and 0.06g sulfate per 5g of concrete. That matches the percentages of sulfate contamination between 0.8% and 1.2% found in the concrete mass.

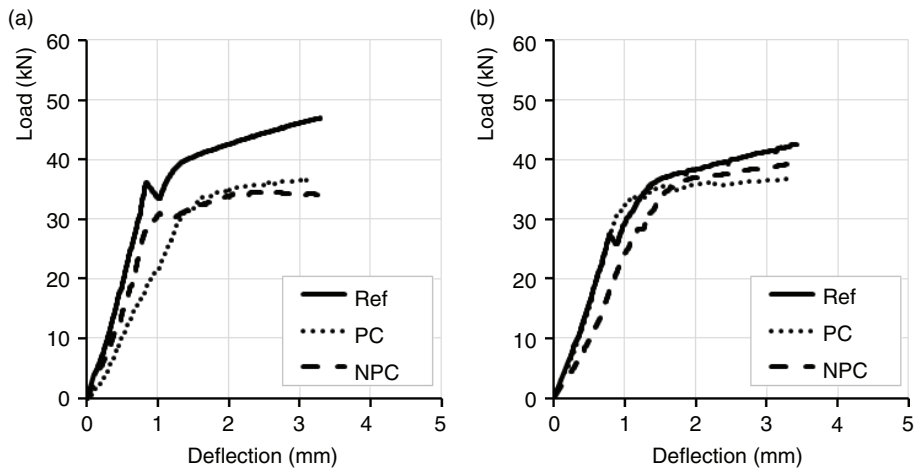
FIGURE 8. Experimental results from the flexural tests for the 6mm rebars beams, concrete C2 (a) and concrete C3 (b).

Figure 8 summarizes the data obtained from the flexural tests in the beams reinforced with 6 mm rebars, where “Ref” designates the reference beam without contamination, and PC and NPC refer to the pre-cracked and non-pre-cracked specimens, respectively. The results evidenced the detrimental effects of corrosion caused by the contamination, showing a decrease of the maximum strength of approximately 27% for concrete C2 and 22% for concrete C3, due to the contamination. It is noticed that the mix for concrete C3 had, compared with C2, more cement, more fly ashes and more pozzolith 540 and less water that led to lower porosity and explain the smaller influence of contamination.

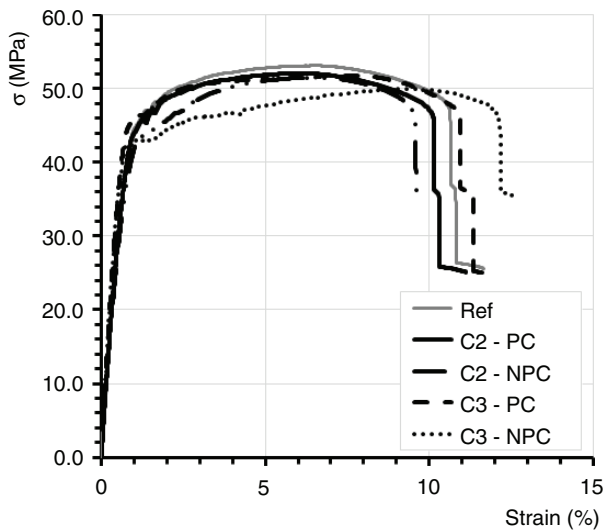
FIGURE 10. Experimental results from the tensile tests of 10 mm rebars (C2 and C3).

Figure 10 presents the results obtained from the tensile tests performed on the rebars extracted from the contaminated beams, after carefully removing the surrounding concrete. To be used as reference values, three coupons from the steel samples had not been subjected to the contamination processes and the average results for their tests are also shown in Figure 10 and identified as “Ref”. The decrease of strength between the reference and the contaminated specimens was small, varying between 2% and 6%.
