Microscopic observations of sites and forms of ettringite in the microstructure of deteriorated concrete

ABSTRACT: The determination of delayed ettringite formation (DEF) in hardened concrete relying simply on the identification of ettringite by electron microscopy or powder X-ray diffractometry can be imperfect because of the high risk of missing other possible deterioration phenomena. The presence of ettringite can be easily biased as an indication of DEF while the actual cause of deterioration is ASR. This paper identifies the deterioration causes and presents different ettringite formation factors based on the petrological observation results. The experiments conditions including depth of carbonation, mix proportions of concrete, curing temperature and others were considered. The deterioration of the samples seem to be correlated to ASR, except for the precast concrete product which presented DEF. In order to determine the deterioration causes and demonstrate the importance of petrological approach, different observations using the same methods were carried out on a concrete specimen blended with fly ash showing some cracks.

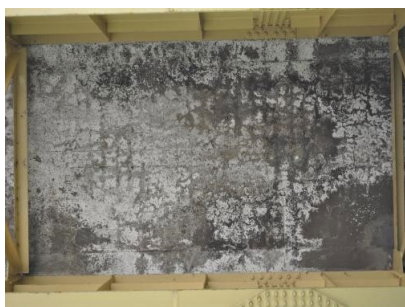
a) Floor slab with high SO₃ concentration (No. 1); Significant deterioration accompanied with widely distributed cracks is often found in the bottom surface of reinforced concrete (RC) floor slabs of steel bridges aged about 40 years in cold regions with snow cover as shown in Figure 1 (27). These RC slabs are being replaced with those made of prestressed concrete (PC) floor slabs in these several years for the safety of traffic. The sample used in this study was a full depth core (55 mm diameter, 215 mm long) taken from a piece of removed RC slab.

FIGURE 1: The bottom surface of the floor slab with lattice-like cracks (No. 1).

a) Floor slab with high SO_3 concentration (No. 1); Aggregate consisted of gravel and sand mainly comprised of granite, diorite, rhyolitic welded tuff and andesite. ASR cracks were found extending from aggregate particles of andesite, rhyolite or rhyolitic welded tuff into the cement paste (Figure 5a). The depth of carbonation was 20 mm in the bottom surface, while being 3 mm in the top surface which had been in contact with the asphalt.

No cracks were found in the SO₃ rich area in the floor slab (No. 1). Considering the depth of carbonation, it was likely that sulfate ions were formed during decomposition of ettringite in the carbonation area, eluted into the pore solution, carried to the inside due to concentration diffusion and concentrated

there, then used to form ettringite (30). Therefore, the main cause of the deterioration is thought to be ASR.

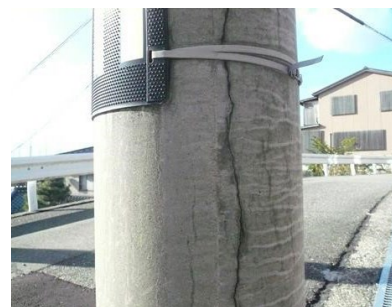
c) PC pole with vertical cracks (No. 3); The PC pole in this study was of a tension-type which was required to have a high strength. As shown in Figure 3, two vertical cracks originating from the ground

FIGURE 3: Vertical cracks in the PC pole (No. 3).

level occurred in the opposing positions in about ten years from the installation. The pole with a nominal strength of 80 N/mm², a W/C of 30.5% and a cement content of 525 kg/m³ had been manufactured by applying centrifugation in a centrifugal casting machine, followed by 4 hours of steam curing at 70°C (28).

c) PC pole with vertical cracks (No. 3); In the PC pole manufactured by centrifugal casting, a larger amount of coarse aggregate was present near the surface, and larger amounts of fine aggregate and cement were present in the inside. The coarse aggregate was gravel mainly comprised of diorite, granite, gabbro, gneiss and rhyolitic welded tuff, and the fine aggregate was sand mainly comprised of rhyolitic welded tuff, granitic rocks and andesite. ASR was found around the coarse aggregate particles of rhyolitic welded tuff near the surface of the pole (Figure 5d), and around the fine aggregate particles of andesite in the inside (Figure 5e). ASR was more significant in the inside of the pole where the andesite content was higher. In the inside, ASR cracks were propagating into the cement paste, and they were filled with needle-like crystals that formed

There was a concern of DEF for the PC pole (No. 3) which had been steam cured at high temperatures. However, observation showed no characteristic findings of DEF, i.e. gaps between aggregate particles and the cement paste, and web-like cracks in the cement paste (9). The cracks filled only with ASR products were likely to have occurred due to a large tensile stress acting on the concrete surface as a result of ASR expansion of concrete. Formation of ettringite was found in cracks that were obviously attributable to ASR, which suggested no association with expansion. Replacement of ASR gel by ettringite, leaving a texture of original ASR gel within cracks, has been reported (31). One of the possible factors of ettringite formation was considered to be the high SO_3 concentration which was originally high due to the high cement content in the concrete mix proportions and further increased in the inside by the centrifugal casting. The other possible factor was the water which could enter from the ASR cracks and promoted re-formation of ettringite (12, 32).

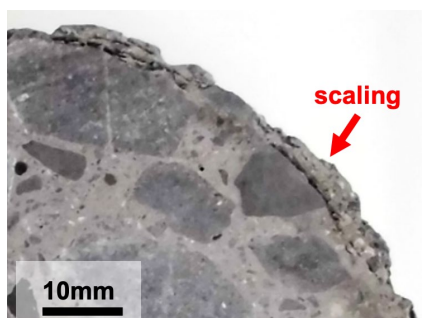
FIGURE 4: Concrete specimen immersed in a paste of incineration fly ash (No. 5).

filled with fly ash-water mixture with an addition of CaCl₂. The mix proportions (water: 150 kg/m³; cement: 370 kg/m³; lime based expansive admixture: 25 kg/m³) and the curing conditions (steam curing for 3 hours at temperatures up to 65°C) used for the cylinder were the same as those of the precast concrete container. The specimen after four months of exposure to fly ash had cracks and scaling in the circumferential surface as shown in Figure 4.

Reported strain of the precast container indicated expansion in winter and overall contraction in other seasons (33). Therefore, the reason of the parallel cracks at the concrete surface can be attributed to frost attack due to the freezing and thawing and combined formation of the 3-1-15 crystalline phase within cracks.
