Evaluation of nanoparticulate consolidants applied to Novelda Stone (Spain)

ABSTRACT: The main objective of this work is to test several nanoconsolidant treatments (pure Nano Estel, 1:1 diluted Nano Estel and Tecnadis ZR-110), with the aim of improving the intergranular cohesion of the Novelda Stone. The treatments were applied in laboratory by capillary suction and their effectiveness and depth of penetration have been evaluated on the basis of the petrophysical characteristics of the stone (petrography, elemental physical properties, hydric properties and ultrasound propagation), before and after consolidation. Subsequently, in order to estimate the durability of the treatments, accelerated ageing tests (salt crystallisation, freeze-thaw and wet-dry) were carried out. According to the results, we can conclude that none of the treatments is suitable for the treatment of Novelda stone. However, we consider that with further in-depth study Tecnadis ZR-110 could offer good results.

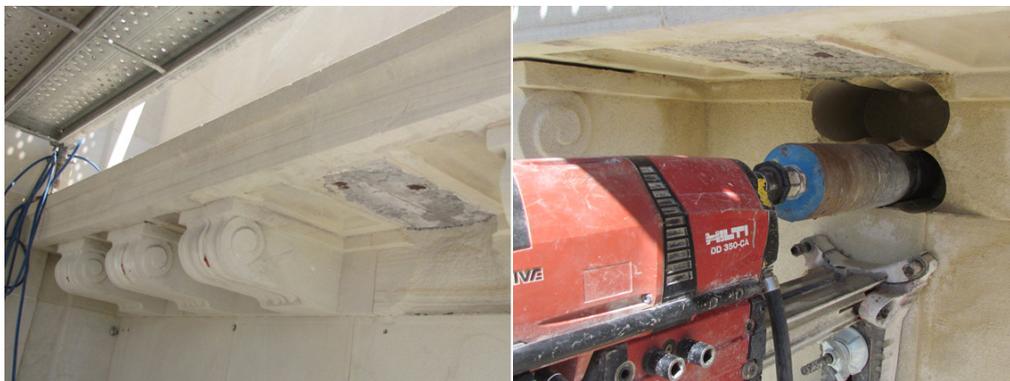
FIGURE 1. Location of the detached modillion and testification of the cores.

In this work, we used Novelda stone obtained from a modillion on the facade of the building of the Bank of Spain in Malaga. The entire modillion was detached from the facade due to extensive scaling processes in the rock. The cores were obtained with a Hilti tester as shown in Figure 1. The upper part of the cores were exposed to the scaling, while the rest of the stone showed no signs of alteration, this deteriorated part was not used in the study. Three cores of approximately 11 cm in diameter and lengths between 24-2 cm were used to prepare 12 slabs of 5x5x1 cm (A - L), 4 prisms of 5x5x10 cm (NV1 - NV4), 4 prisms of 5x5x9.5 cm (NV5-NV8) and 4 tablets of 2x2x1 cm (NV, NP, ND and TZ). The 5x5x1 cm slabs have been cut with the dimensions established for the vapour permeability test, while the 5x5x10 and 5x5x9.5 cm prisms have been used for the rest of the water related properties. According to the UNE-EN and CNR-ICR standards, the dimensions of the specimens for water related properties should be 5x5x5 cm, however, due to material limitations, one of the dimensions has been modified, giving priority to the length of the specimens in order to record the penetration of the treatments inside the stone.

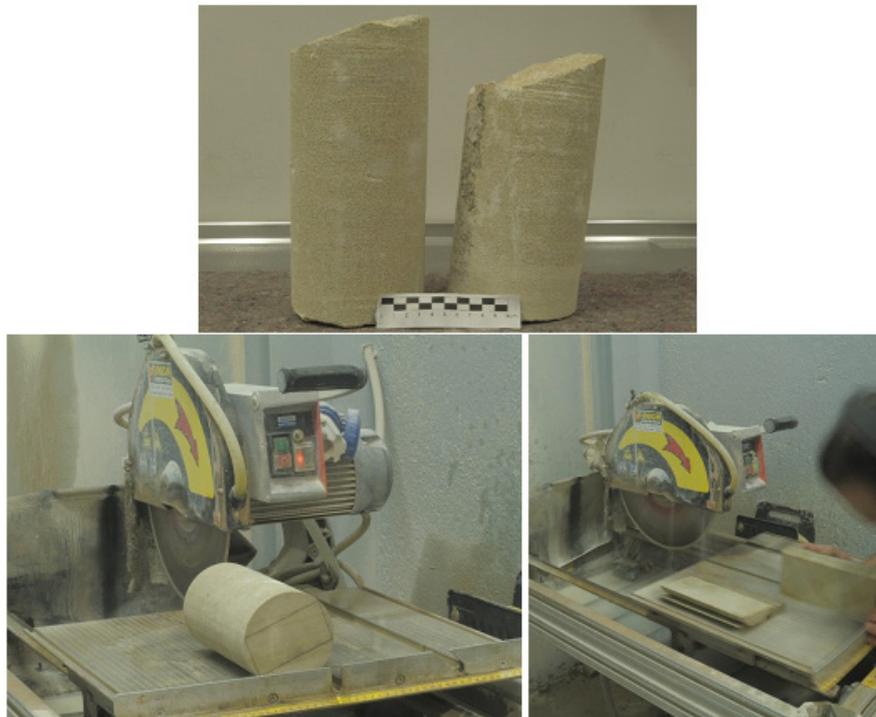
FIGURE 2. Novelda stone cores used to obtain the samples. It is shown the cut and orientation of the samples with respect to the cores.

For the cutting of the samples a diamond saw blade was used. The prisms were obtained using the centre of the cores as shown in the Figure 2, and the slabs and tablets were obtained from the remain material.

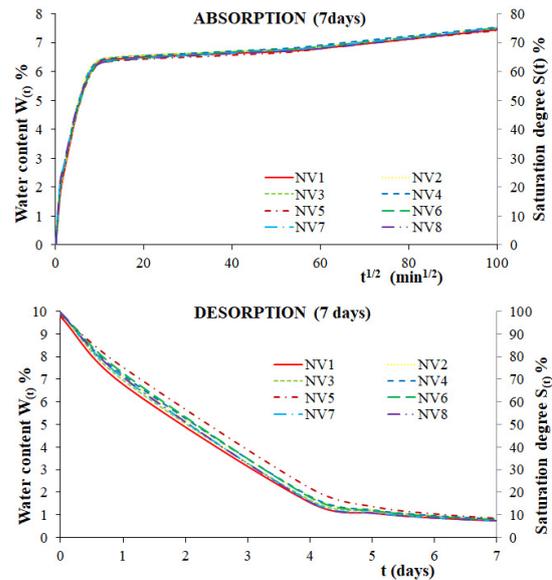
FIGURE 3. Absorption and desorption kinetics for the Novelda stone (blank).

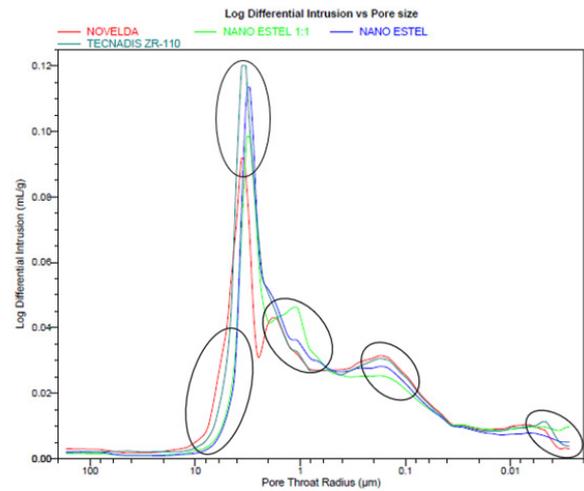
FIGURE 4. Mercury intrusion curves for unconsolidated Novelda stone-blank (red), consolidated with pure Nano Estel (blue), 1:1 diluted Nano Estel (green) and Tecnadis ZR-110 (bluish grey).

The configuration of microporosity was significantly modified (Figure 4), a decrease in the pores with pore throat radii between 4-7.5 μm was observed. New pore throat radii were generated around 3 μm, consolidants seem to be particularly effective in this radius range, especially Tecnadis ZR-110.

An increase in the number of pores with pore throat radii around 1 μm and below 0.001 μm, and a decrease in the radius range around 0.1 μm was observed. This effect is the most evident in the case of the 1:1 diluted Nano Estel.

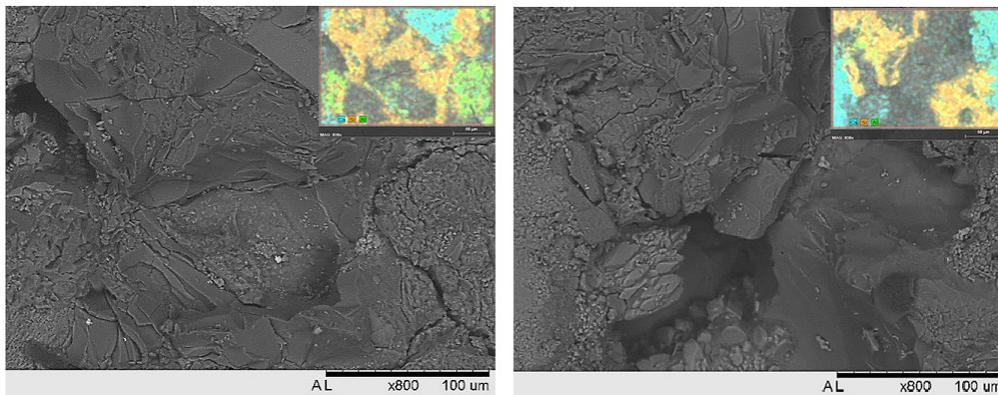
FIGURE 5. Detailed micrographs of pores filled with 1:1 diluted Nano Estel in slab F. Elemental mapping with calcite (blue), silica (orange) and aluminium (green) is shown. Aluminium is shown in order to distinguish the consolidant from the phyllosilicates.

The study of the larger pores near the 1:1 diluted Nano Estel application surface shows the presence of the consolidant filling and covering the pores (Figure 5). The treatment appears with a glassy texture similar to the conchoidal fracture of the obsidian.

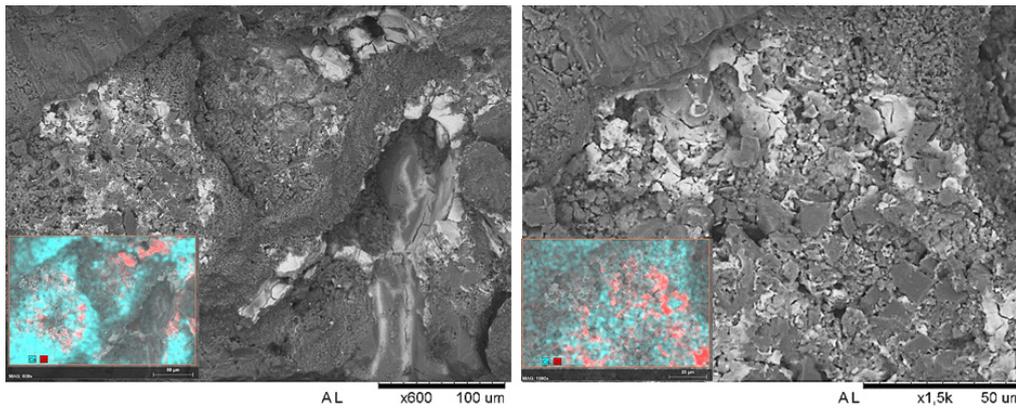
FIGURE 6. Detailed micrographs of the longitudinal section of slab I consolidated with Tecnadis ZR-110. Elemental mappings with zircon (red) and calcite (blue) are shown.

Tecnadis ZR-110 appears at the base of the sample creating a film on the cement and pores. It is not a continuous film but appears cracked and discontinuously distributed (Figure 6). This cracking contributes to an increase in microporosity as the treatment itself is creating new pores.

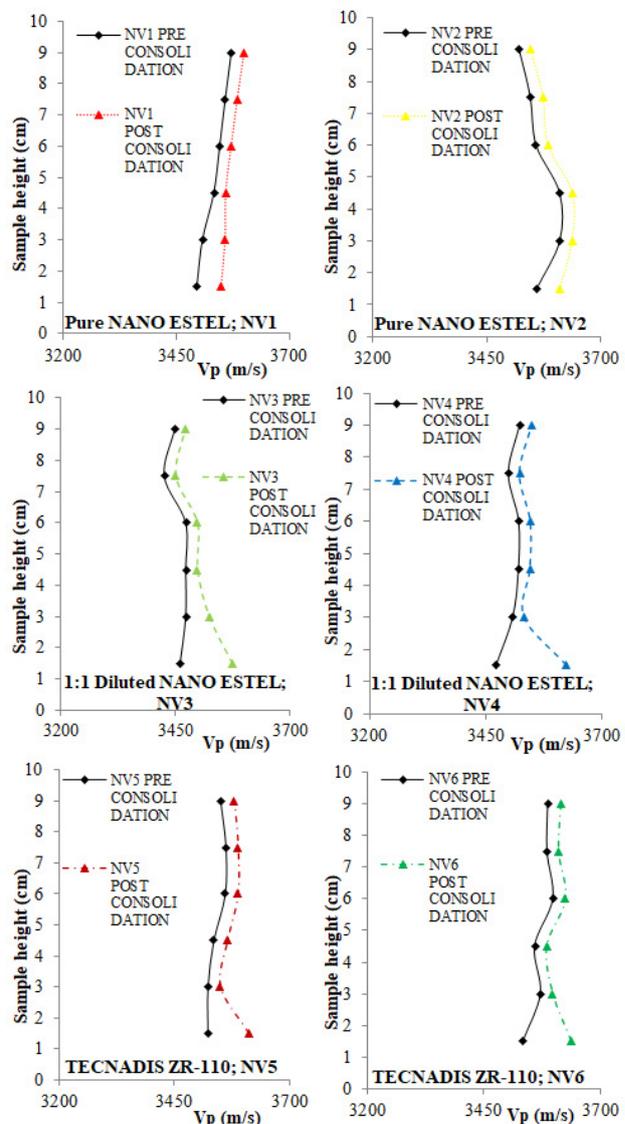
FIGURE 7. Elastic wave propagation profiles before and after consolidation of Novelda stone.

The pure Nano Estel is distributed homogeneously along the first 1.5-3 cm. The penetration depths of 1:1 diluted Nano Estel are similar to those of the pure product, but the concentration is higher in the first 1.5 cm. The concentration of Tecnadis ZR-110 is also higher in the first 1.5 cm. This is manifested by a steep increase in P wave velocity in this lower part of the samples. In consolidated areas the treatments produce an improvement in cohesion (increase in V_p) compared to unconsolidated values.

As was seen in the porosity study, the Tecnadis ZR-110 provided a slight increase in porosity which was not reflected in the ultrasound study. This was explained by the fact that the treatment produced a new microporosity, so at the same time is filling larger pores but creating new smaller ones. However, this only occurred in the first 1.5 cm of the base of the sample, which causes the observed increase in P wave velocity. The rest of the specimen was not affected by the treatment and therefore no changes in the ultrasound profile appeared.

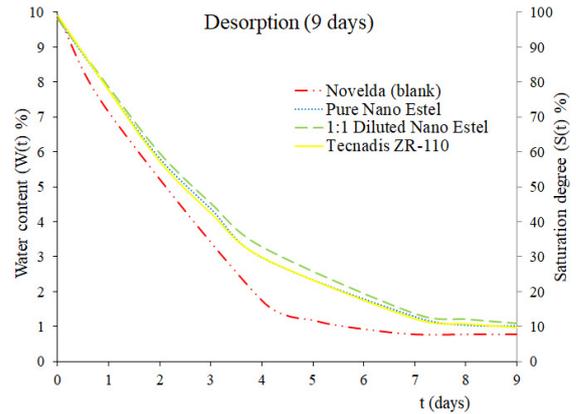
FIGURE 8. Desorption kinetics for the Novelda stone (blank) before and after the treatments.

Desorption kinetics were affected by the new microporosity generated by the nanoconsolidants. In the treated samples, desorption is slower and the content of water in retention is higher (Figure 8). Saturation degree at seven days (S_{7d}) was 7.9% in the unconsolidated samples, and it reached 13% in the treated ones. In general, the behaviour of all treated samples is similar to each other, and it differs from their pre-treatment behaviour. However, the sample treated with 1:1 diluted Nano Estel is slightly different to the other samples due to the more noticeable change in porosity (Figure 8).

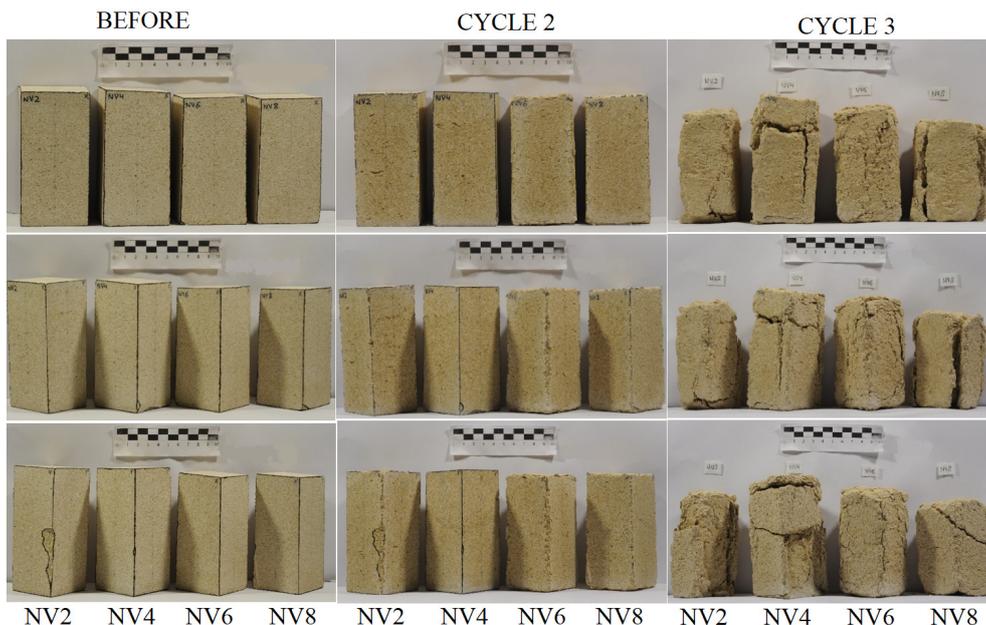
FIGURE 9. Front and lateral views of samples before and during salt crystallization test. NV2: Pure Nano Estel; NV4: 1:1 diluted Nano Estel; NV6: Tecnadis ZR-110; NV8: Blank.

The sample consolidated with pure Nano Estel suffered the highest weight loss (31%), followed by the blank with 19%. Weight loss of the sample treated with 1:1 diluted Nano Estel was 7%, and the sample treated with Tecnadis ZR-110 lost 6% of its weight. Figure 9 demonstrates the observed surface damage.

NV2 sample; pure Nano Estel. This sample suffered loss of material on all its faces, losing some fragments of 0.5 cm length and 0.1 cm width. The deterioration occurred in the form of spalling, so that entire slabs of material were detached leaving the interior of the stone uncovered in some sections. Also hairline cracks appeared with apertures of 0.1-0.5 cm.

NV4 sample; 1:1 diluted Nano Estel. The base of the sample resisted better and only suffered spalling in one of its faces losing a fragment of 0.5 cm, while in the upper part hairline cracks appeared with apertures between 0.1-0.8 cm. These fractures spread through the faces causing this complete section to separate from the rest of sample and divided it into two pieces.

NV8 sample; blank. Significant loss of material was observed on this sample, resulting in a 1.5 cm decrease in length. Hairline cracks appeared that cross several faces with apertures between 0.1-0.6 cm and form slabs of material parallel to the long axis of the prism.

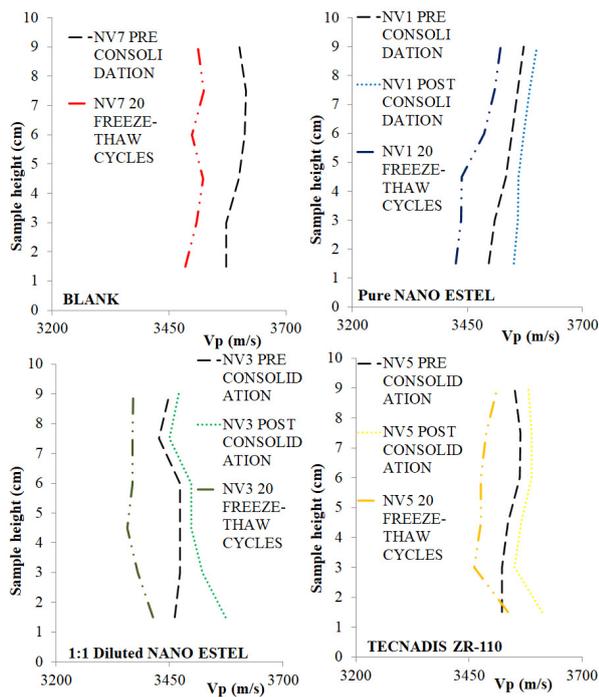
FIGURE 10. Elastic wave propagation profiles during the freeze-thaw test.

The ultrasound study revealed the internal damage suffered by the samples due to the action of ice (Figure 10).

It should be noted that in the samples consolidated with 1:1 diluted Nano Estel and Tecnadis ZR-110 the damage suffered at the base is less significant than in

the rest of the samples due to the higher effectiveness of the consolidant in these areas.
