Shear behavior of hollow clay brick masonry wallet coated with short jute fiber reinforced mortar

ABSTRACT: The objective of this study is to present a new method of reinforcing masonry using layers of mortar reinforced with short jute fibers. Mortars were produced with 0%, 2% and 3% jute fibers with cementitious matrices free of calcium hydroxide. The effectiveness of the reinforced mortar was evaluated through diagonal compression tests of hollow ceramic brick masonry prisms. The prisms were coated on both sides. The experimental results demonstrated that the diagonal resistance of the fiber system increased by 28 to 30% and presented greater resistance to elastic deformation during load application, with deformation coefficients 2 and 3 times greater for 2% and 3% of fibers, respectively. Therefore, jute fibers prove to be a sustainable and efficient alternative for masonry reinforcement applications, with maximum applied loads considerably higher than the unreinforced system, in addition to better crack control.

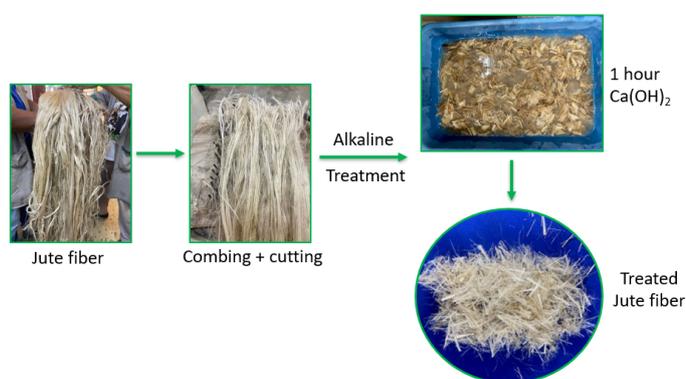
FIGURE 1. Processing and alkaline treatment of jute fibers.

The fibers used were obtained from the city of Coari, in the Brazilian Amazon region, specifically from Coari – AM, in long bundles, as depicted in Figure 1. In the laboratory, the fibers were aligned and cut into lengths of 40 mm. Subsequently, an alkaline treatment was applied to the jute fibers to reduce water absorption and enhance the fiber-matrix adhesion. The treatment followed the method presented by Ferreira et al. (34): the fibers were immersed in a solution of $\text{Ca}(\text{OH})_2$ at a controlled laboratory temperature (23°C) with a concentration of 0.73% of the fiber weight for 50 minutes. Afterward, they were dried in a chamber with forced air flow at 40°C for 72 hours.

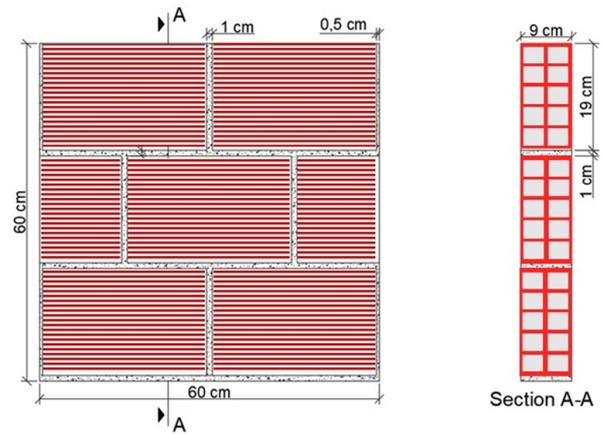
FIGURE 2. Configuration and dimensions of uncoated walls.

A 10 mm-thick mortar was applied in the joints between the blocks (Figure 2), prepared with a mass ratio of 1:0.5:2:1 (cement, hydraulic lime, sand, and water). The assessment of this mortar used in the masonry joints exhibited a compression strength of 6.4 ± 0.4 MPa after 28 days.

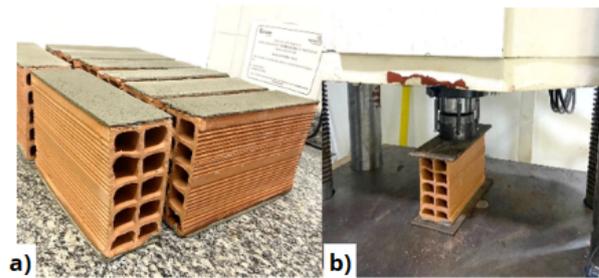
FIGURE 3. Testing of ceramic blocks in accordance with ABNT NBR 15270-3 (55). a) regularization of blocks, b) test setup.

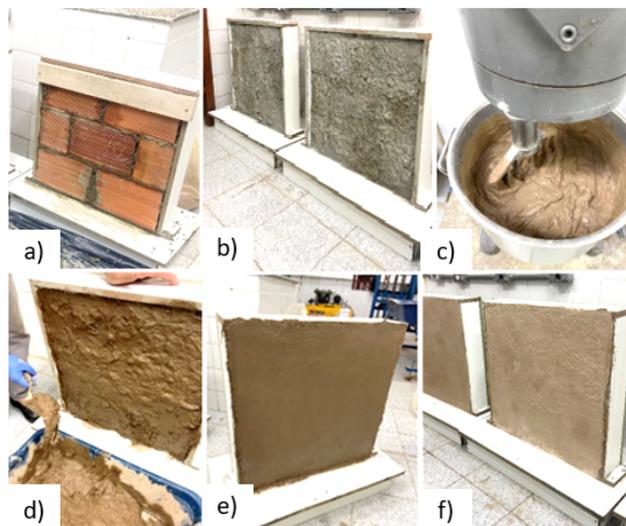
FIGURE 4. Production of wall samples. a) construction of hollow brick masonry, b) roughcasting, c) preparation of rendering mortar, d) application of rendering mortar, e) finishing and smooth surface, and f) curing.

The production and application process of the rendering mortar are illustrated in Figure 4. Following the construction of the block wall, a first thin layer of mortar (approximately 5 mm thick), without fibers, was applied using a trowel on the moistened masonry surface to enhance adhesion (Figure 4b). After 14 days from the construction of the masonry wall, the JFRM was prepared in a 20 dm³ bench mount (Figure 4c) and manually applied (Figure 4d) until reaching a total thickness of 20 mm on each side of the wall (Figure 4e). To ensure the perfect hydration of the cement

The walls were air-cured within the laboratory premises until the date of testing (Figure 4f).

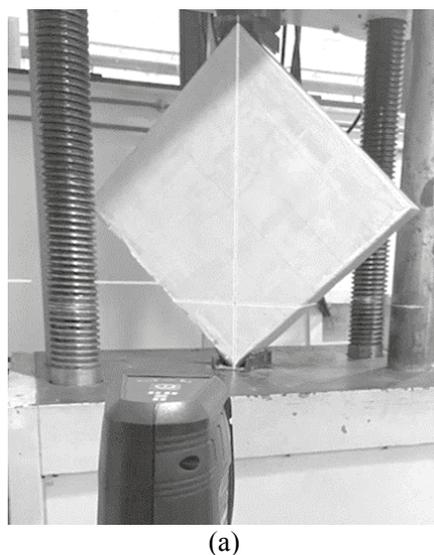
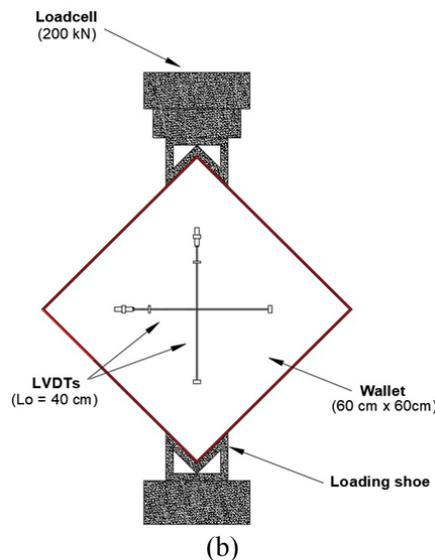
FIGURE 5. Configuration of the diagonal compression test. a) alignment with laser sight, b) support devices and LVDTs.

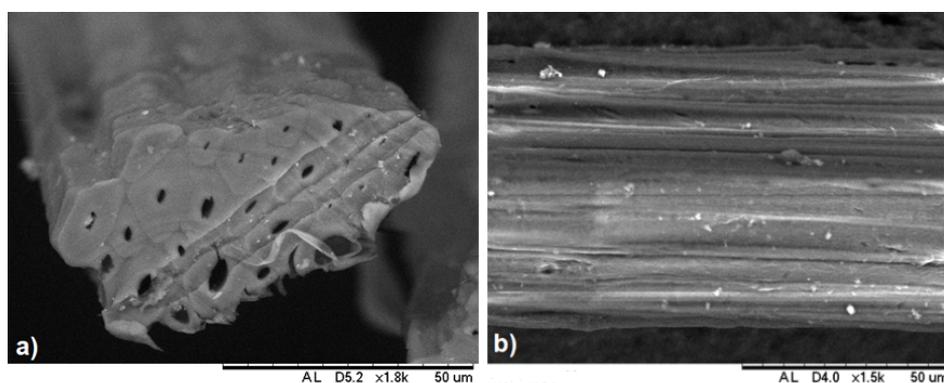
FIGURE 6. Microscopy images of natural fibers. a) cross section, b) lateral surface.

The jute fibers are formed by an irregular aggregation of fibrocells containing a central channel (lumen) inside them. Some modifications were observed in the morphology of jute fiber after alkaline treatment. Images obtained by SEM, shown in Figures 6 and 7, revealed a reduction in the cross-section with a change in fiber diameter and closure of some lumens. Additionally, the lateral surface was damaged by the fiber treatment, resulting in the appearance of lateral cracks due to delamination between the fibrocells, as previously observed by Jo et al. (35) after alkaline treatment. Moreover, deposits of calcium hydroxide crystals of varying dimensions were found on the surface of the treated fiber, which, coupled with increased roughness, could contribute to increased fiber-matrix adhesion (31, 58, 59).

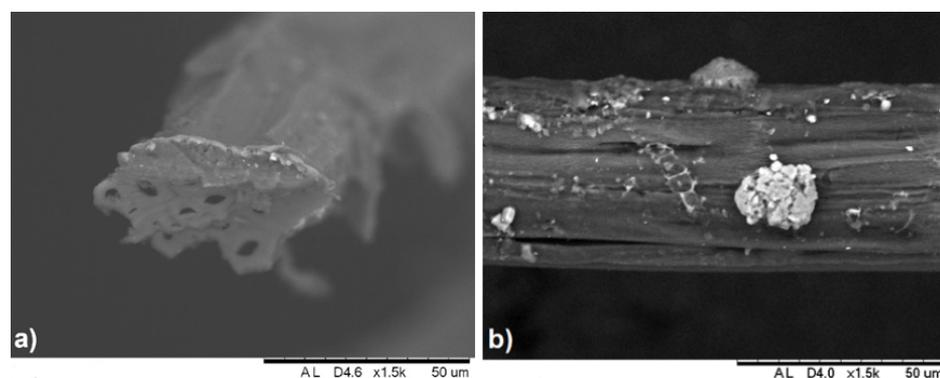
FIGURE 7. Microscopy images of treated fibers. a) cross section, b) lateral surface.

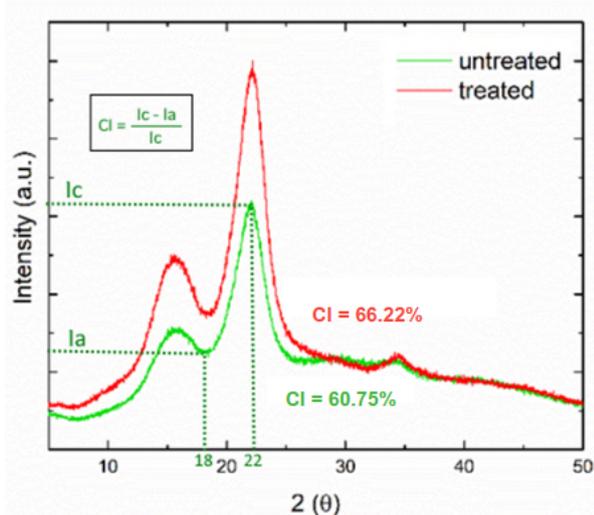
FIGURE 8. Crystallinity of jute fibers.

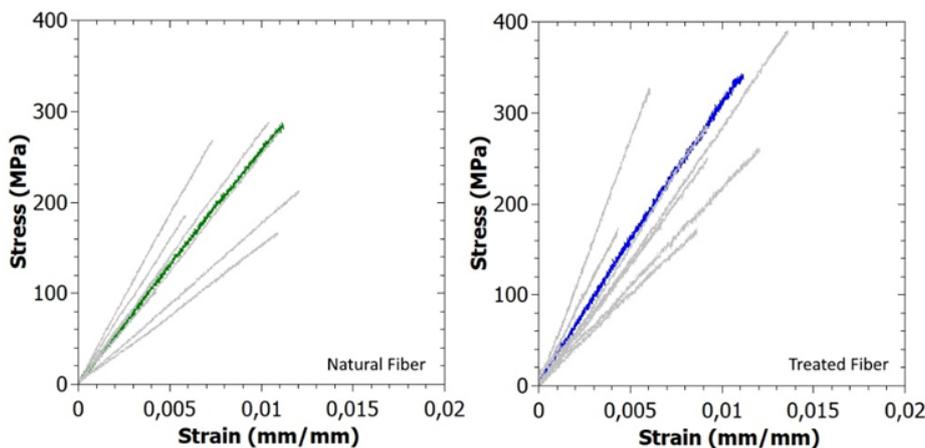
FIGURE 9. Typical tensile behavior for natural and treated fibers.

Figure 9 illustrates stress-strain curves depicting the tension testing of both natural and treated jute fibers. Their typical behavior demonstrates linear elasticity until a sudden, brittle rupture occurs. The values for tensile strength, rupture deformation, and modulus of elasticity presented in Table 4 were obtained from these curves.

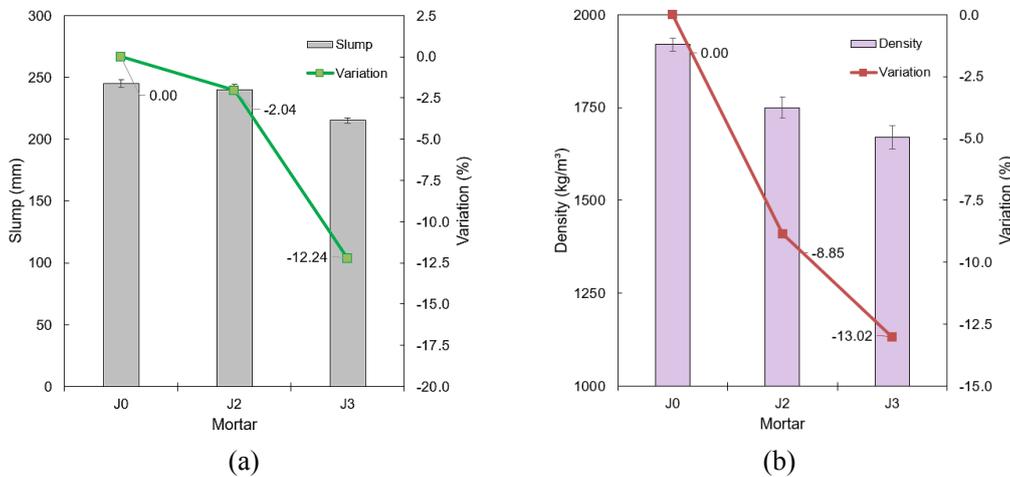
FIGURE 10. Fresh state of mortars. a) consistency, b) density.

Mortars reinforced with 2% and 3% of treated jute fibers, denoted as J2 and J3, respectively, underwent a consistency test (flow table test) to assess workability compared to the fiber-free mortar (J0). Figure 10a presents the values obtained in the test and the consistency reduction observed upon fiber introduction. There is a reduction of 2.04% and 12.24% in consistency, concerning J0, for the J2 and J3 mortars, respectively.

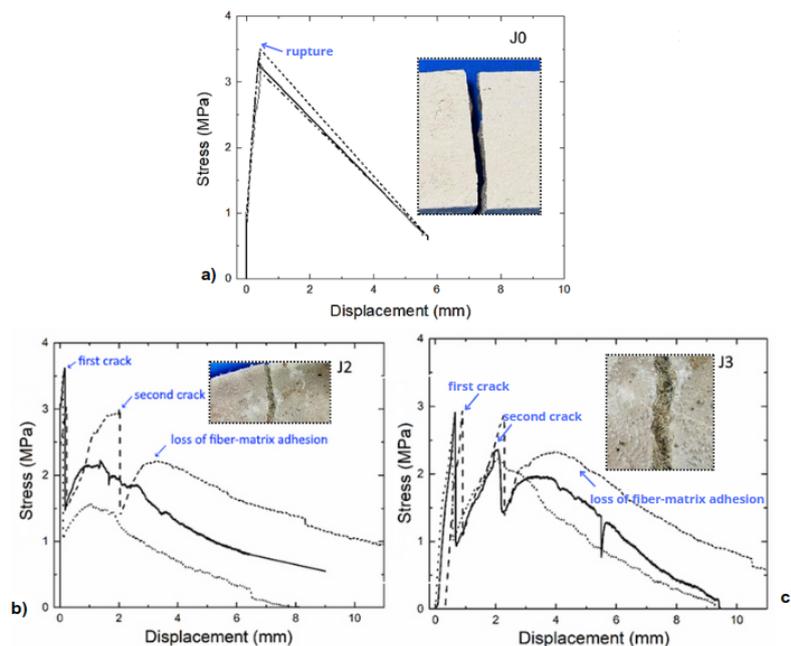
FIGURE 11. Stress x displacement curves under bending. a) J0, b) J2, c) J3.

The stress-strain curves obtained in the flexural test are shown in Figure 11. While the mortar J0 exhibited sudden failure after the appearance of the first crack, in the J2 and J3 mortars, a change in behavior under flexion is observed, with the maintenance of residual stress after cracking and an increase in rupture deformation. This leads to an increase in energy absorption capacity (material toughness). Before the appearance of the first crack, the mortars exhibit linear elastic behavior with minimal contribution from the fibers to the flexural strength or stiffness. When compared to the flexural strength of mortar J0, it's observed that the first crack stress remains unchanged with the addition of 2% of fibers, as indicated in Table 6. However, with the addition of 3% of fibers, there is a 14% reduction in flexural strength.

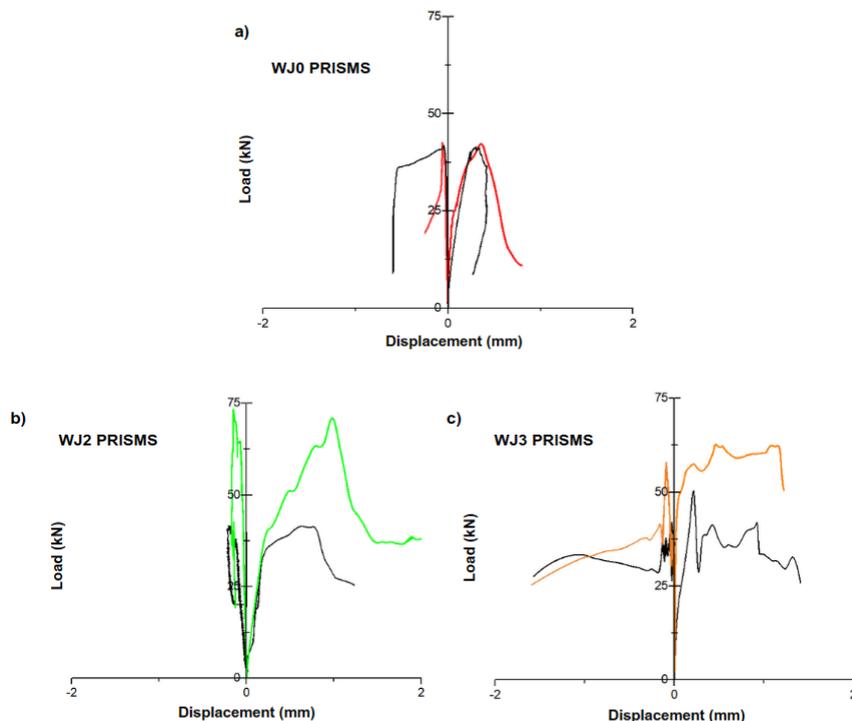
FIGURE 12. Typical load displacement curves obtained in the diagonal compression test: a) WJ0 prisms, b) WJ2 prisms, c) WJ3 prisms.

Figure 12 shows the typical load displacement curves obtained in the diagonal compression test of walls. The mechanical behavior of the walls is characterized by an approximately linear load-displacement relationship until the appearance of the first crack in the coating lay-

The WJ0 prisms reached maximum applied load forces around 42.1 kN, on average. The unreinforced specimens exhibited typical brittle failure behavior, consisting of an elastic phase until reaching the maximum load, followed by sudden failure in both samples, as shown in the curves in Figure 12a. During the test, detachment of the mortar coating from the units was observed, indicating low adhesion, along with diagonal cracks extending towards the edges of the specimens. Unlike the unreinforced prisms, the curves of the reinforced prisms, with 2% and 3% fibers, were characterized by a post-peak phase with load maintenance up to higher deformations. As the crack opening grows, there is a gradual reduction in load due to the fiber pull-out process in the crack region.

Evaluating the prisms reinforced with mortars containing 2% fibers, there was a greater difference in the maximum load obtained by each sample, WJ2-1 and WJ2-2, which obtained peak loads of 42 kN and 73 kN, respectively. The lower peak load of sample WJ2-1 resulted from the detachment between the masonry and the reinforcement layer at the point of load application, as shown in Figure 15. Wall WJ2-2, which reached the highest applied load among the studied walls, exhibited an initial crack with a load close to 50 kN, with a slight drop in load, followed

The effect of applying mortar with 3% of fibers can be observed in Figure 12c. Specimens WJ3-1 and WJ3-2 exhibited peak loads of 53 kN and 64 kN, respectively. In prism WJ3-1, delamination was observed between the coating and the ceramic block near the lower load application shoe, along with horizontal cracks that appeared in the blocks after reaching the maximum load. There was also rupture between the block-coating in contact with the crack region. Small cracks at the top and bottom of the prism were caused by tensile forces. Sample WJ3-2 exhibited small diagonal cracks, attributed to diagonal/shear compression forces. Despite the crushing of the blocks near the load application, there was significant maintenance of wall stability even after the end of the test.

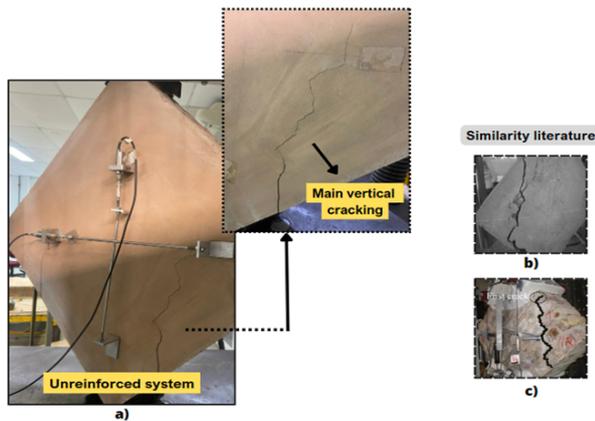
FIGURE 13. Failure of walls without fibers and comparison with the literature. a) WJ0 prisms (without fibers), b) Mezrea et al. (72), c) Sherny; Dubeo (13).

The unreinforced walls, under diagonal compression test, presented vertical cracking from the point of load application, which is common for this type of test, as shown in Figure 13. This shear failure mode, already identified by other authors (72, 13), occurs when the principal tensile stress developed internally in the wall exceeds the tensile strength of the masonry components, including the coating (73).

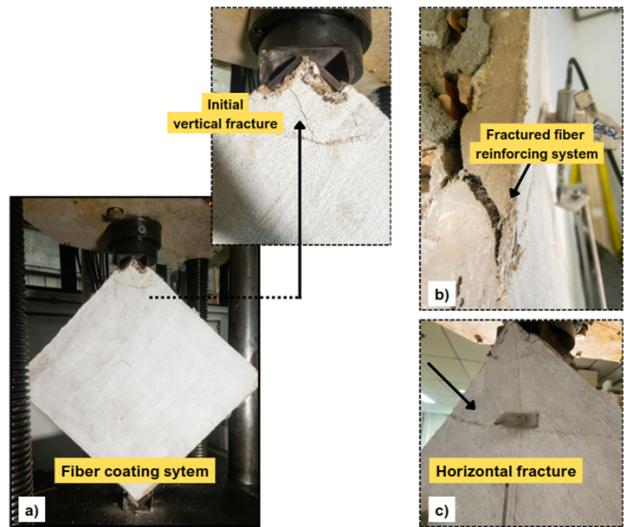
FIGURE 14. Cracking pattern of walls coated with mortars reinforced with jute fiber. a) initial vertical fracture in fiber coating system, b) fractured fiber reinforcing system, c) horizontal fracture in fiber coating system.

Figure 14 depicts the failure mode of walls reinforced with short jute fibers, identified as toe crushing, which is a result of wall crushing under compression (toe compression failure). In this case, initial arched cracking is observed below the loading apparatus and roughly transverse to the loading direction. With increasing loading, a vertical crack appears, and the ceramic block is crushed by the support apparatus. Laterally, the crack propagates between the wall and the coating, with the fibers acting to inhibit crack propagation, as shown in Figure 14b. Figure 14c illustrates the crack propagation on the other side of the wall.

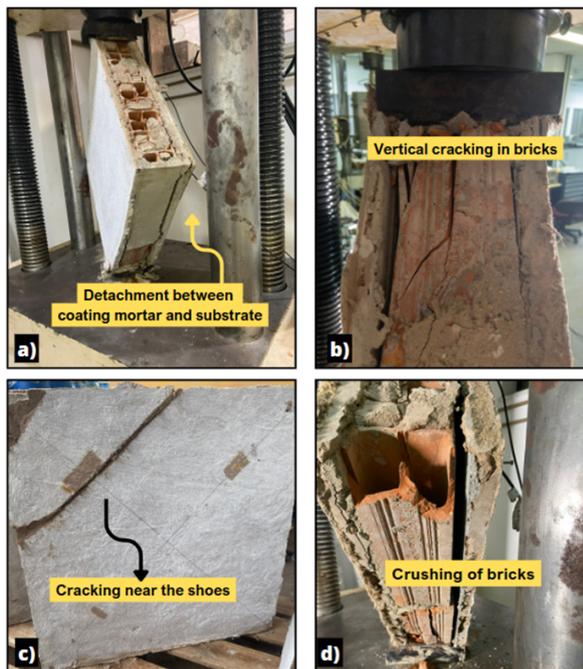
FIGURE 15. Failure modes of the test specimens. a) detachment of the plaster, b) cracks in the bricks, c) cracks in the masonry in contact with the footing, d) crushing of the brick.

Four failure mechanisms of walls coated with mortar reinforced with jute fibers, both with 2% and 3% fibers, were more notably encountered in the diagonal compression tests. Based on Figure 15, the following are identified in the samples:

- Detachment at the interface of the reinforcement mortar with the masonry substrate, i.e., between the plaster-coating-bricks. Caused by the loss of adhesion between the materials, as shown in Figure 15a;

- Emergence of cracks in the ceramic block used, which had much lower resistance than the other materials used (mortar for laying and the produced coating mortar), resulting in vertical and/or horizontal cracks (Figure 15b). Points of fragility are observed in the walls due to the heterogeneity of the materials, as in the case of the bricks;

- Emergence of cracks near the steel shoe, in lower or upper contact, near the application of load. There was also a tendency for fiber pullout in these regions (Figure 15c);

- Crushing of the bricks (Figure 15d). There is a mechanism of failure development in the region near the steel shoes that implies the emergence of several cracks both in the coating mortar and in the bricks. The cracks that appear through the bricks led to their total rupture (by crushing) at some moments.
