Comparative scanning electron microscope study of the degradation of a plasticized polyvinyl chloride waterproofing membrane in different conditions

A. Pedrosa✉, M. Del Río

Escuela Técnica Superior de Edificación de Madrid, Universidad Politécnica de Madrid (Madrid, Spain)
✉a.pedrosa@alumnos.upm.es

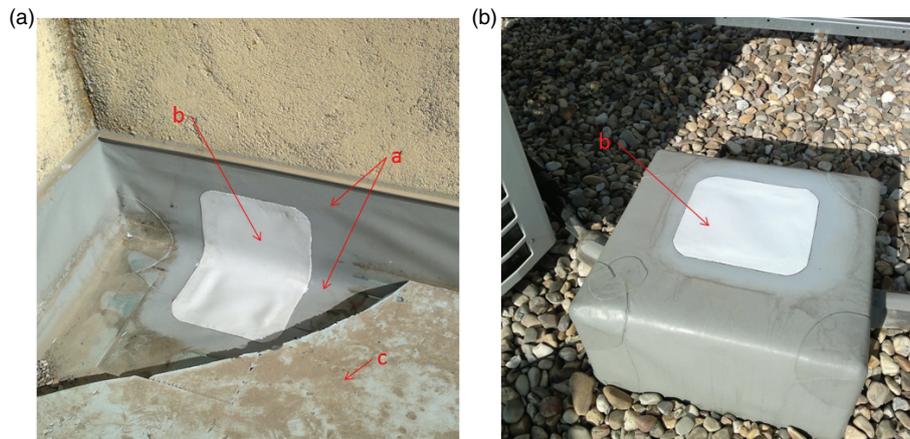
Figure 2 shows the sunny areas from which two of the samples were taken. Image (A) shows the first condition analyzed (position A in Figure 1); image (B) shows the second (position B in Figure 1). Note that this sample was located away from the influence area of XPS.

Figure 2 shows the extraction areas once the samples had been taken and the areas had been patched with a compatible material. Every sample drawn from the roof had to be repaired immediately. Before that, to make welding easier, the contact surface between the new and the old membranes (overlap) was cleaned with ethyl acetate, as can be seen in the photographs. The images show the PVC-P waterproofing membrane (a),

FIGURE 2. The images show the sunny areas from which two of the samples were taken once they had been repaired. In image (A), the first condition is presented (position A - Figure 1); in image (B), the second condition is presented (position B - Figure 1). Nomenclature: a – PVC-P waterproofing membrane; b – Patch of PVC-P compatible material covering the gap of the sample previously extracted; c – XPS.

the patch of PVC-P (b) covering the gap where the sample had been taken and the XPS (c).
