Characterisation and diagnosis of heritage concrete: case studies at the Eduardo Torroja Institute, Madrid, Spain

✉ P.M. Carmona-Quiroga^a, A. Pachón-Montaño^a, J. Queipo-de-Llano^a, J.A. Martín-Caro^{b,c},
D. López^b, I. Paniagua^b, I. Martínez^a, F. Rubiano^a, I. García-Lodeiro^a, L. Fernández-Ordóñez^d,
M.T. Blanco-Varela^a, E. Frías-López^a

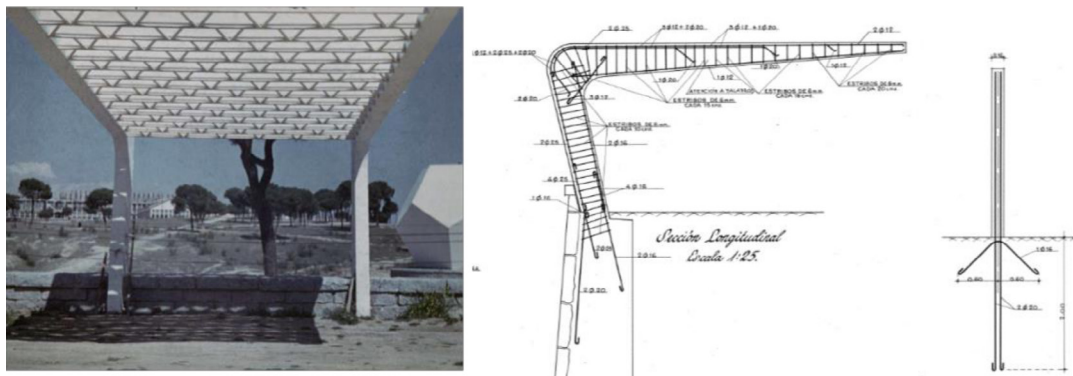
FIGURE 2. Car park pergola: construction and reinforcement drawings (38).

Located in the car park, this outdoor structure comprises 22 'sidewise-seven'-like 2.5x5.55x0.17 m (height x length x thickness) supports spanned by wooden shading slats. Both concrete and slats (the latter not conserved) were initially painted white (Figure 2). The structural review was based on the original drawings and information in the general design specifications on the type of concrete and reinforcement used to build the supports (Table 2).

Surface spalling on the concrete members was patch-repaired in 2007 when the white paint, biological colonies, rust from the exposed reinforcement and poorly bonded grout were sand-blasted off the supports. An epoxy resin passive seal (Legaran by Degussa) was subsequently applied to protect the exposed steel rebar and ensure the bond (with hydraulic binders and resins (Degussa PCC-20)) to the patch mortar used to restore the detached cover.

All the surfaces were then painted with Masterseal 325E, a white anti-carbonation coating to detain reinforcement corrosion.

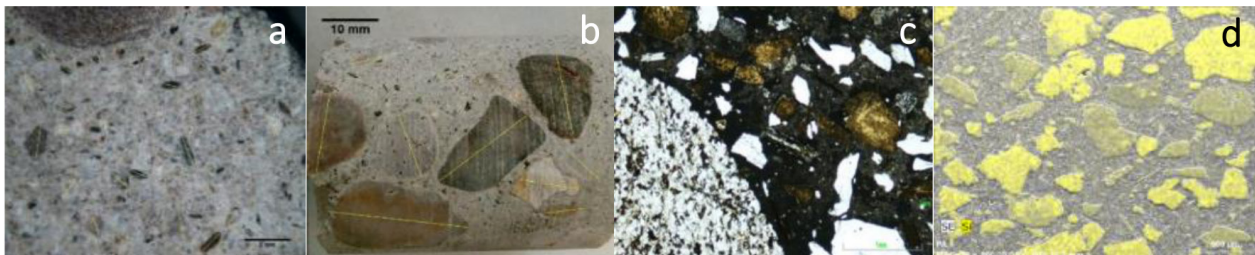
FIGURE 4. Photo- and micrographic scale images for determining aggregate particle size distribution in the pergola concrete: (a) Standard camera. (b) 2x binocular microscope. (c) polarized light microscope. (d) BSEM-EDX.

Aggregate size distribution was determined by analysing the macroscopic (with no or low enlargement) and (optical and electronic) microscopic images of the core samples (Figure 4), which also revealed their composition, found to be: in the gravel ($d/D=2.5/28$), carbonate (micritic texture) and polycrystalline quartz grains (with and without mica and iron oxides); in the sand ($d/D=0.05/2.5$), primarily monocrystalline quartz, and secondarily metamorphic rock fragments (schist), potassium feldspar (microcline) and plagioclase (albite). Both size and

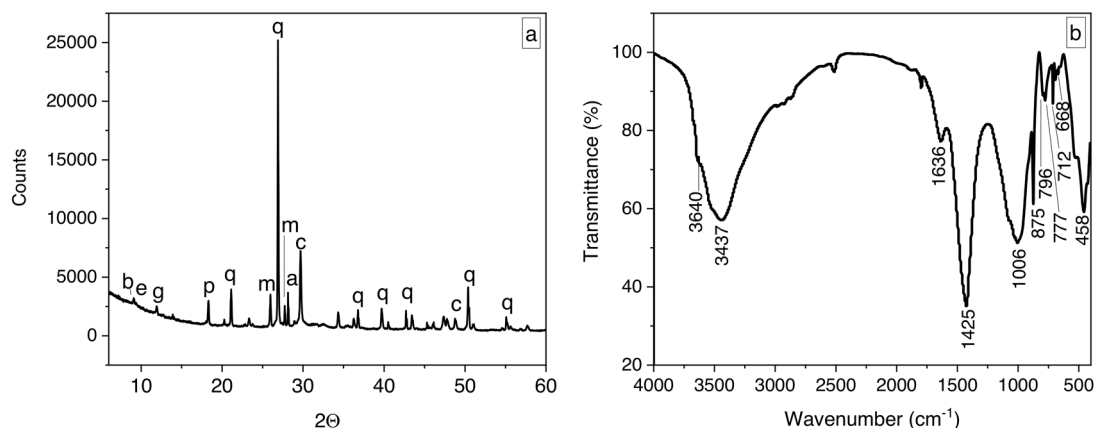
FIGURE 5. Pergola concrete components identified by: (a) XRD, where b=biotite (COD: 9000025) e=ettringite (COD: 9011103); g=gyypsum (COD: 1010981); p=portlandite (COD: 9009098); m=microcline (COD: 9000189); q=quartz (COD: 1011159); a=albite (COD: 9001631); c=calcite (COD: 9007689). (b) FT-IR.

sition of atmospheric SO₂ (59). The most intense lines identified the quartz, calcite, feldspars, albite and microcline present in the aggregates (Figure 5a). The signals for calcite might also have been generated as a result of cement paste carbonation. Further to the DTA/TG study, this hydrated cement-high sample contained 22 wt% calcite and 5 wt% portlandite, denoting the persistence of a store of alkalinity available for reinforcement passivation (60).

The FT-IR spectrum, in turn, exhibited the bands characteristic of the aforementioned mineral phases (Figure 5b): calcite at 1425, 875 and 712 cm⁻¹; silicate vibrations at around 1000 cm⁻¹; the double band characteristic of quartz at 796 cm⁻¹ and 777 cm⁻¹; the bending vibrations typical of the S-O in sulfates at 668 cm⁻¹; and the stretching vibrations generated by the OH groups in portlandite at 3640 cm⁻¹ (61).

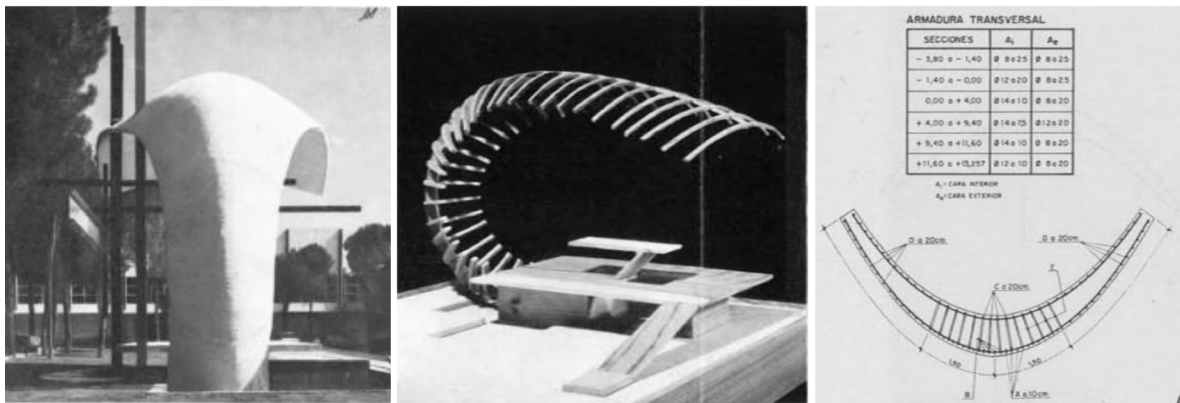
FIGURE 9. Finished shell, reinforcement mock-up and design drawings (37).

The reinforced concrete rib-like shell (Figure 9), designed to serve as an outdoor chapel, was built nearly two decades later than the main building, in 1969. Its constructional details are described in Cassinello et al. (37). The 6.5 m high, 10 m long shell is characterised by a complex geometry defined by a Bernoulli lemniscate in which the 40 cm thick base wanes to 6 cm at the outer edge. It is reinforced with steel bars ranging in diameter from 12 mm to 20 mm. When the structure was stripped of the formwork 3 d after casting, the quick set concrete used in its construction exhibited compressive strength of 19 MPa whilst the tip was positioned 12 cm below the design height.

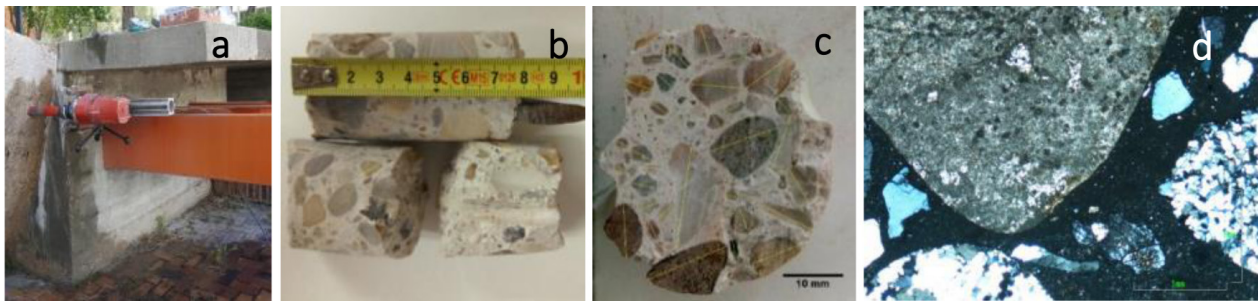
FIGURE 11. (a) Coring the rib-like shell. (b, c) core samples dimensions. (d) SEM micrograph of concrete

Two core samples were taken from the rib-like shell, one from the slab and the other from the lower part of the rib (Figure 11), for subsequent mineralogical and physical characterisation. Analysis of the optical micrographs revealed that the mineralogical composition of the gravel differs from design specifications (Table 3), for it comprises not only polycrystalline quartz (with and without muscovite and iron oxides) but biomicroite and sparry calcite. In contrast, the primarily quartz-grain based siliceous composition of the sand, with some K-feldspar and plagioclase, is essentially the same as initially designed. Further to their respective particle size distributions, both aggregates are well-graded, with $d/D=2/26.7$ in the coarse material and $d/D=0.02/4$ in

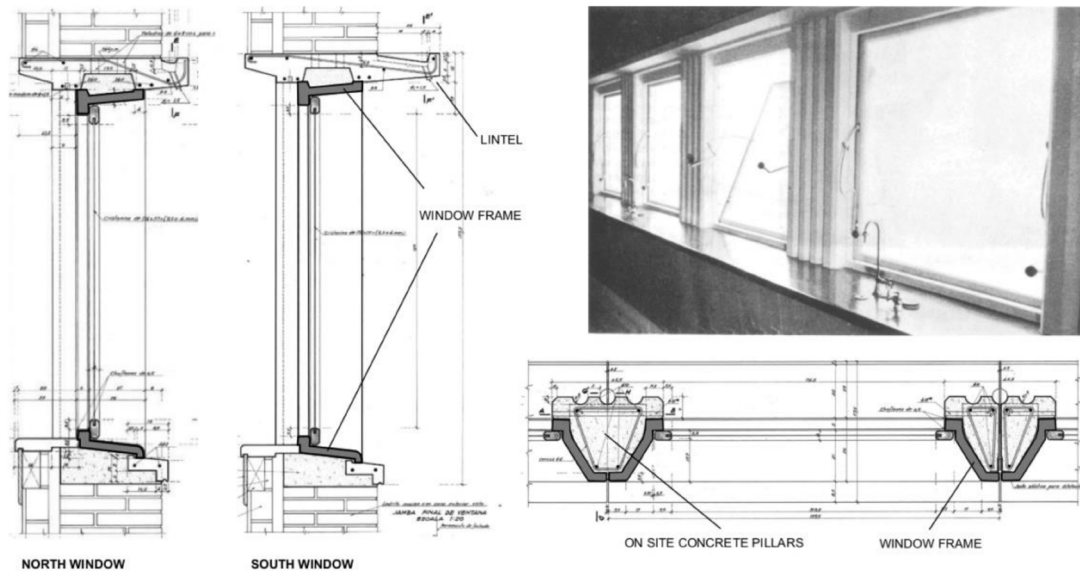
FIGURE 15. Design drawings for window frame assembly and worksite photograph (39).

The building's 400 low-strength, 1.60 m high window frames were cast at an on-site workshop using mortar with a sand:(white) cement ratio of 1:2. Bearing capacity is provided by the likewise 1.60 m long lintels and the vertical supports (concrete columns). The reinforced concrete columns were cast between the windows into forms comprising the vertical members in the two adjacent window frames as the sides, the indoor building façade at the rear and temporary corrugated sheet steel panel across the front. The latter stripped served as ornamentation in this inter-window space (39) (Figure 15).

reinforcement in the precast window frames was also determined. The minimum design thickness was 6 mm (Figure 15), whilst in situ GPR delivered a mean of 15 mm (in the south-facing window the readings were more scattered than in the north, with a maximum thickness of 40 mm and minimum of 0 mm).

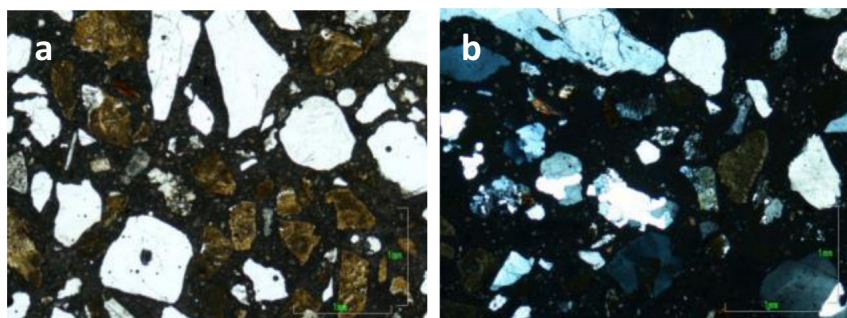
FIGURE 17. Thin section micrographs showing: (a) Sub-angular quartz (white), angular K feldspar (dyed brownish) and plagioclase (grey) particles under plane-polarised light. (b) Primarily mono- and polycrystalline quartz under cross-polarised light.

The petrographic and SEM/EDX (Figure 17) analyses conducted on the sample to characterise the mortar showed that the sand ($d/D=0.1/4$) comprised well-graded, sub-angular monocrystalline (together with some polycrystalline) quartz grains ranging in size from 100 μm to 4 mm and smaller (250 μm to 3 mm) angular potassium feldspar particles (Table 4). A minor fraction (around 10 %) of 0.5 mm to 1.5 mm plagioclase was also present. Briefly, the design specified the same mineralogy for the mortar sand as for the concrete fines (57).

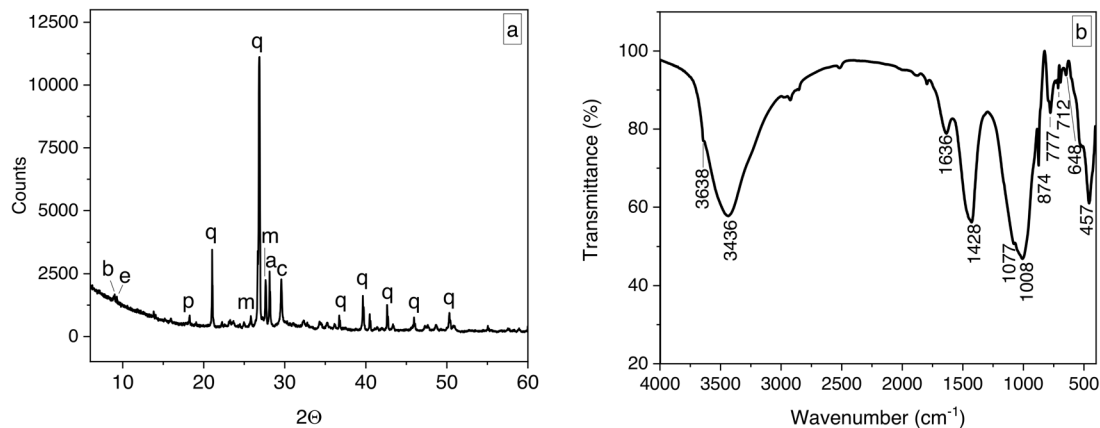
FIGURE 18. (a) XRD pattern for the lintel mortar (b=biotite, COD: 9000025); e=ettringite, COD: 9011103); p=portlandite, COD: 9009098); m=microcline, COD: 9000189); q=quartz, COD: 1011159); a=albite, COD: 9001631); c=calcite, COD: 9007689). (b) FTIR spectrum for the same element.

In addition to the intense quartz and feldspar reflections, the XRD pattern (Figure 18) exhibited signals attributed to mica, hydrated cement phases ettringite and portlandite and cement paste carbonation-induced calcite, all confirmed by FT-IR analysis (Figure 18).

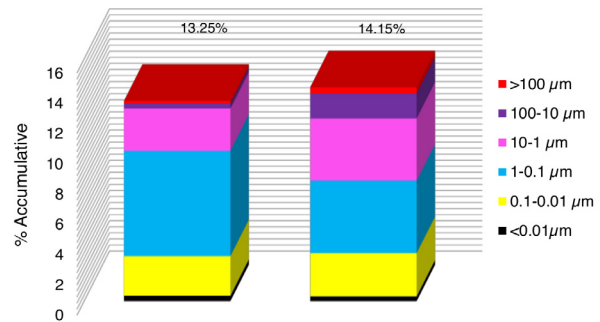
FIGURE 19. Total Hg intrusion porosity and pore size distribution in mortar window frames.

Despite the well-graded quality of the sand, the mortar is fairly porous, exhibiting mean porosity of 13.7 % (Figure 19), with pores $<1 \mu\text{m}$ accounting for 9 %. Those data, found with mercury intrusion porosimetric techniques, are not comparable to the water-accessible porosity findings described above, however, for the two parameters measure different size pores, the former in the 3 nm to 350 μm range and the latter 50 nm pores only (66).
