# Electrical resistivity tomography for moisture dynamics analysis in historic adobe structures: practical case of Casa Terán, Aguascalientes, México

**ABSTRACT:** This study employs Electrical Resistivity Tomography (ERT) to analyze moisture dynamics in an adobe wall of Casa Terán, a historic building in Aguascalientes, Mexico. By modifying the ERT technique with medical electrostimulators, the study identifies the causes and propagation patterns of moisture based on material properties. Previous interventions are also reviewed to determine the materials used. By integrating geotechnical and geoelectrical data, the study evaluates subsurface saturation levels, moisture propagation zones, and potentially weak areas in the wall. The correlation of ERT derived models with intervention images helps interpret the influence of construction materials on moisture propagation. This research is crucial for conserving historic structures and mitigating moisture-induced damages.

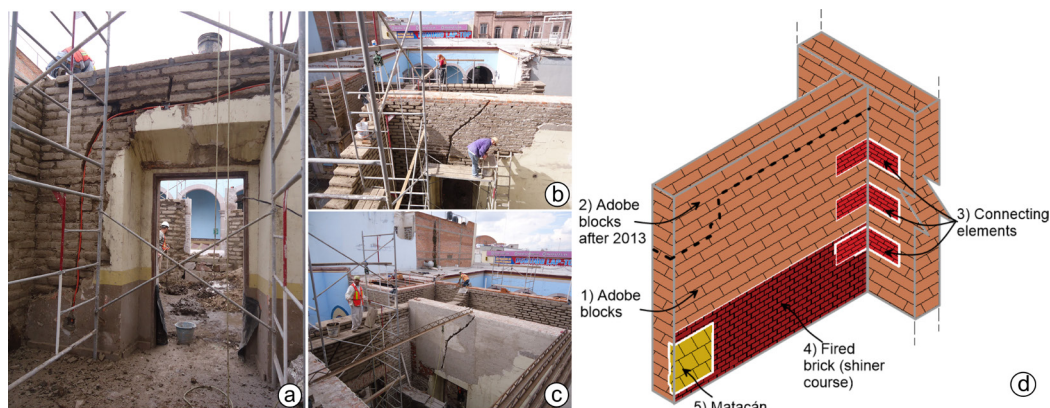
After the 2013 intervention, the wall was composed of the following materials (Figures 3 and 4): 1) adobe blocks of 0.09x0.2x0.4 and 0.09x0.4x0.4 m from the original wall joined with slaked lime mortar and small elongated stones, 2) adobe blocks of 0.09x0.2x0.4 and 0.09x0.4x0.4 m in the reconstructed area of the wall after 2013, joined with slaked lime mortar and small elongated stone, 3) volumes of 0.6x1x0.28 m of fired brick with dimensions of 0.07x0.14x0.28 m joined with cement mortar, used as connection elements between the study wall and the cross wall of axis D (Figure 5a and Figure 4d) from 1.1 m in height and at every 1 m in height (Figure 3b). This practice is common in Central Mexico, as it is believed to ensure a strong connection between the perpendicular walls made of adobe blocks. 4) Fired brick of 0.04x0.13x0.26 m in the lower part of the wall with a tambourine rigging (Shiner course) between 0 to 2 m high as wall consolidation elements (Figures 3c and 4d), 5) prismatic elements of the locally named maticán (fine-grained white sandstone) between 0 and 1 m high as wall consolidation material (broken fired brick bonded with lime mortar). Consolidation elements are materials used to reintegrate a weakened wall due to the loss of material or the occurrence of fractures or cracks.

**FIGURE 4.** Reconstruction of dividing wall. a) Placement the first rows of adobe over the door. b) Insertion of mortar and small elongated stones joints. c) Reconstructed wall covered with slaked lime mortar (32). d) Drawing showing the different materials that make up the study wall.

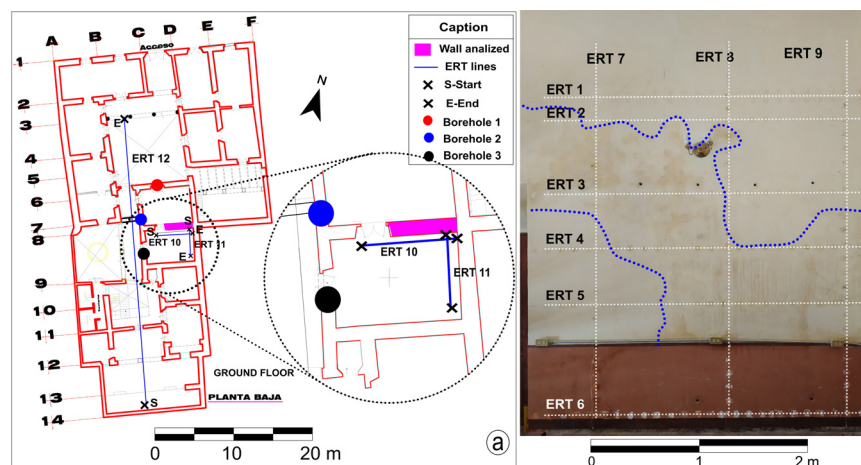
The ERT measurements were located on the area with the highest presence of moisture (on the right side of the wall), obtaining horizontal and vertical profiles in the wall, from left to right and from bottom to the top, respectively (Figure 5b). Six horizontal lines of 2.99 m long with electrodes every 0.13 m were carried out at different heights of the wall, while three verticals of 3.45 m long with electrodes every 0.15 m, completing the ERT arrangement with two floor lines of 4.6 m long with electrodes every 0.20 m (Figure 5a). Figure 5b illustrates the non-uniform ERT grid, with the highest density of horizontal lines concentrated in the area exhibiting visible surface moisture (marked in blue). The vertical lines were strategically placed based on the horizontal ERT data, targeting low resistivity zones that indicating wet conditions, as shown below in the results.

**FIGURE 5.** Location of ERT and boreholes lines on the plan view and on the wall. a) Floor plan with location of ERT lines and boreholes. b) ERT lines located on the wall. Lines in white correspond to electrical tomography measurements.
