Influence of projection angle in sandblasting cleaning on detritic stone materials in Architectural Heritage

ABSTRACT: In this research, the influence of the angle in abrasive blasting cleaning is studied on Montjuïc sandstone with black crust. After analyzing the properties of the soiling and the material, and their possible influence on the treatment, different cleaning tests were made at four different angles, keeping the complementary parameters constant. Taking the restorer's perspective as a starting point, and in order to fulfill the practical requirements of an intervention —time and cost reduction—, tests were evaluated with USB digital microscope, stereomicroscope with 3D visualization and measurement, and colorimeter. From the results it is established that angles close to 75° minimize surface alteration, reducing differential erosion in the binding phases of detritic materials usually caused by this treatment.

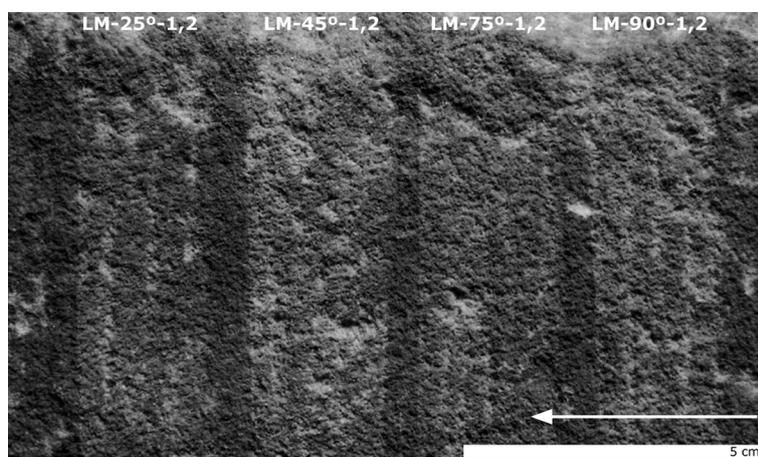
FIGURE 1. Image of the test areas with 1.2 mm nozzle.

For the tests, the fragment, of $33 \times 8 \times 2.5$ cm, was placed vertically to simulate its position in a wall and four surfaces of 20 cm^2 were generated (Figure 1).

At every surface test the angle was modified and 25°, 45°, 75° and 90° angles were used. Regarding the distance, to unify the real measurement from end of the nozzle with the selected angles 10 cm was determined, that is the distance corresponding to the hypotenuse of the triangle formed between nozzle and surface with a distance of 4.3 cm at

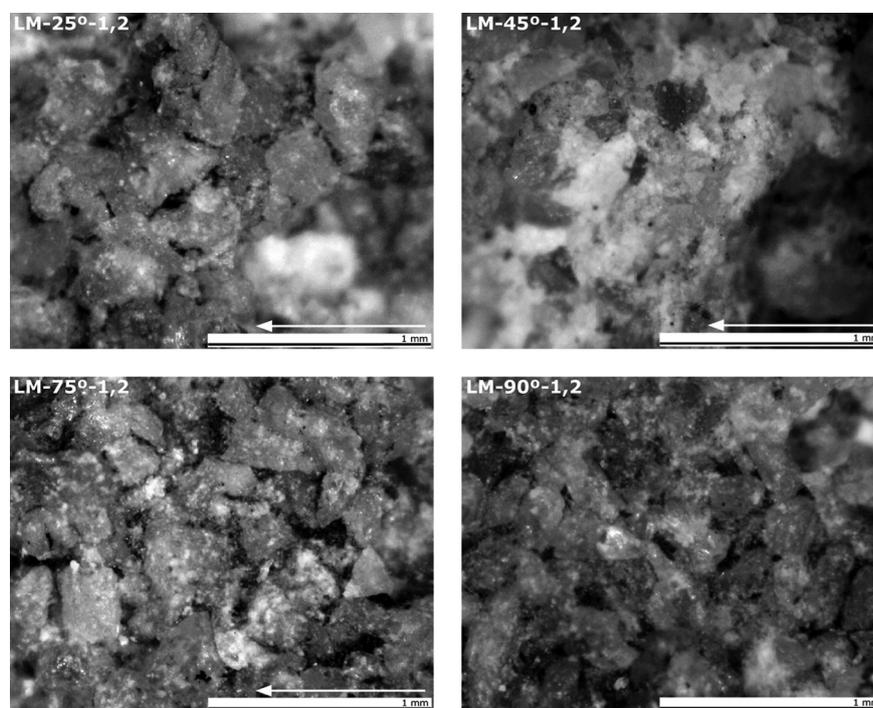
FIGURE 2. Detail of the tests after cleaning with 1.2 mm nozzle on the toothed chisel valley — arrow: blasting direction —. USB digital microscope image.

From the analysis of the tests with USB digital microscope (Figure 2) and stereomicroscope with visualization and measurement in 3D (Figures 3–4), it can be observed that the main damage has been produced in the binding phases of the stone minerals, provoking the detachment of the mineral grains according to the angle used.

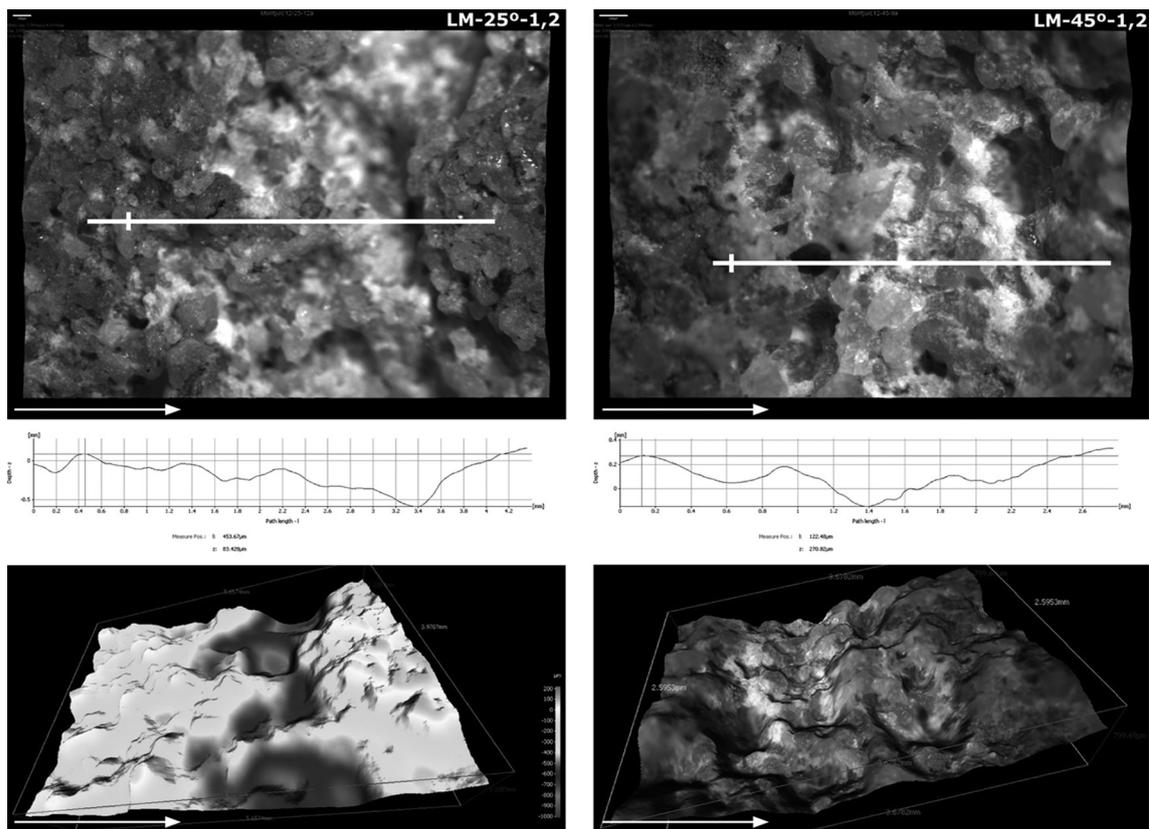
FIGURE 3. Detail of the topography and primary profile after cleaning with 25° and 45° on the toothed chisel valley — arrow: blasting direction —. Stereomicroscope with 3D visualizing and measuring image. Scale 200 µm.

The greatest alteration is observed with 45° angle. Schematising the cleaning mechanism shows that the abrasive has the capacity to penetrate most of the surface valleys, acting on peaks with a combined friction and impact mechanism. In the claw chisel grooves cavitation occurs and damage is increased by a greater impact energy than with 25°: the attack is strongest on binding phases facilitating the detachment of the grains. The surface after this cleaning is clearer.

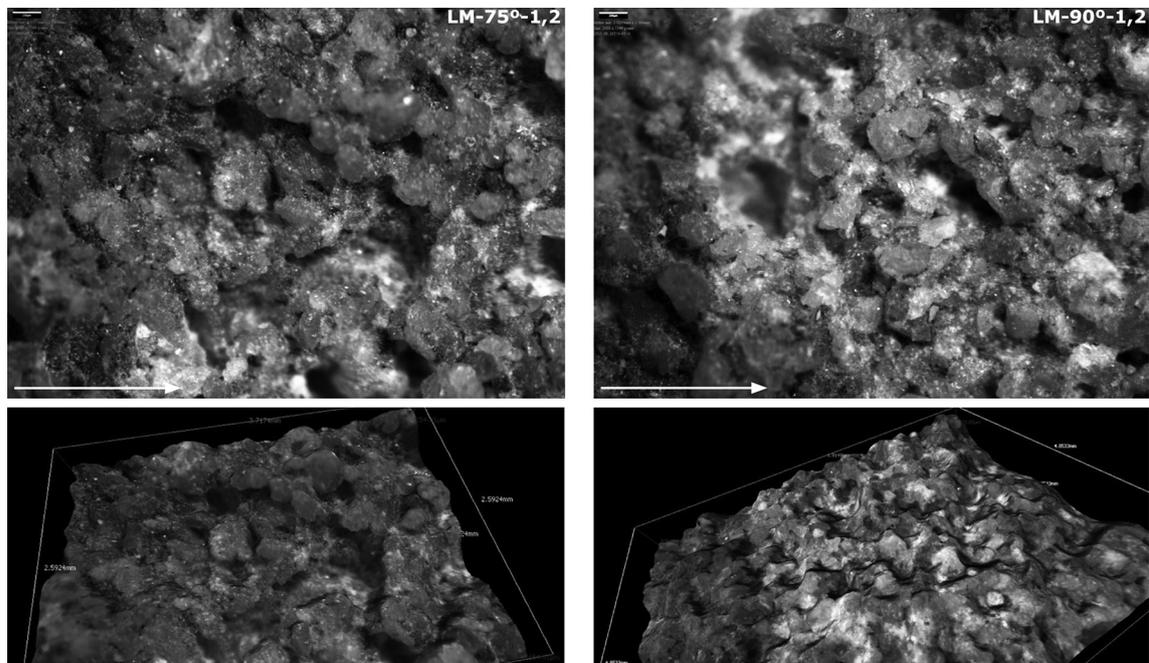
FIGURE 4. Detail of the topography after cleaning with 75° and 90° on the toothed chisel valley — arrow: blasting direction —. Stereomicroscope with 3D visualizing and measuring image. Scale 200 µm.

With 75° the penetration of the abrasive between the intergranular spaces is reduced, as confirmed by the remaining dirt. Although the impact slightly increases, it reduces friction and cavitation in the

groove of the claw chisel, but light pitting is observed on the surface of the mineral grains manifested as visual brightness loss. A lower friction reduces erosion in the binding phases and minerals are not detached. The surface is darker.

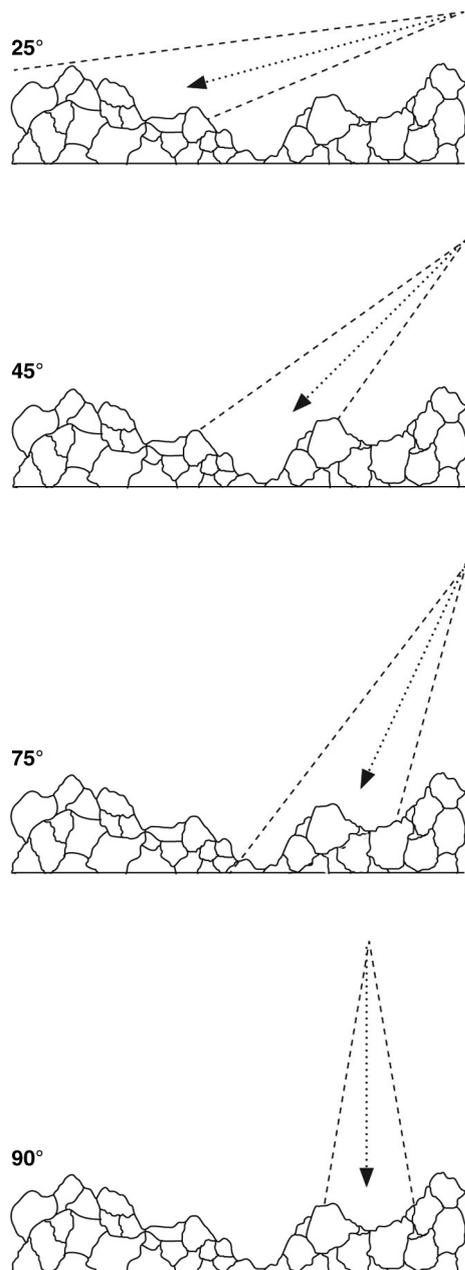
FIGURE 5. Blasting scheme on the surface with the different angles used in the trials.

By schematising the abrasive effect on the surface the reason can be determined/found (Figure 5).

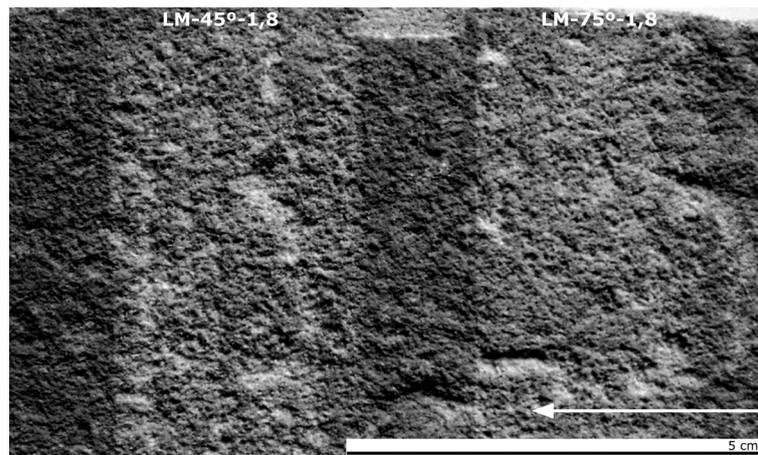
FIGURE 6. Image of the test areas with 1.8 mm nozzle.

As mentioned, after obtaining these results the test was repeated maintaining the constant parameters, and selecting the angles that have caused major and minor alteration (45° and 75°, respectively) but increasing the nozzle diameter to 1.8 mm (Figure 6).

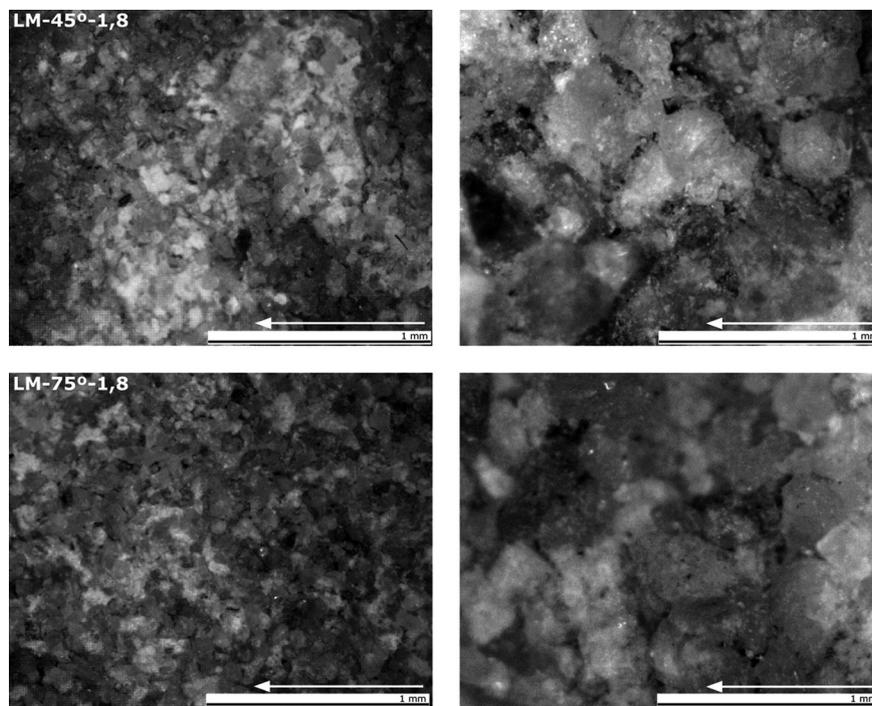
FIGURE 7. Detail of the tests after cleaning with 1.8mm nozzle on the toothed chisel valley — arrow: blasting direction —. USB digital microscope image.

In the visual analysis with magnifying optical techniques (Figure 7) and colour measurement (Table 2), similar results are obtained. Although damage is minimized, each angle provides cleaning and alteration similar to previous tests.

With 45°, comparable mechanisms are deduced: the abrasive has the capacity to penetrate most of the valleys and act on peaks with a combined mechanism of friction and impact. In the groove of the carving tool some cavitation occurs, attacking the binding phases and facilitating the detachment of the mineral grains. The hue of blackness decreases in the same way as in the preceding tests (Table 2) obtaining a lighter surface. 75° angle, reduces erosion of the binding phase and the mineral grains are not detached. With both angles dirt remains in the intergranular spaces due to the shielding produced by the grains according to the angle of incidence of the abrasive but less than with 1.2 mm nozzle.
