Erosión controlada en tubos de asbesto-cemento conductores de agua potable

Controlled erosion in asbestos-cement pipe used in drinking water distribution systems

MARIANA RAMOS P.

Departamento de Ciencia e Ingeniería de Materiales (IDIEM)
Universidad de Chile
Casilla 1420, Santiago, Chile

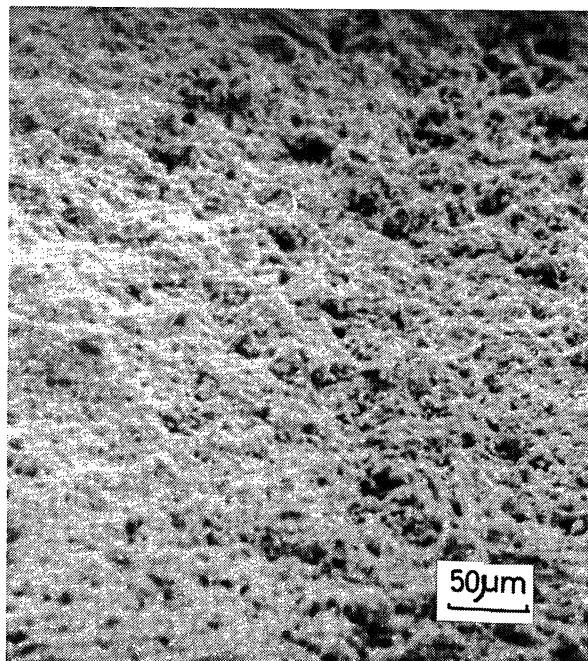
Fig. 1.—Tubo nuevo sin tratamiento. Vista general en la que se observa la rugosidad de la superficie.

Fig. 1.—New Pipe, Untreated. Overall View Showing Surface Roughness.

En los tubos sin uso no sometidos a tratamientos erosivos la superficie de la cara interna de los tubos estaba rugosa y continua, la mezcla de cemento y fibras de asbestos era homogénea y las fibras de asbestos visibles estaban entrelazadas a la matriz de cemento (Fig. 1).

In the new pipes without erosive treatment the inner face was rough and continuous, the mixture of cement and asbestos fibers was homogeneous, and the visible asbestos fibers were interlocked with the cement matrix, as can be observed in Fig. 1.

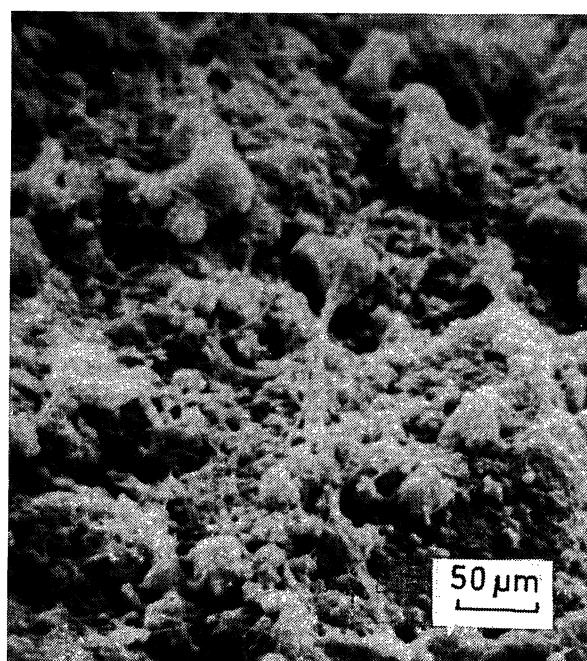
Fig. 2.—Tubo nuevo ensayado durante 60 min., con agitación. Se aprecian fibras sueltas en la superficie.

Fig. 2.—New Pipe Subjected to 60-min Agitation Testing. Loose Fibers Appear on Pipe Surface.

Las superficies de las muestras de tubos sin uso sometidas a erosión por agitación durante 60 minutos, presentan un aspecto similar a las de los tubos sin uso y sin tratamiento, pero se observan ciertos sectores erosionados, el inicio de algunas cavidades, las fibras de asbestos están más a la vista y se aprecian tambien fragmentos de la matriz (Fig. 2). Las muestras de tubos sin uso sometidas a erosión por ultrasonido durante 30 minutos, presentan una superficie diferente, más bien lisa pero con cavidades bien definidas. En los huecos producidos por la erosión se pueden observar además fibras libres de cemento (Fig. 3).

The surfaces of the new pipe samples subjected to erosion through 60 min agitation are exhibiting an appearance similar to that of the untreated new pipes, but there can be seen certain eroded areas, the formation of some cavities, the greater visibility of asbestos fibers, and some matrix fragments, as in Fig. 2. On the other hand, the new pipe samples subjected to erosion through 30 min ultrasound exhibit a different surface morphology rather smooth but with well-defined cavities. In addition cement-free fibers can be seen in the voids produced by the erosion, as in Fig. 3.

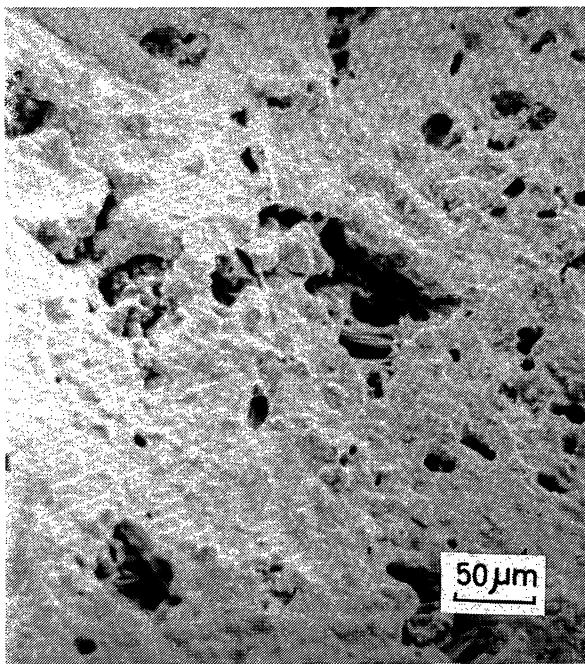
Fig. 3.—Tubo nuevo ensayado durante 30 min., con ultrasonido. Superficie erosionada en la que se aprecian numerosas cavidades.

Fig. 3.—New Pipe Subjected to 30-min Ultrasound Testing. Many Cavities Appear on Eroded Surface.

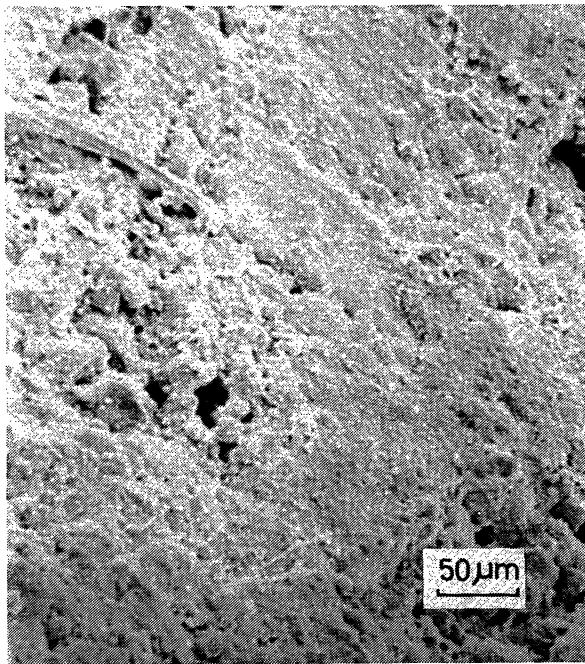
Fig. 4.—Tubo en servicio 10 años. Superficie lisa y cavidades.

Fig. 4.—Pipe in Service for 10 Years. Smooth Pipe Surface and Cavities are Visible.

Tubos en servicio durante 10 años, presentan una superficie lisa con sectores de erosión localizados y se encuentran algunos paquetes de fibras que emergen de la matriz de cemento (Fig. 4). Tubos en servicio durante 40 años también muestran una superficie muy lisa con una mayor proporción de paquetes de fibras, las cuales se observan disgregadas y sueltas (Fig. 5).

The pipes in service for 10 years (Fig. 4) exhibit a smooth surface with localised eroded areas, and some fiber bundles are emerging from the cement matrix. As to the pipes in service for 40 years (Fig. 5), they also exhibit a very smooth surface with a larger proportion of bundles, whose fibers are disgregated and loose.

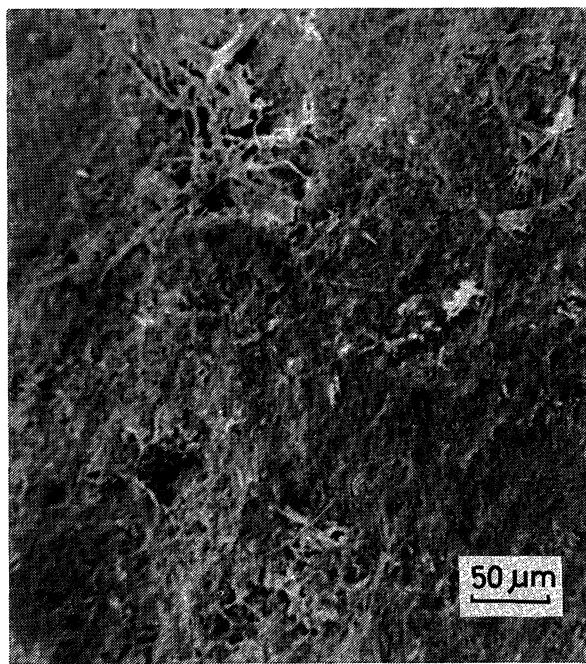
Fig. 5.—Tubo en servicio 40 años. Zonas erosionadas con fibras sueltas.

Fig. 5.—Pipe in Service for 40 Years. Eroded Zones with Loose Fibers are Visible.
